Investigation of dampness

Old Sugar Mill

Canterbury, NSW

May 2017

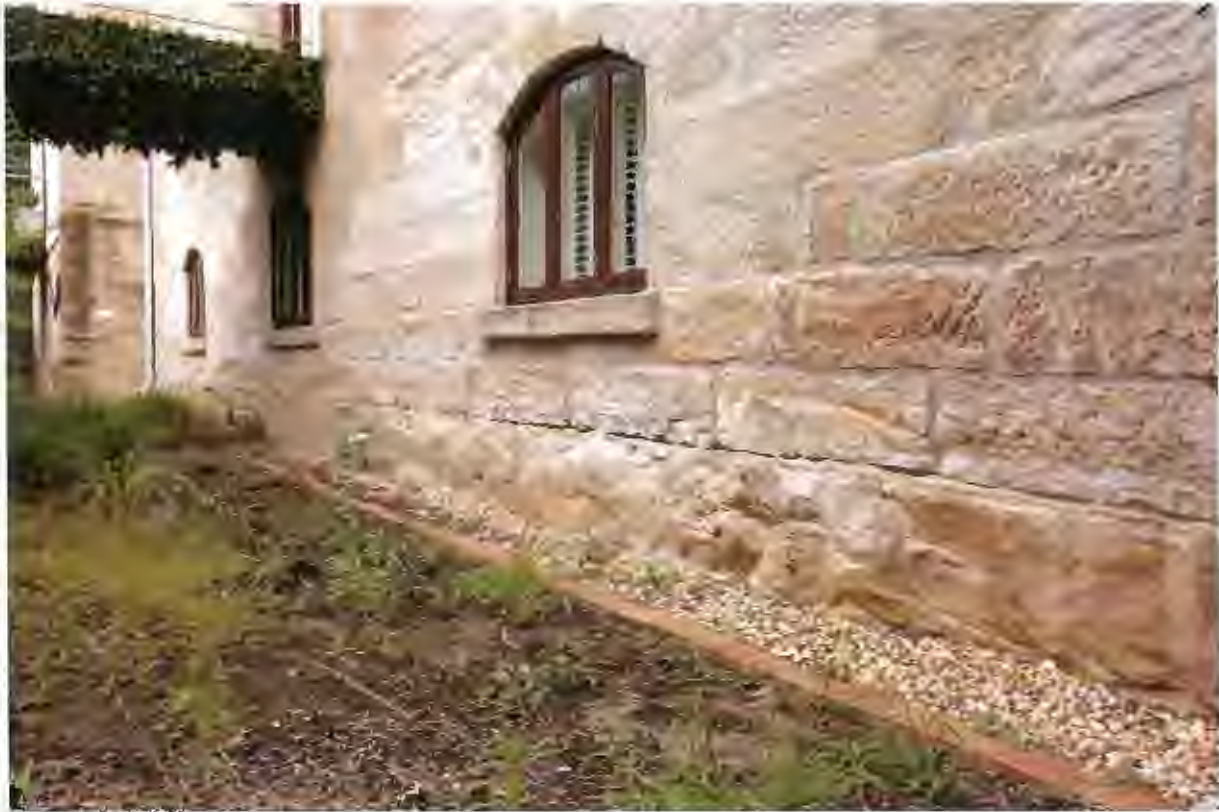
As noted above, the Woodhouse & Danks 1999 drawings show ground levels being lowered, implying excavation into the sandstone bedrock. As a result, for the northern half of the main 1841 building (i.e. Units 2 & 3) and for all of the later east wing (Unit 20), what appears to be the lower course of made stonework, is in fact the natural bedrock (Figure 1). A crude attempt to disguise this was made during the 2002 works by the cutting out and filling of fake joints in the sandstone.

Figure 4 North wall showing the bottom 'course' of sandstone, which is actually natural bedrock. An attempt to divide it into 'stones' has been made by cutting narrow slots and filling them with mortar.

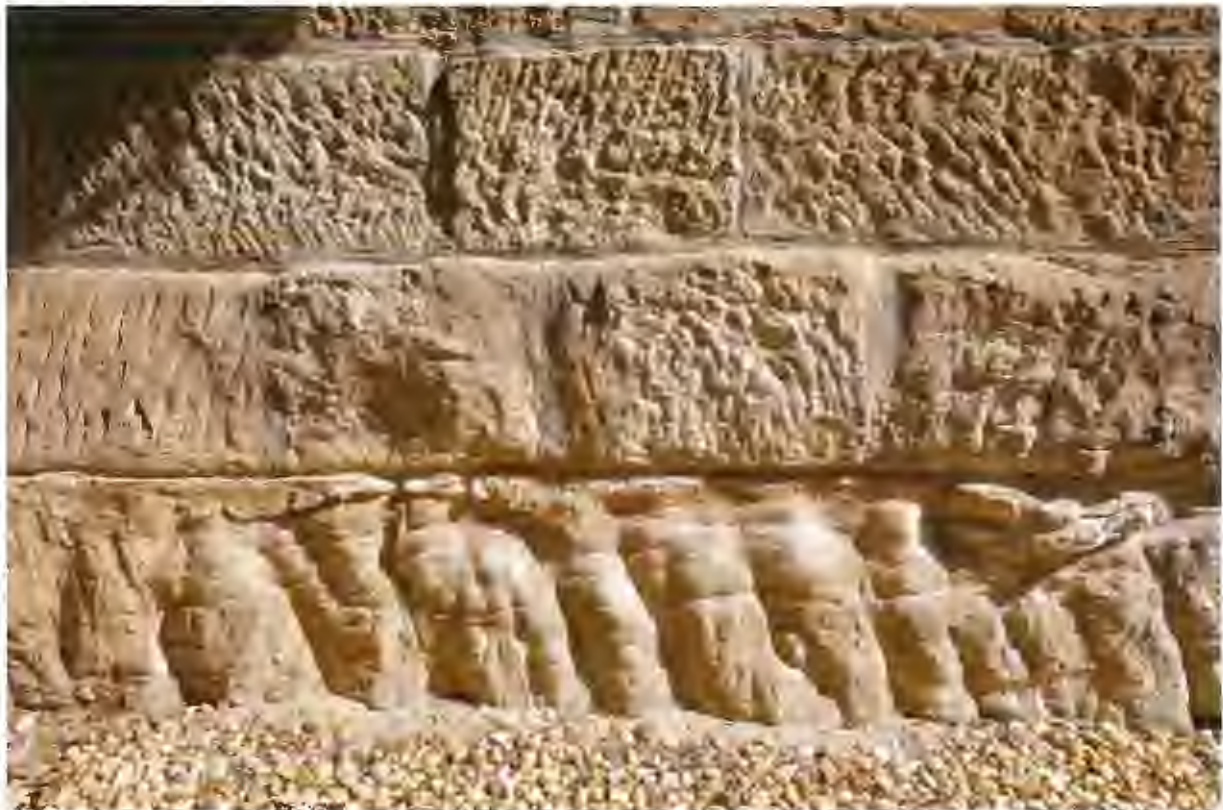
Figure 2 Fretting of the sandstone bedrock of the north wall due to salt attack and rising damp, with sand accumulating in the pebble bed below. Note the mortar patching of some stones at the left.

Most of the masonry appears in good condition, particularly given its age — 175 years. There is some decay in the form of fretting of surfaces, of both the cut stonework and the bedrock, the latter proving that some decay has occurred since 2002 (Figure 2). This is also shown by fretting of stones that likely date from the 2002 conversion (Figure 3). Fretting of the stone surfaces results in accumulation of sand in the pebble beds at the base of walls (Figure 2). Mortar patching of stones is failing in places (Figures 2 and 3). Some of the stone decay is being made worse by the impermeable nature of the cement-lime repointing (Figure 4). The 2013 repointing of the 'lowest bed joint' is decaying due to salt attack and probably, poor practice. The garden sprinkler system is spraying water onto the masonry in places, producing patches of green algae on the walls.

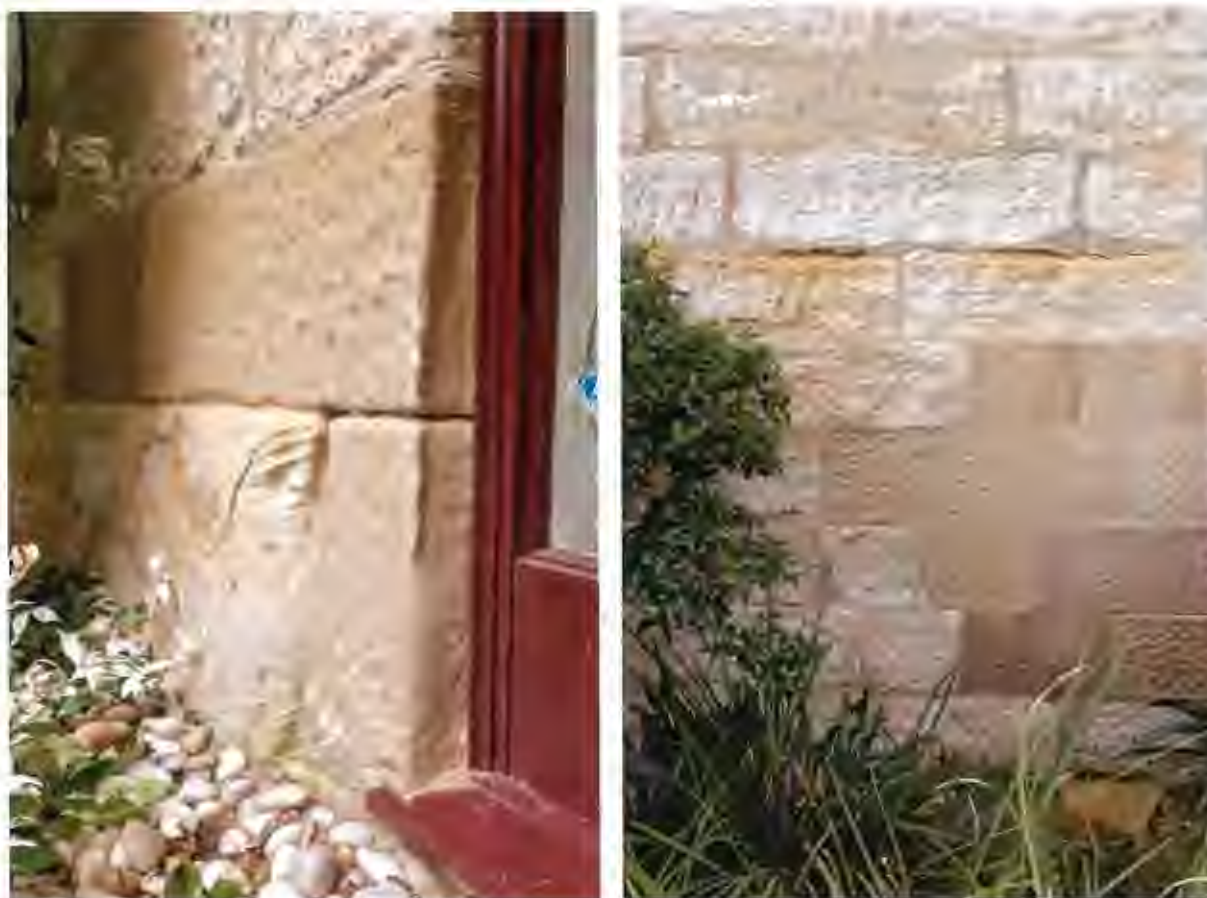
There are substantial areas of new stonework, introduced in 2002 to form openings and to replace missing and decayed stones. The new stones are a pale pinkish or creamy brown colour (Figures 3 and 4). Some stones have been patched with mortar, probably in 2002 though there may be earlier phases. Extensive rendering of the walls was removed in 2002, though traces remain. Some internal walls were rendered and painted during the earlier 'lives' of the building.

Figures 3 and 4. New stone inserted in 2002 has a pale brown colour compared to the original whiter stone. At left, the new stone is decaying, as is the mortar-patched bedrock below and to its left. On the right, decay of two original stones is made worse by the impermeable nature of the cement-lime repointing, the stones are retreating from the mortar which now stands proud, leaving a shadow line.

6.7 Other areas where stone is decaying back from impermeable cement mortars (e.g. on the south wall, Figure 4) may also warrant repointing, and so the lower parts of the walls should be carefully surveyed.

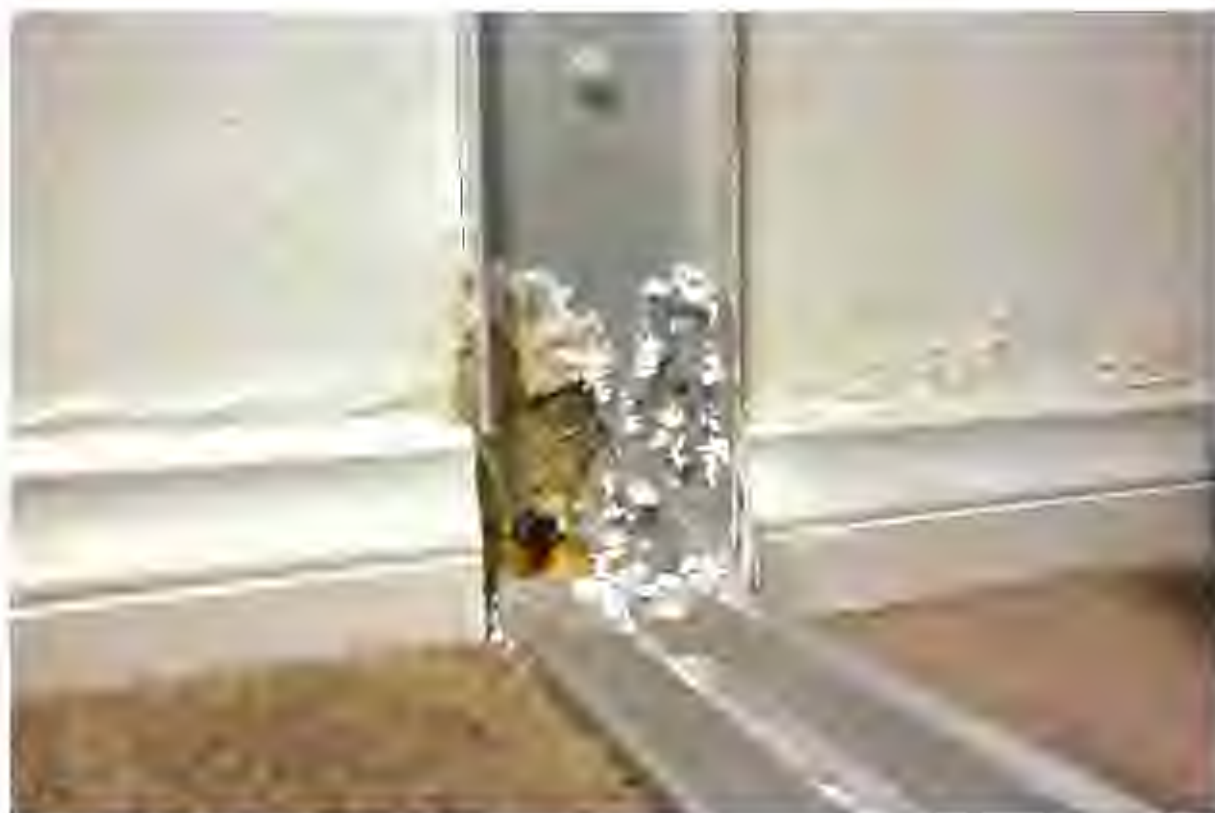
Figure 5 Corrosion of aluminium sliding wardrobe door frame due to salts and to dissimilar metals (Unit 3). Early stages of corrosion of the same aluminium detail can be seen in Units 1 and 2. Also note typical bubbling and blistering of paintwork due to moisture and salts. See also Figure 11.

Other observations include ongoing corrosion of the aluminium wardrobe door frame seen in Core Project Consulting’s report of 2012 (Unit 3, Figure 5) and early stages of corrosion in

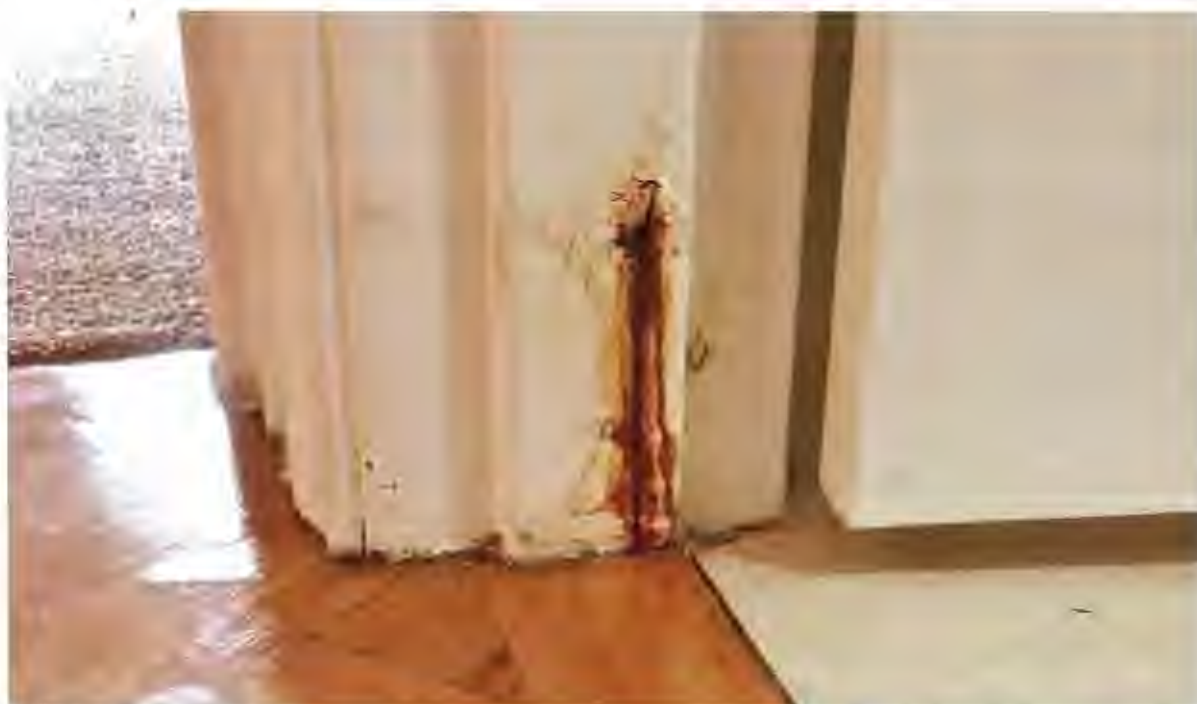
similar frames in Units 1 and 2. There are rusting steel door frames to bathrooms in Units 1 and 3 (Figure 6) and salt damaged grout between bathroom tiles in Unit 1 (Figure 7). Water staining of the parquet flooring is apparent in several units. The staining occurs near the edges of the floor close to skirtings and the old walls behind. Unexplained puddles of water have been found by the owners on parquet flooring in Units 1 and 3. These may have been related to now-resolved plumbing and drainage issues.

Figure 6 Corrosion (rusting) of steel bathroom door frame due to moisture from behind, Unit 3. Similar corrosion is apparent in Unit 1.

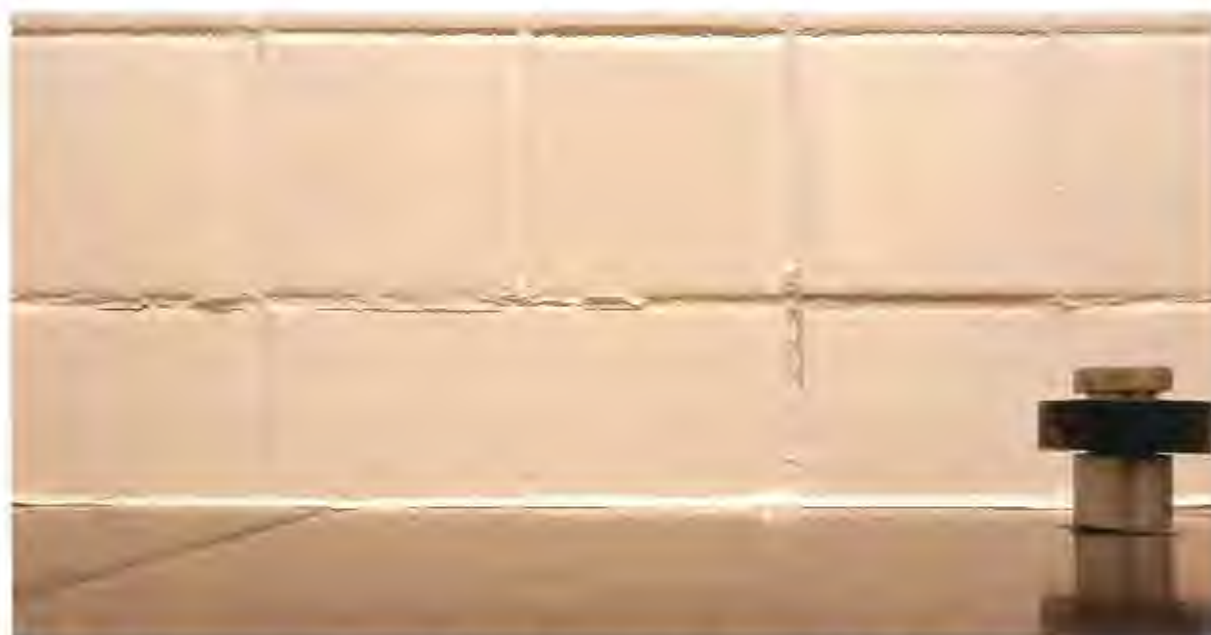
Figure 7 Decay of grout between bathroom tiles in Unit 1, due to salt attack.

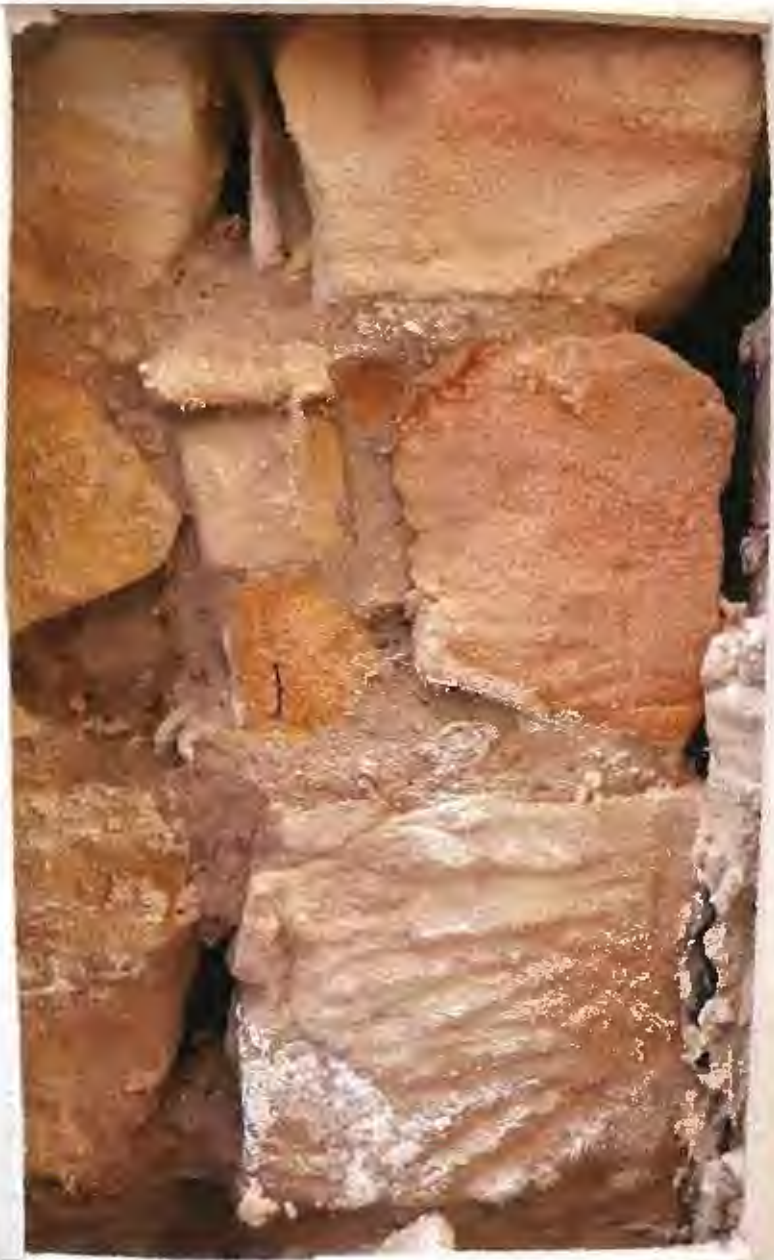
- damp and fretting stones raining sand into the void behind the plasterboard
- substantial salts crystallising on the surfaces of the stones
- deterioration of 'water-resistant' plasterboard
- corroding galvanised steel furrings that support the plasterboard
- mortar droppings bridging from stone to plasterboard
- significant loss of mortar and sandstone from salty internal walls
- bridged metal DPCs in 2002 brickwork allowing penetrating dampness
- ineffective separation of new from old, due to inadequate or torn membranes
- corrosion of 2002 galvanised steel wall ties, tying new brick to old stone
- deterioration of new brickwork due to salts nearly 2m above floor level.

Figure 8 Opening 2 in Unit 1, showing a cross section of about two thirds of the width of an internal sandstone wall. Note salts on surfaces of all stones, particularly the lower ones, and the decay of the mortar from between the stones.

Although this section had been treated in 2013, there was a new layer of damp sand bridging across from stone to plasterboard at floor level. Compare with Figure 11.

8.4 The extent of salt contamination in the basement (level 1) units should be investigated by extending some of the existing openings (up to the ceilings, and out to the full width of the old walls) to enable a thorough look at the wall sections. Of the existing openings, those that should be extended are numbers 1, 2 and 6.

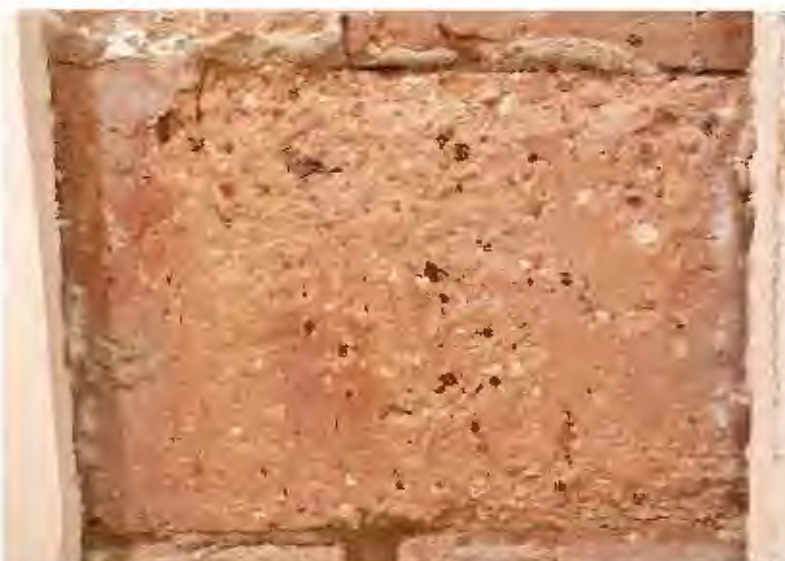
Figure 9 Opening 1a in Unit 1, which is on a short return at right angles to opening 1. This 2002 brick is decaying due to salt attack, the salt and dampness coming from the adjacent sandstone. Bubbling of the plasterboard extends almost to the ceiling, indicating that salts may be found in the next level above.

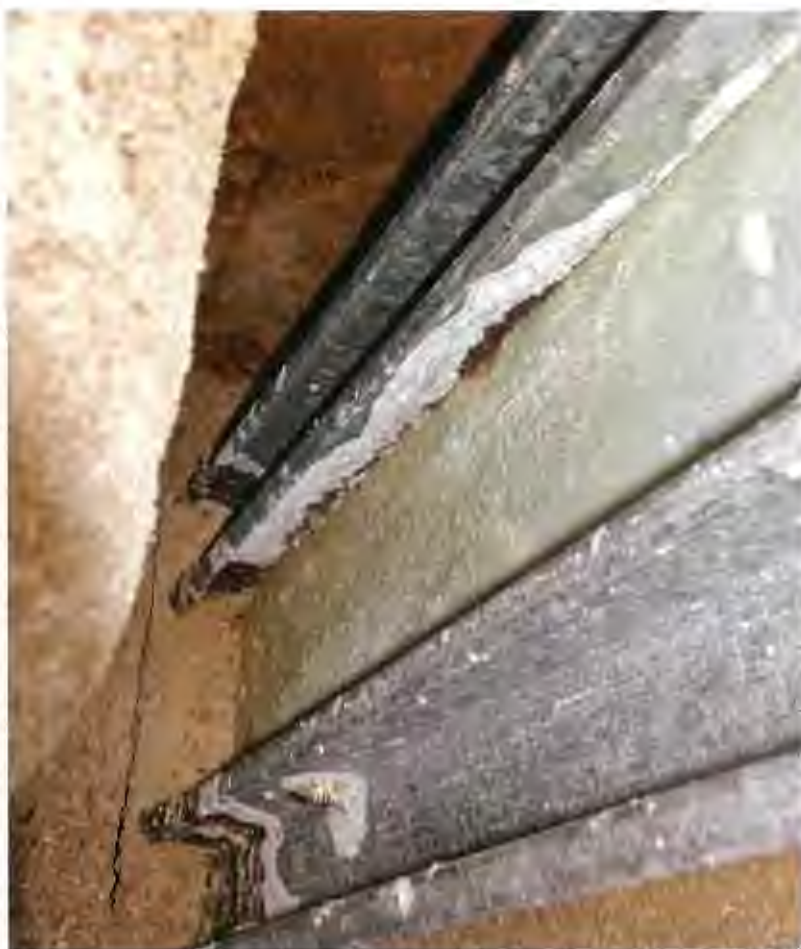
Figure 10 Opening 6 in Unit 3, looking down the gap between salty stone at left and the galvanised steel frame that supports the plasterboard lining at right. Note how the almost hidden U-section channel at the base is full of sand. Corrosion of the zinc galvanising (white) has lead to brown rusting of the steel beneath. The inner surface of the grey-green plasterboard is speckled with white salts.

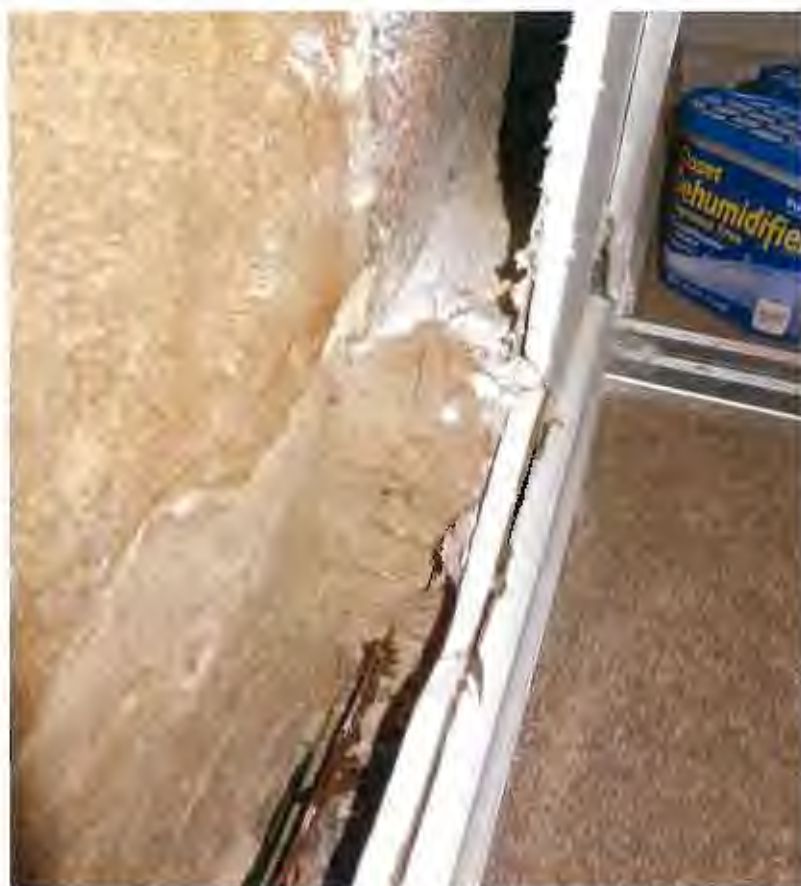
Figure 11 Opening 5 in Unit 3, which is against an external wall. Note the damp sand that has accumulated behind the plasterboard. Vacuuming out the debris in the foreground has revealed the substantial depth of sand, and the rusting steel channel at the bottom, which sits on the concrete slab floor. To the left of the rusting channel is the black plastic membrane that is intended to protect the concrete from dampness. This area was not treated in 2013.

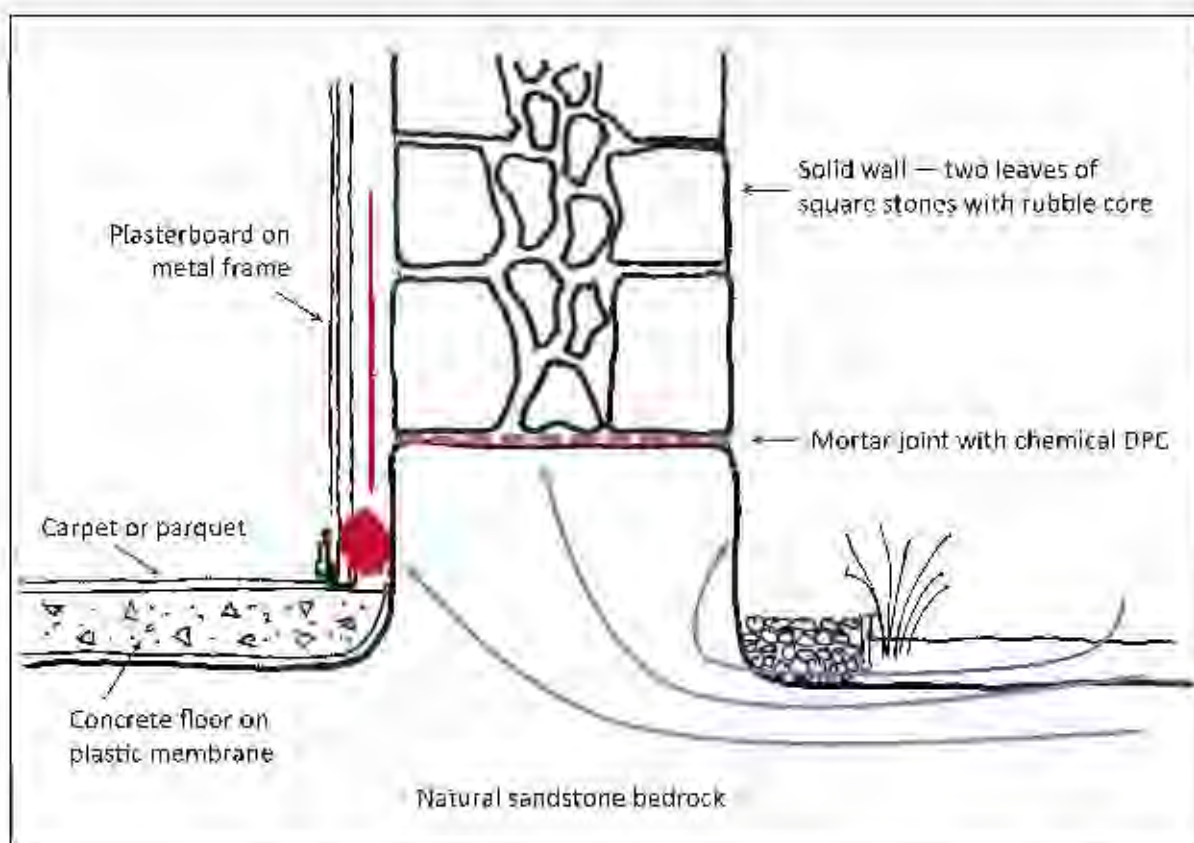
Figure 12 is a sketch showing the position of 2002 damp-proof course (DPC) relative to the internal floors and the external pebble and garden beds. As can be seen from the sketch, dampness penetrating from the gardens and through the bedrock can reach the internal surface of the sandstone walls. Sandstone that is fretting due to salt attack leaves a pile of sand at the bottom of the void behind the plasterboard linings. This salty sand permits the dampness to reach the plasterboard and cause the observed bubbling and blistering of paint and the high internal humidity leading to the growth of moulds. It also leads to the corrosion of the galvanised steel furrings (or frame) that supports the plasterboard (Figures 10 & 11).

Figure 12 Schematic section through the external wall in the northern part of the main building. Dampness (blue arrows) penetrating from the gardens and percolating through the bedrock can reach the inside face of the wall, because the damp-proof course (DPC) is positioned too high in the wall. Sand (red arrow) from fretting sandstone falls down the void behind the plasterboard linings and accumulates at the base of the void, producing a damp bridge across to the plasterboard (for example see Figure 11). The DPC should have been installed at the level shown in Figure 13.

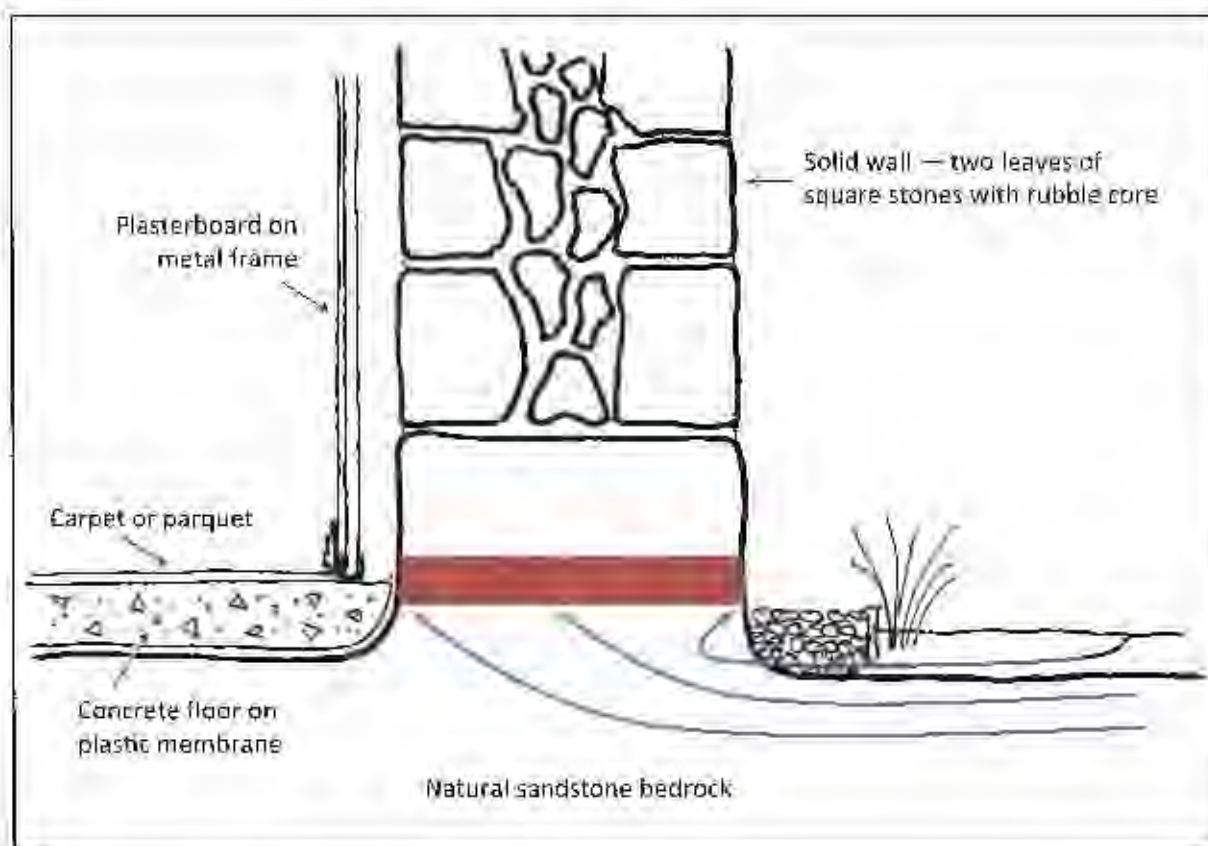
The DPC should have been installed at and just below the intended floor level as shown in Figure 13. Had that been done, and had the injection process produced a complete water-repellent zone across the full width and length of the walls, then the present problem would be much less severe than it is now. That there would still be a problem is explained below under Salt attack.

Figure 13 The same section as in Figure 12 but showing the correct position of the DPC (red-brown). Good practice would also have seen the new concrete floors kept back from the sandstone walls by at least 150mm, and the bottom third of the channel so created, filled with coarse sand to provide an evaporation zone (and drain) against the walls.

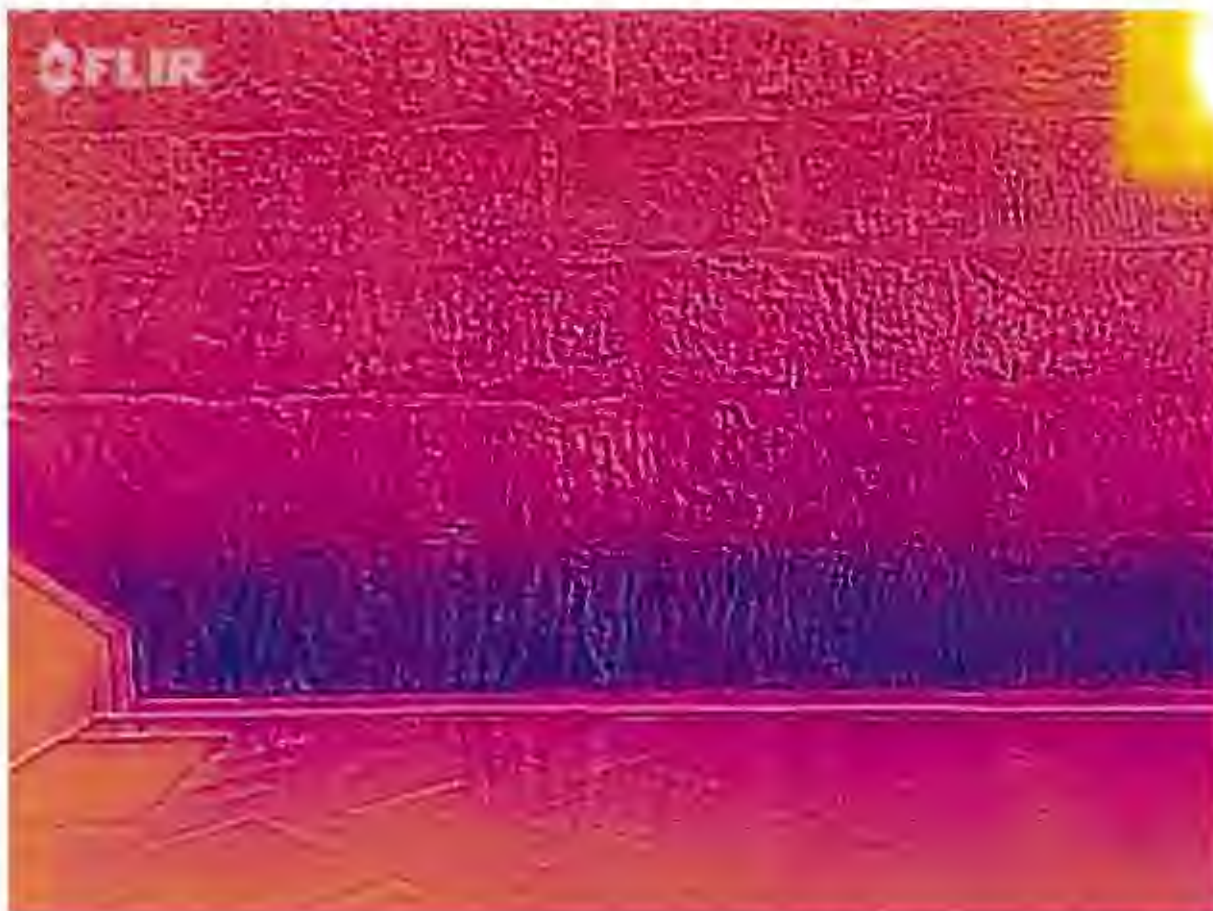
Another factor to consider is the question of the effectiveness of the present DPC. While reducing the amount of dampness rising in the walls, it may not be eliminating it entirely, and could thus be contributing to the overall problem by allowing dampness to activate soluble salts in the walls above. Given that the sandstone continues to deteriorate and rain sand into the voids behind the plasterboard, it is likely that the DPC is either not fully effective, or was not installed throughout the building. Figure 14 is a thermal image of the exposed stonework on the inside of the north wall of Unit 20. It shows the lower 'course' of stone (actually the bedrock) to be much cooler (i.e. damper) than the made stonework above it. The reasonably crisp distinction between the bedrock and the made stonework suggests that the DPC is moderately effective, though the apparent 'leakage' of colder temperatures into the stones above, does suggest that the DPC may not be fully effective.

Figure 14 Thermal image of the exposed stonework on the inside of the north wall of Unit 20. Yellow colours are warm (TV at top right, stairs and mat at bottom left), deep purple is cool. Note how the bedrock is coolest and how there is a reasonably crisp distinction in temperature between the bedrock and the made stonework above. Part of the reason that the bedrock is cooler is because of evaporation of moisture into the room.
