ARCHAEOLOGICAL TEST EXCAVATION REPORT

RESEARCH DESIGN & EXCAVATION METHODOLOGY

**13 Lower Fort Street
Dawes Point
NSW**

May 2018

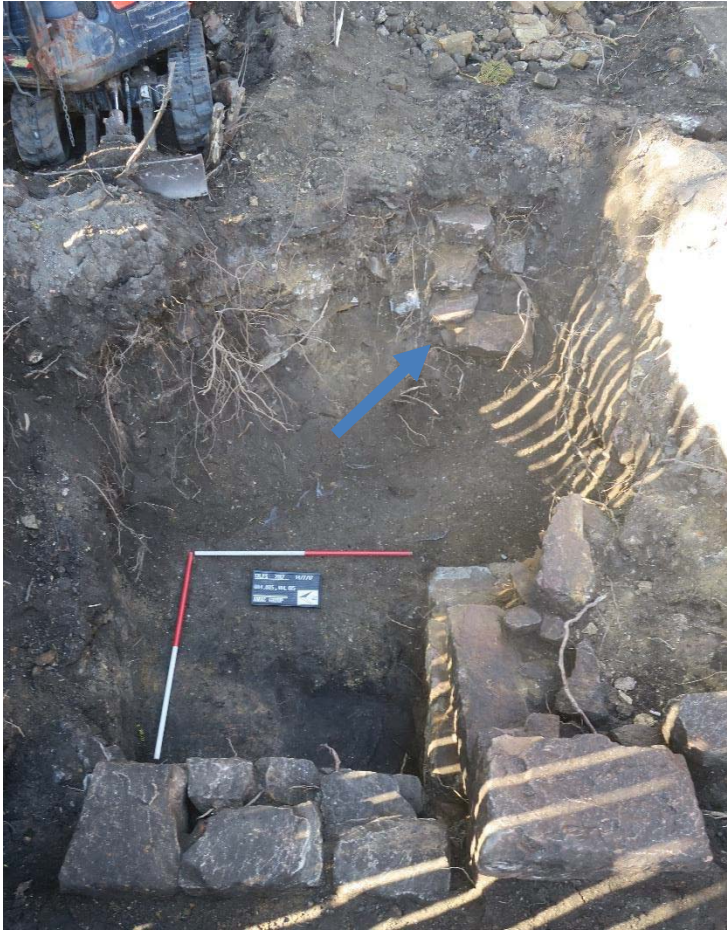
Figure 3.15 Final Trench 2, Trench 1 extension, and Trench 1, facing southwest. Continuation of wall [005] can be seen in section cut by service trench [015] (blue arrow). AMAC 0724, 14/07/17

Cut [015] has removed a substantial portion of wall [005] and is likely to have significantly disturbed any occupation deposition that may still exist within the structure.

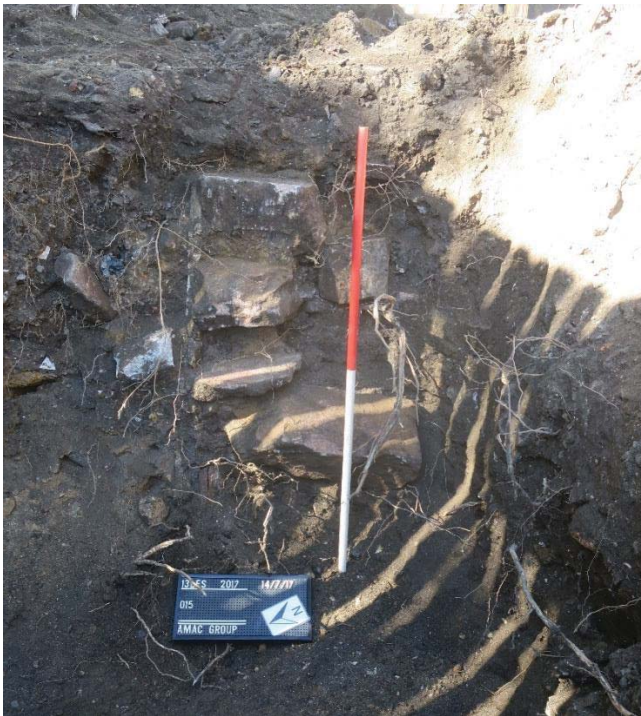
Figure 3.16 Final Trench 2, facing southwest, detailing continuation of wall [005]. AMAC 0754, 14/07/17

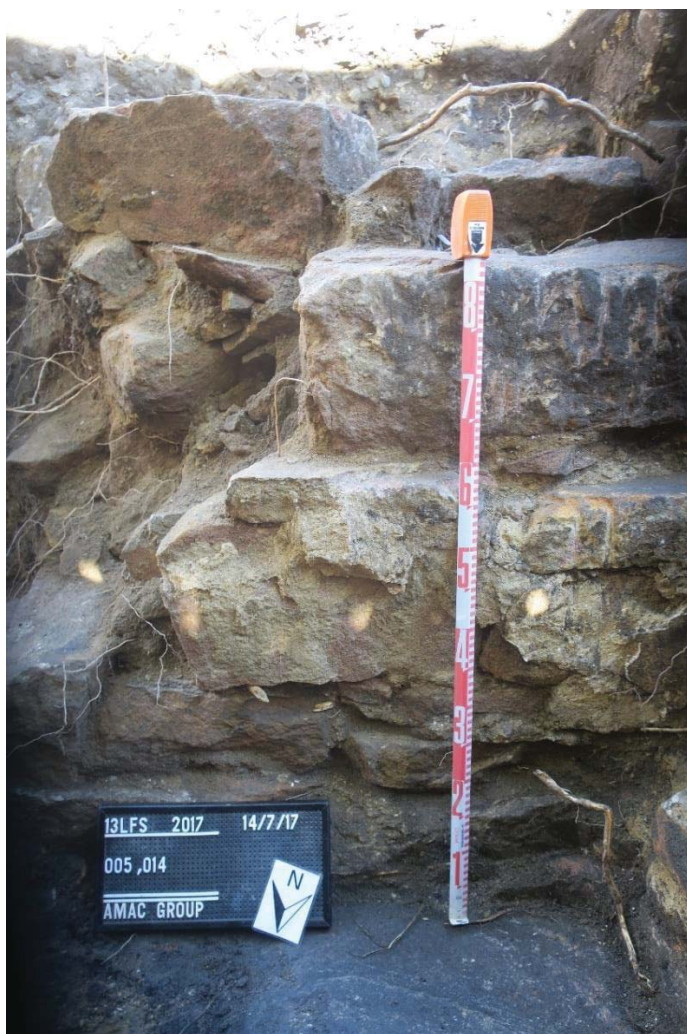
Figure 3.17 Section of wall [005] with remnant plaster, facing southwest
AMAC 0731, 14/07/17

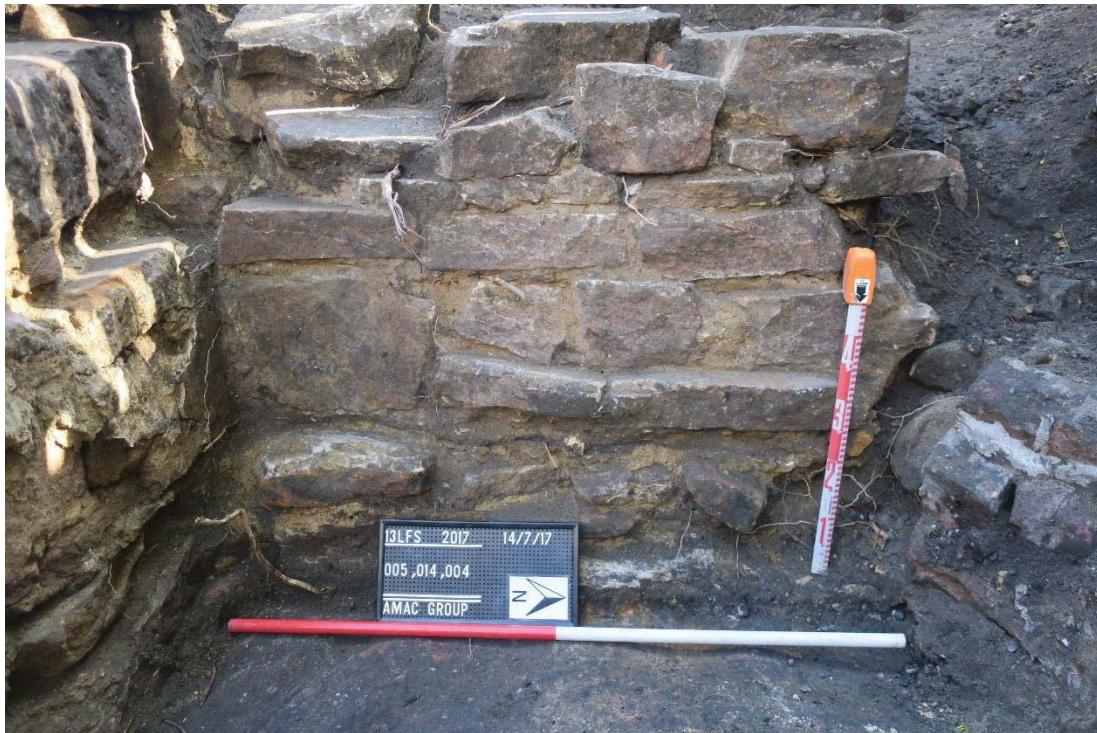
Wall [004] has been interpreted as a retaining wall (Figure 3.14; Figure 3.18). The foundation course of this wall was wider than the rest of the wall at a full width of 50cm tapering in to only 35cm in width by the upper course. This wall was constructed of up to eight courses of roughly cut irregular sandstone blocks, using far thinner blocks than the neighbouring walls [005] and [014]. Although no bonding was evidence on the surface, in section a yellow-grey shell lime mortar was identified. Only a 108cm length of this wall survived within the trench, with the northeast end robbed away, either by robber trench [017] or by the continuation of the disused service trench [015]. Wall [004] survived to a height of approximately 80cm and it is clear that the upper courses were robbed away by [017].

Figure 3.18 Section of wall [004], facing northwest
AMAC 0740, 14/07/17

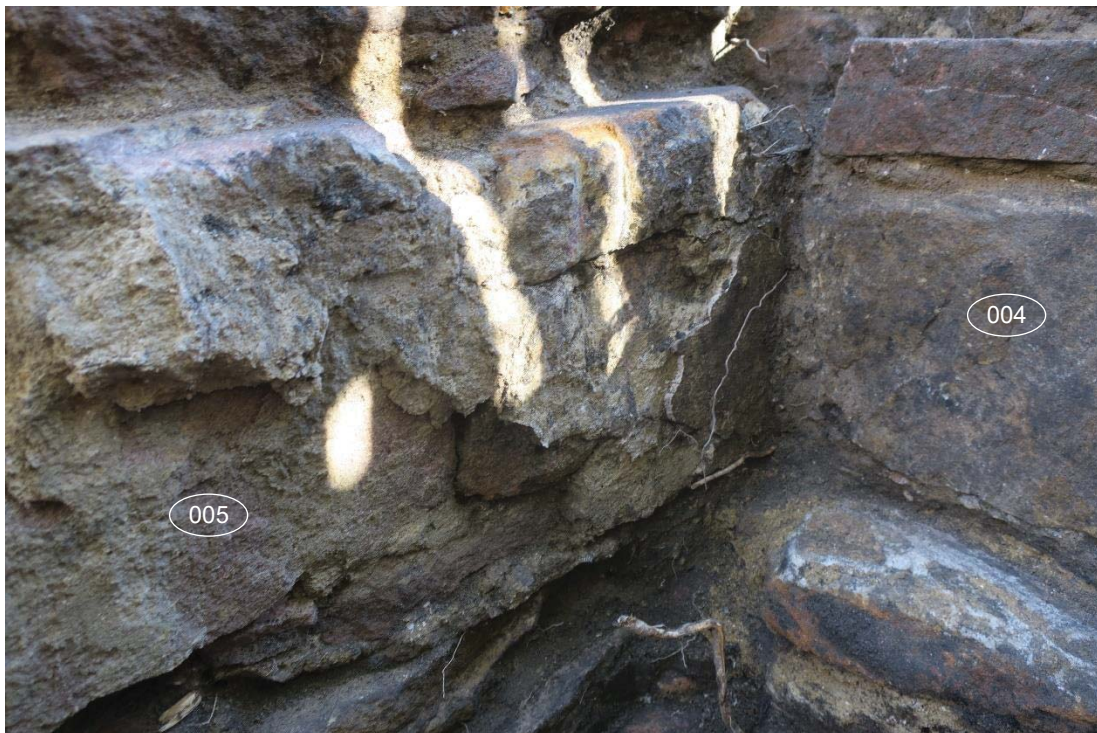
Figure 3.19 Detail of wall [004] butting wall [005], facing west
Note the plaster adhering to wall [005] in the join between walls.
AMAC 0752, 14/07/17

Wall [004] clearly butted earlier wall [005] and therefore postdates the construction of Durham Cottage. The dating of this wall is more difficult to interpret. Historic plans indicate that by the 1860s an additional building had been added to this side of Durham cottage however the plans seem to indicate that the front wall of the addition was slightly set back from the façade of Durham Cottage (Figure 3.22); wall [004] was found flush with the front wall of Durham Cottage [005]. By 1879, with the construction of the Milton Terrace Group, a retaining wall had been established along what would later become Hickson Road (Figure 3.23-Figure 3.24). This wall followed the line of the front wall of Durham Cottage, continuing northeast before a dogleg leading into the neighbouring yard. This depiction corresponds well with the archaeological evidence showing the front of Durham Cottage [005] aligned with the retaining wall [004]. It is possible that there is an error in the 1865 plan where this is shown. The shape of the yards during this period does not appear consistent with photographic evidence from a decade later. If this is the case, this would date the wall to the 1860s extension of Durham Cottage. This extension may have been necessary to support the foundations of this two-storey building which had been constructed on bedrock. The 1875 photograph (Figure 2.4) shows these wings on both sides of the building as almost a lean-to which would have provided extra support for the outer walls.

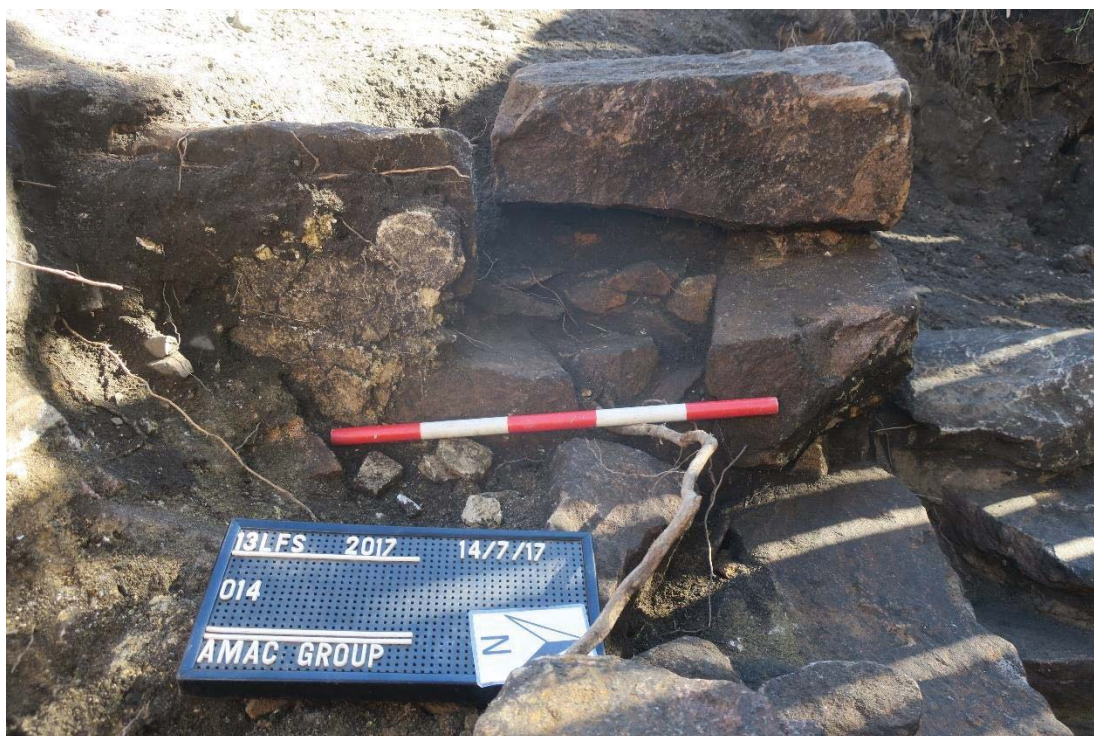
Figure 3.20 Detail of plaster on insider face of wall [014], facing northwest
AMAC 0761, 14/07/17

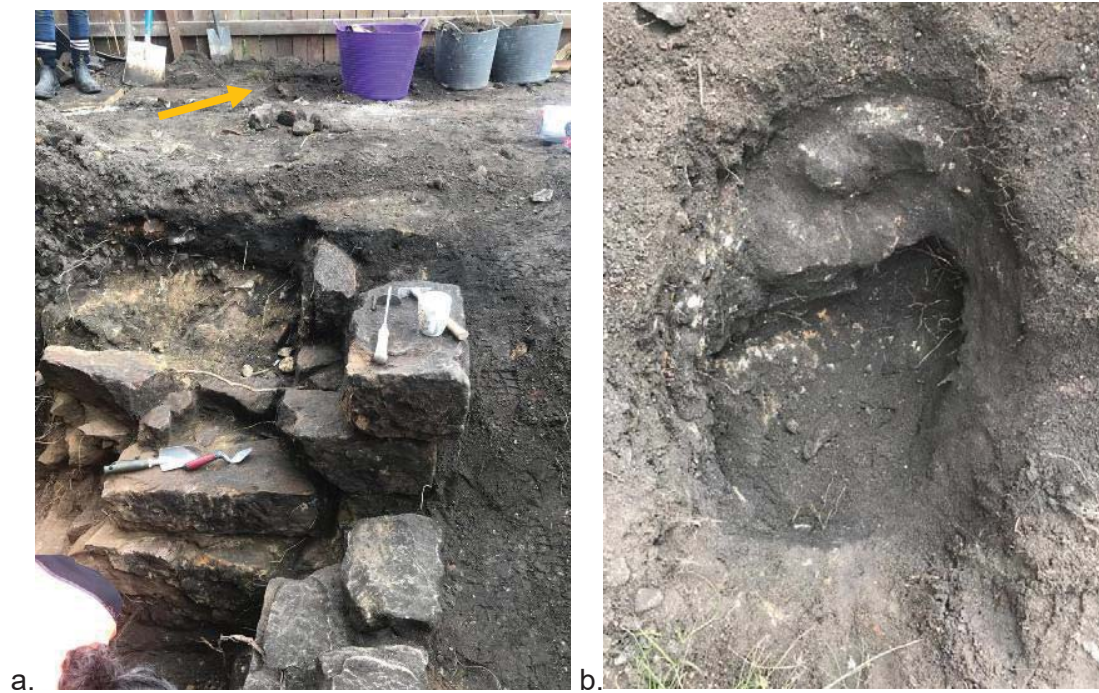
Figure 3.26 Hole 1 – abandoned due to proximity to Durham Cottage
a. Facing southwest b. facing northwest. J.Baloh, 14/07/17

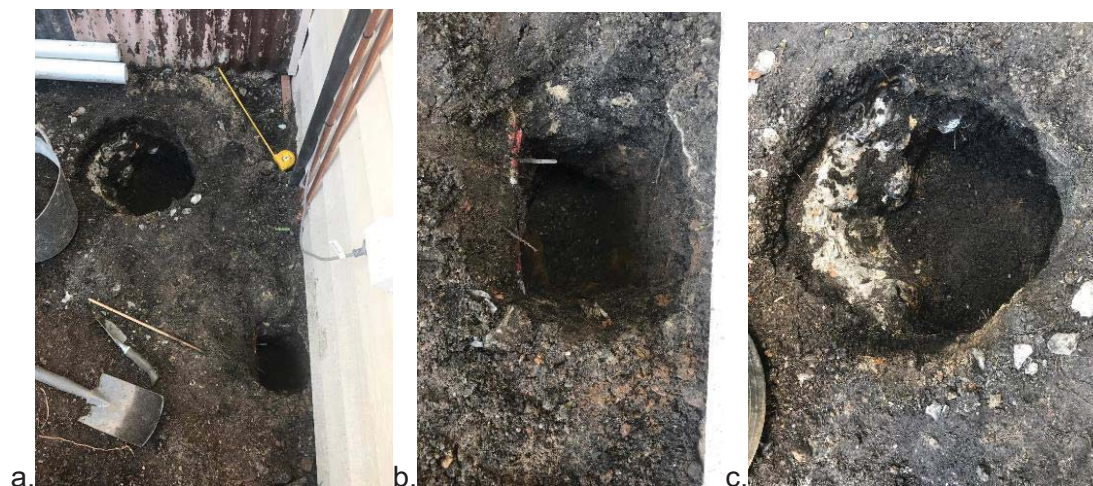
Figure 3.29 Holes 4 and 5
a. Location of Holes 4 and 5, facing northeast. b. Hole 4 facing northeast. c. Hole 5, note presence of concrete, facing northeast. J.Baloh, 14/07/17
