RAILWAY GATEHOUSE /GATEKEEPER'S COTTAGE No 4 112 Green Parade, Valley Heights, NSW, 2777

HERITAGE IMPACT STATEMENT

Revised, August 2011

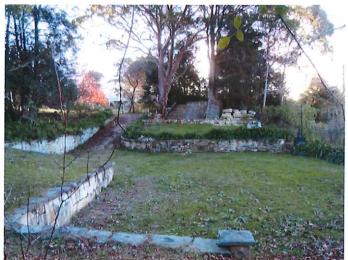
Photo 2: View west from the subject property across adjacent (vacant) lot

Note that the property has been reduced in size since original listing (1999) following subdivision, the adjacent property now being known as No. 110. This adjacent property has been modified with changed levels, stone retaining walls and the like – as shown in Figure 2 below. It is for sale.

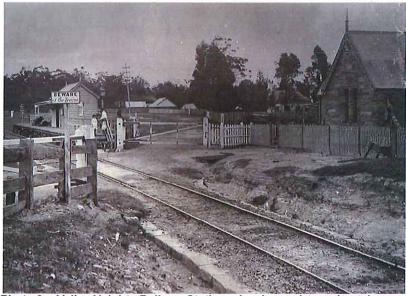
Photo 3: Valley Heights Railway Station - level crossing and gatehouse, 1878.

The two 'Valley Heights' photographs below (Photo's 3 and 4) are not of the subject building. There were two railway crossings at Valley Heights and those images conform better to a site near the (rebuilt) railway station (making it 'No. 5'). We arrive at this conclusion from studying the topography of these photos and the location of the front door/verandah - which obviously faced the point of crossing for easy access. The standard plans were obviously mirror reversed for different locations.

Nevertheless, the photographs illustrate the standard design for all the western railway residences of the time that. We suggest this permits accurate reconstruction where required for the subject building ('No. 4') at Valley Heights. Hence we include below both old and contemporary photographs of such buildings. Most usefully, they give certainty of relevant details where they are to be reconstructed for No. 4.

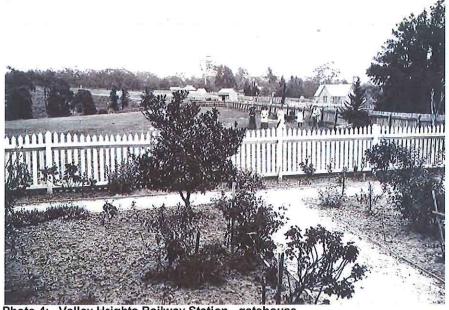
Photo 4: Valley Heights Railway Station - gatehouse

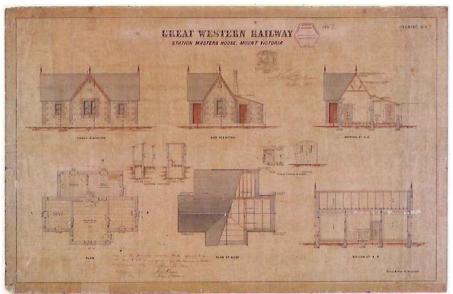
Photo 7: 1867 drawing of Station Masters House Mt Victoria – seemingly identical to the subject property. Source: State Archives, Roll 301 (Roll 164 – Plan 103)

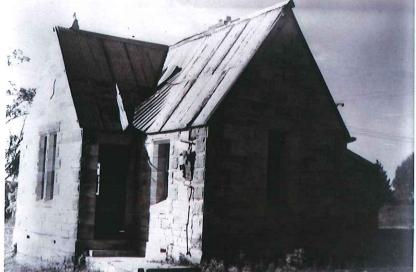
Photo 20: View c.1980 from the north west. Note the roofing, electrical meter and lower porch level (ie. intermediate threshold step since relocated).

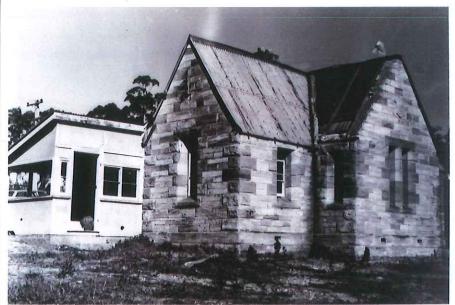
Photo 21: View from the north east, showing the rear fibro additions of the 1950's – since demolished.

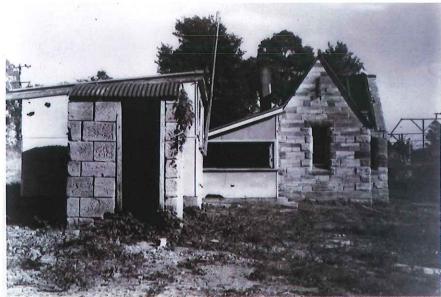
Photo 22: View from the east, showing that the sandstone ablutions block still stood at that time – since demolished. Note the roof open to the elements and leaning chimney of which the lower portion appears to be original and intact (octagonal stone) before later changes. The entire chimney was replaced in the 1980's.

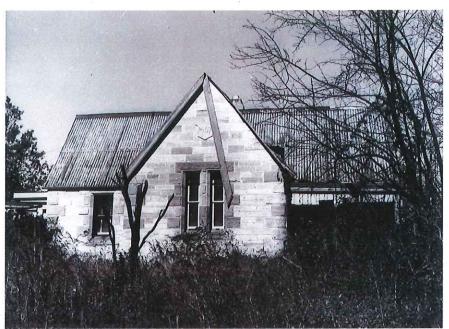
Photo 23: Northern façade with collapsing barge board, tattered verandah sun awning and over-grown garden.

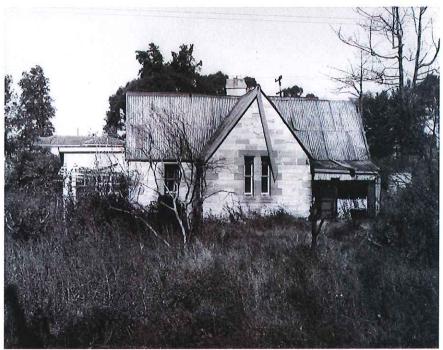
Photo 24: Similar northern view from further away also shows a collapsing pergola.

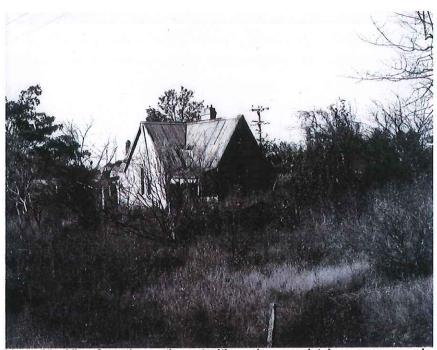
Photo 25: View from the north west with garden completely overgrown and absence of trees. The current trees, garden and stone walls have all been established since the mid 1980's.

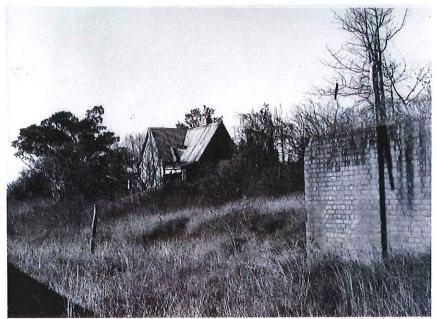
Photo 26: View further back from the north west that shows the brick abutments used for vehicular bridge between 1902 and 1913.
