## Mount Victoria Railway Station Remodelling—Geotechnical Investigations Archaeological Monitoring Report

Prepared for Sydney Trains

March 2019 – Final

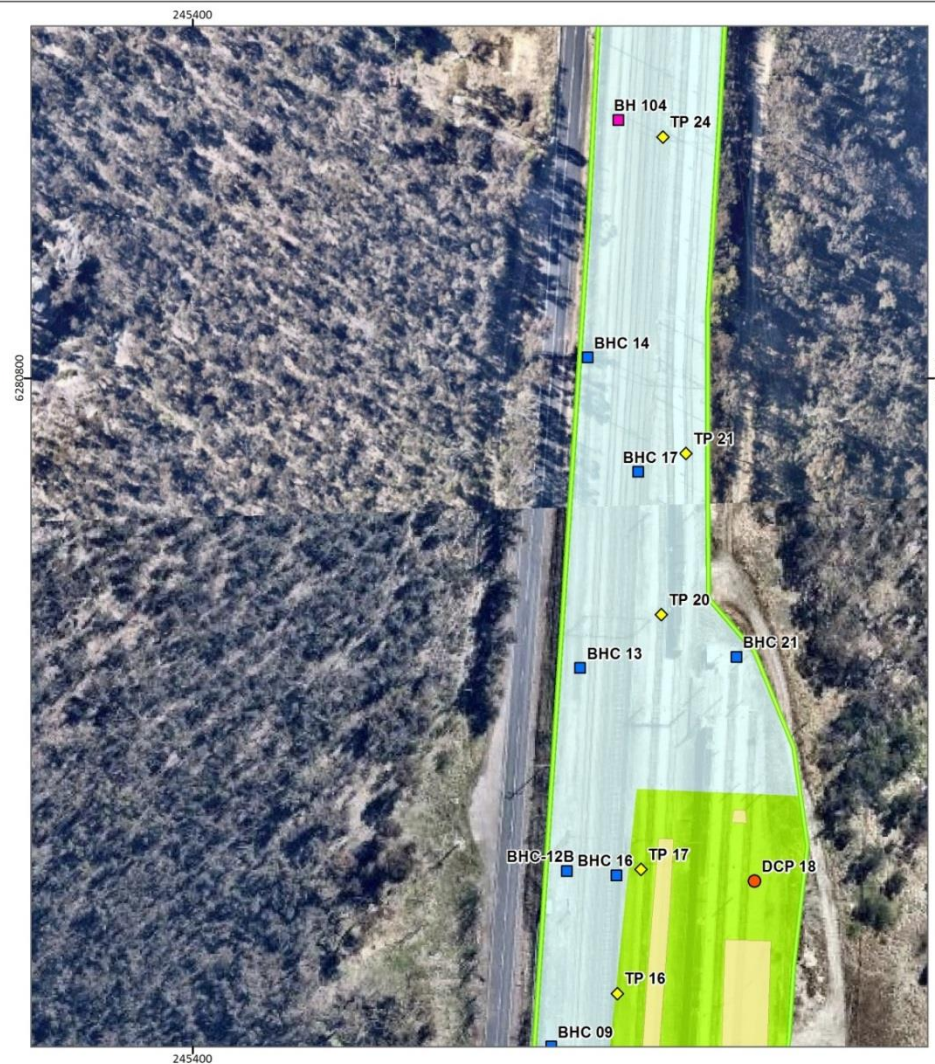
**EXTENT**  
HERITAGE ADVISORS  
**Geotechnical Investigations**  
**Sheet 8**

Figure 4. Location of geotechnical investigations—northern portion of the investigative area.

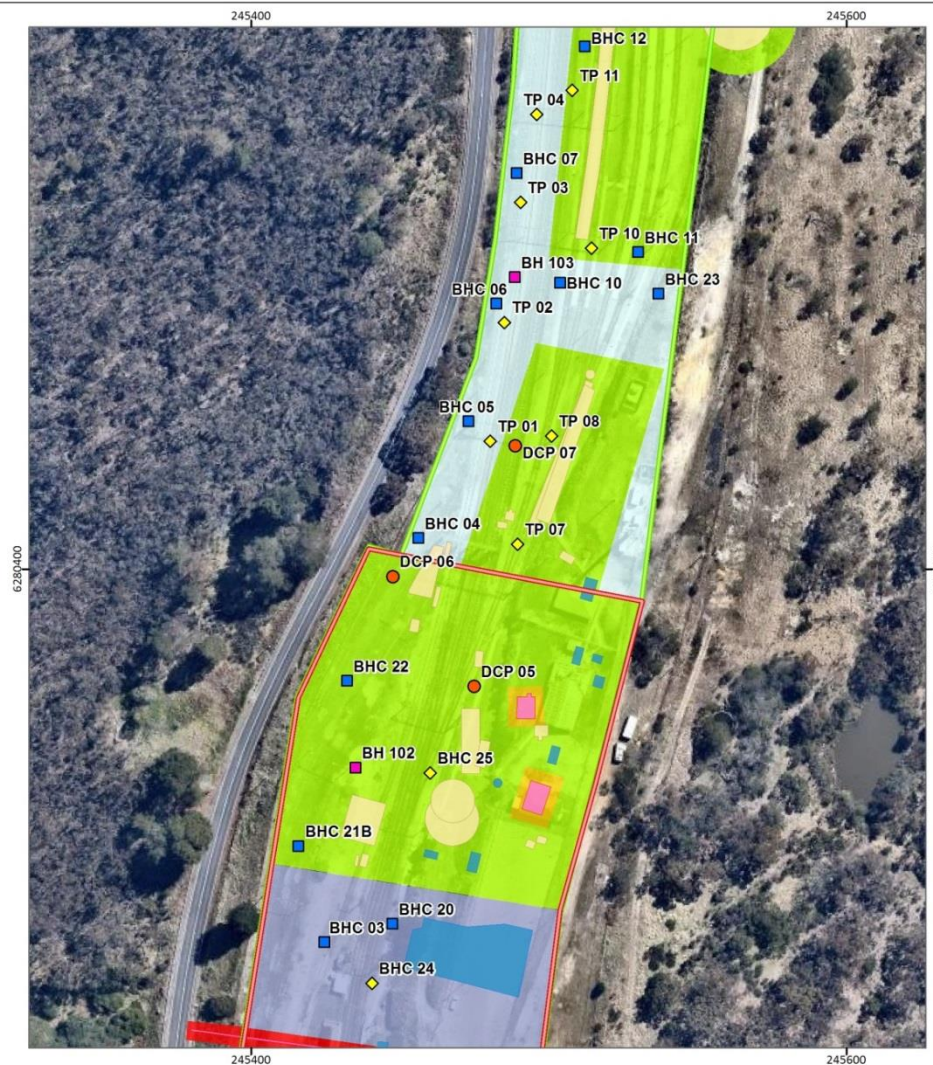
## Geotechnical Investigations Sheet 9

Figure 5. Location of geotechnical investigations—central portion of the investigative area including the north part of the SHR curtilage.

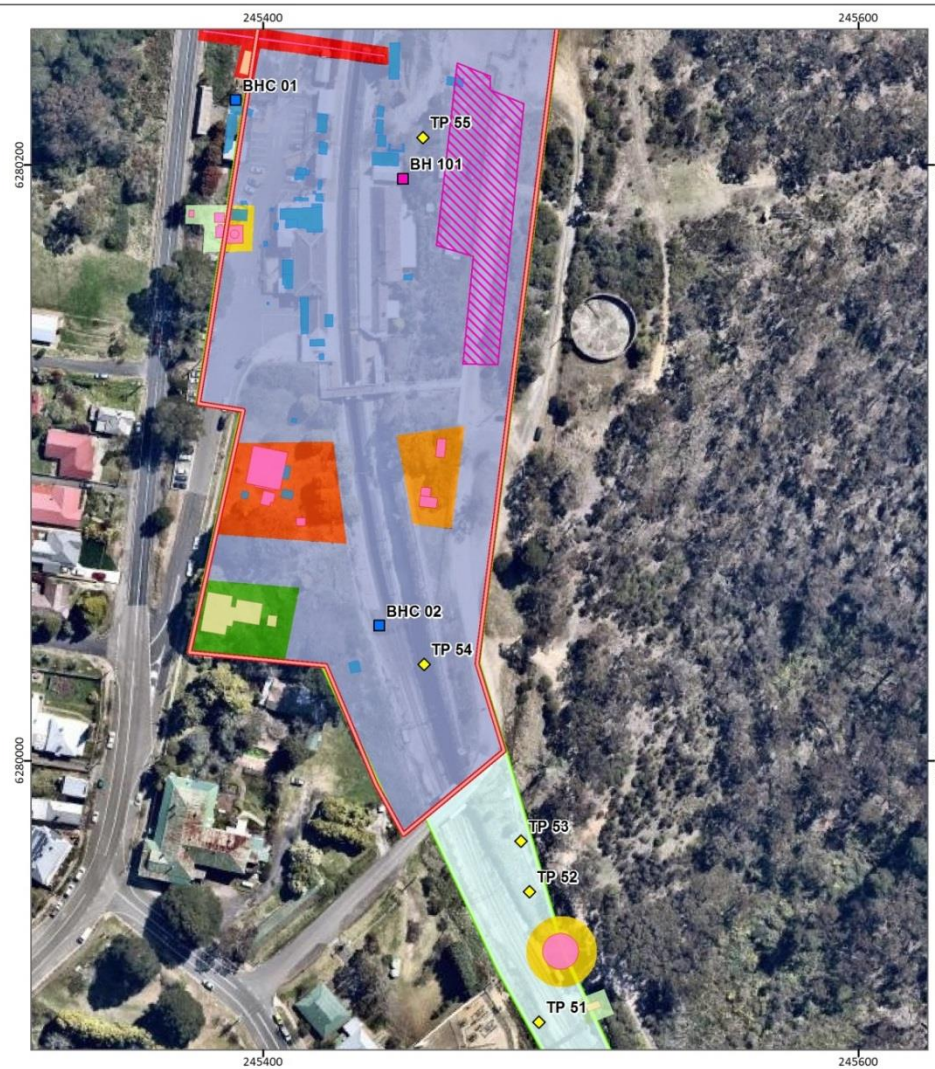
**Geotechnical Investigations  
Sheet 11**

Figure 6. Location of geotechnical investigations—southern portion of the investigative area including the southern end of the SHR curtilage.

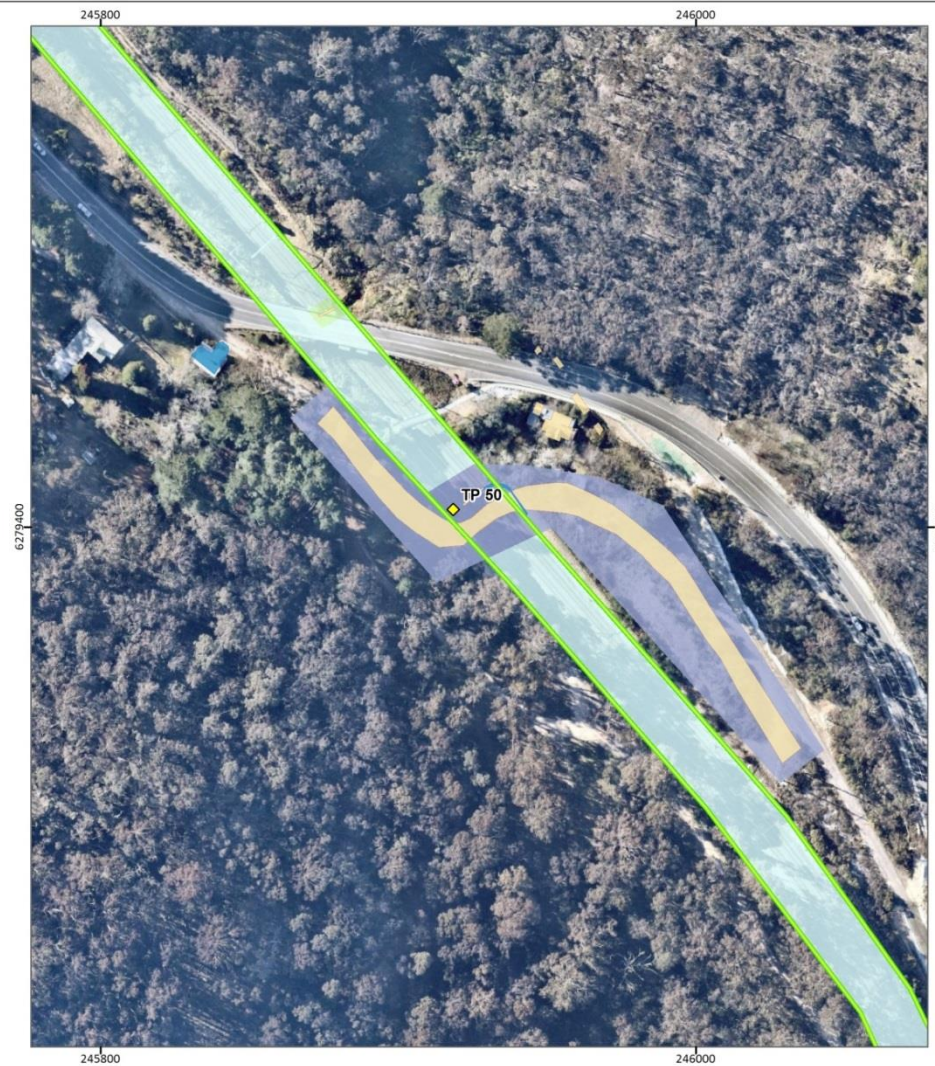
Figure 7. Location of geotechnical investigations—southernmost portion of the investigation area.

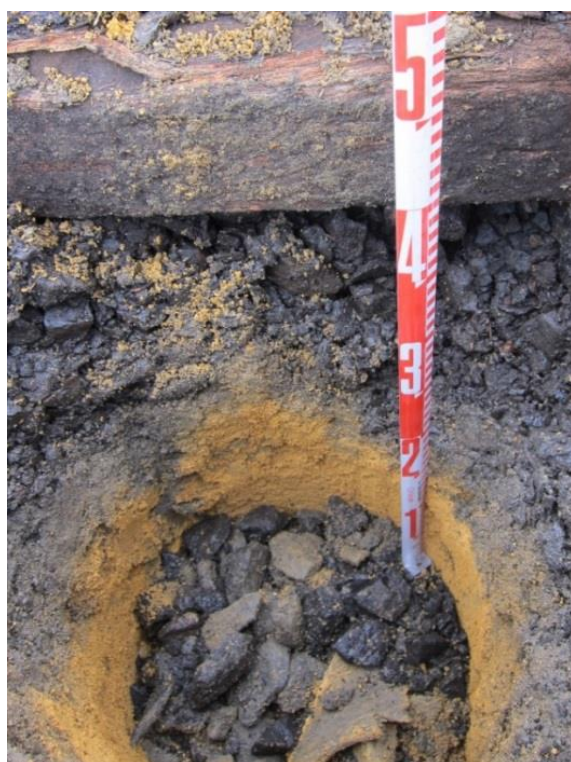
The typical subsurface soil profile at geotechnical testing locations within the active rail corridor and stabling yard is summarised in Table 3 and shown in Figure 8.

Layer	Description
Ballast	Grey medium to coarse grained gravel, with igneous cobbles
Drainage Layer	Grey fine to coarse grained silty sandy gravel, fine to coarse grained sand, with slag
Geotextile	Layer of geofabric
Fill	Fine to coarse grained gravelly sand, fine to coarse grained sandstone gravel
Subgrade	Natural bedrock of fine to coarse grained Banks Wall Sandstone

Figure 8. TP 11, showing stratigraphy within rail corridor.

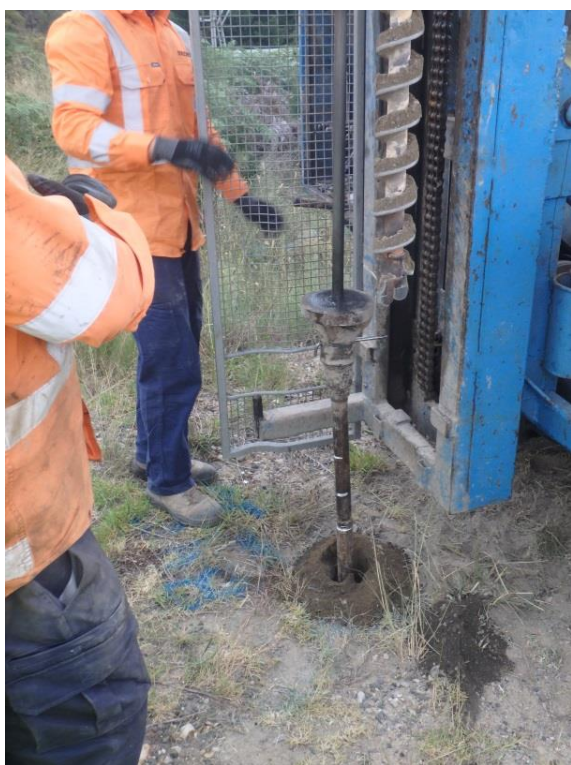
Residual natural soils (comprising silty, clayey and gravelly sand), were identified in boreholes on the western boundary of the site in BHC 1 and BHC 09; and in the cutting adjacent to (east) of the railway line in BHC 20, BHC 24, and BHC 25 (Table 4) (Figure 9-Figure 10).

ID	Description	Depth Below Surface (m)
BHC 1	Fine to coarse grained orange brown and light grey clayey sand	0.4-1.1
BHC 09	Fine to coarse grained orange brown clayey sand, trace of fine to medium grained ironstone gravel (possibly fill)	0.5-2.9
BHC 20	Fine to coarse grained orange brown and light grey clayey sand	0.8-1.1
BHC 24	Fine to coarse grained clayey sand, trace of fine to coarse grained ironstone gravel	0.8-1.1
BHC 25	Fine to coarse grained light grey clayey sand (possibly fill)	1.9-2.5

Figure 9. Excavation of BHC 24.

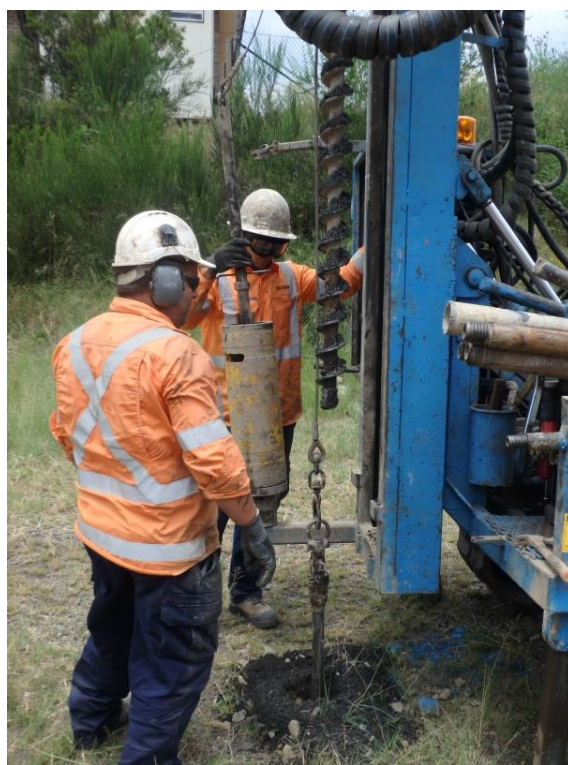
Figure 10. Excavation of BHC 25.

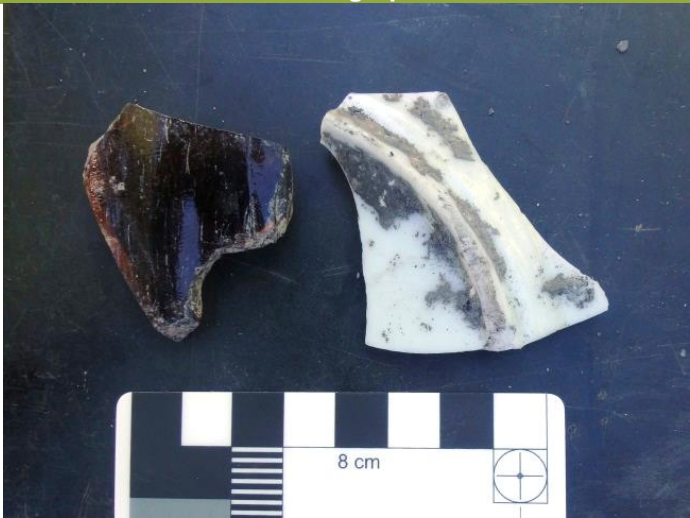
ID	Description of Finds	Photograph
TP 55	<p>bottle, brown, curved body fragment with vertical mould seam</p> <p>saucer, basal sherd with foot ring, undecorated institutional porcelain</p>

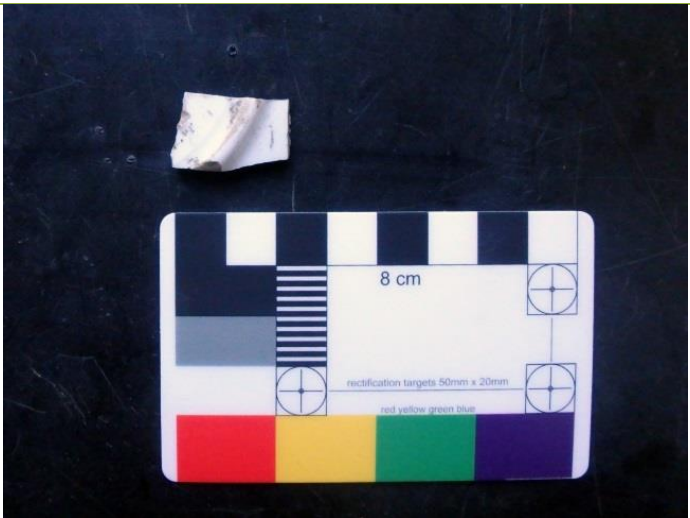
BH 103	<p>saucer, basal sherd with foot ring, undecorated institutional porcelain</p>

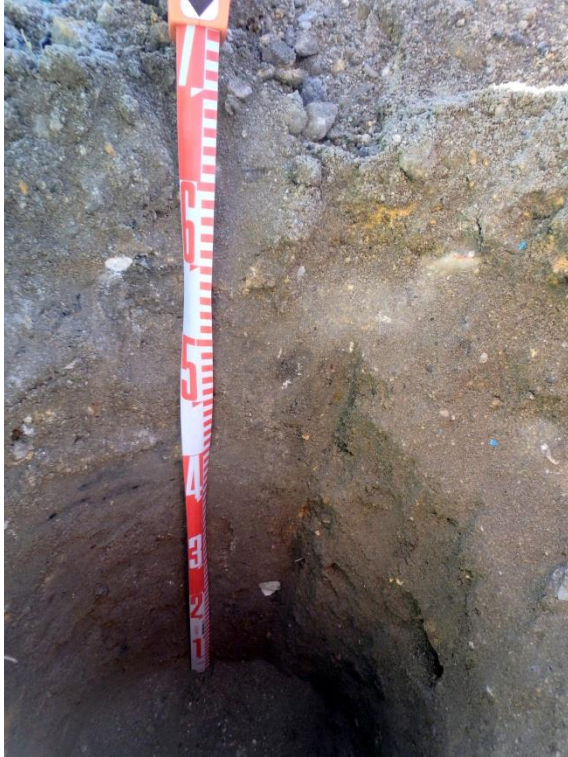
TP 55 is located to the north east of the Up platform (Platform 1) on a ramp to the overflow car park, in an area identified as having moderate archaeological potential. The soil profile in this location is predominantly fill, consisting of well compacted brown gravelly silty sand with sandstone gravel and traces of sandstone cobbles and slag (0-30cm), overlying moderately compacted brown silty sand with sandstone gravel and slag (30-85cm) on sandstone bedrock (JK Geotechnics 2018) (Figure 11-Figure 12). Highly fragmented sherds of institutional porcelain are visible in the soil profile, and are also present in a surface scatter in the vicinity of the borehole (Figure 13).

Figure 11. Soil profile, TP 55.

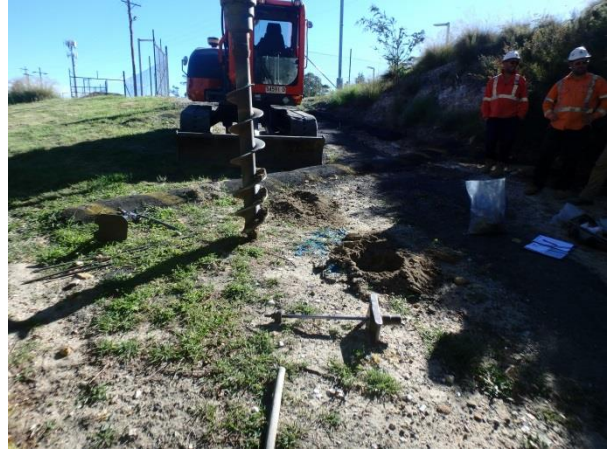
Figure 12. Excavation of TP 55 to the north east of the Up platform (Platform 1).

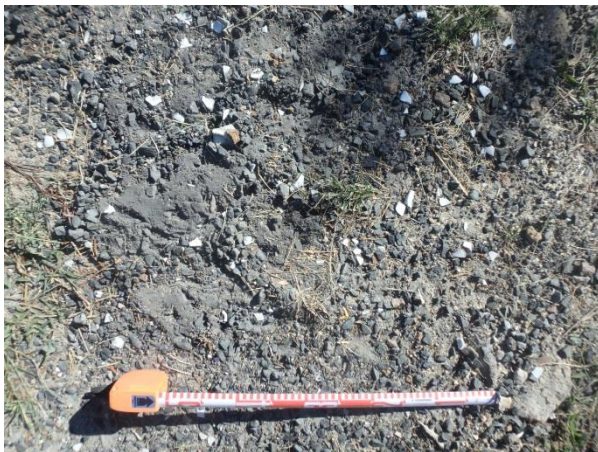
Figure 13. Surface artefact scatter in vicinity of TP 55.

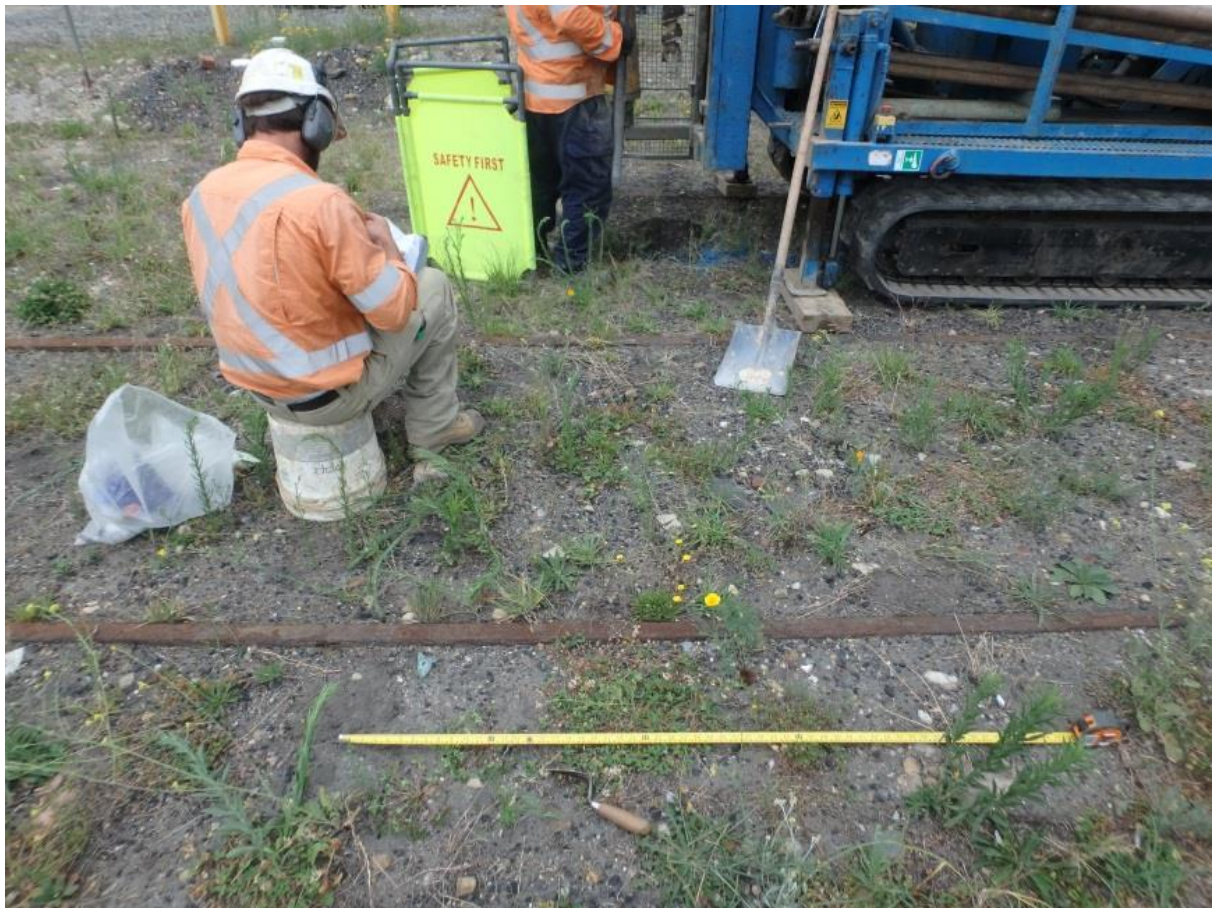
Surface artefact scatters at Mount Victoria railway station were also noted at two additional locations: in the vicinity of BHC 1, to the west of the station in the vicinity of the septic tank, approximately 9m south of the location of a former refuse bin; and BHC 11, within the stabling yards to the north of the station and east of the former coal stage. Artefacts observed included a Codd bottle body fragment (c.1880 *TPQ*), a ceramic fragment with brown banded decoration, and window glass fragments approximately 2m west of BHC 1 (Figure 17), and a scatter of highly fragmented surface finds immediately north of BHC 11. Neither of the scatters was impacted by the geotechnical investigations.

Figure 17. Excavation of BHC 1 with surface artefact scatter in foreground.

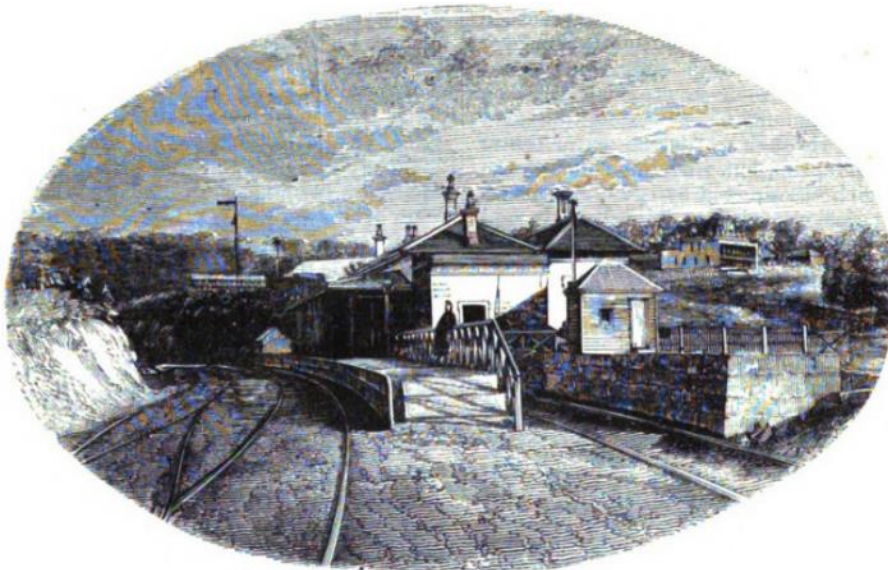
**Illustration of Mount Victoria Railway Station in 1879 (Source: *The Railway Guide of New South Wales 1879:54*)**

The original station building was a single storey Victorian Regency building constructed of sandstone. This contained a porter's room, parcels office, booking office, waiting room, ladies waiting room and lavatories. The station buildings design was consistent with designs made by the Engineer-in-Chief of the NSW Railways, John Whitton. In 1868, Mount Victoria was described by Sydney Morning Herald at the opening ceremony as a 'model station':

*[...] it would be well if the Government would repeat it as often as they have got occasion to build a railway station in the future. It is a plain structure, with a verandah and stone platform. It is built of coursed rubble, tuck-pointed and roofed with slate (SMH 1868:7).]*

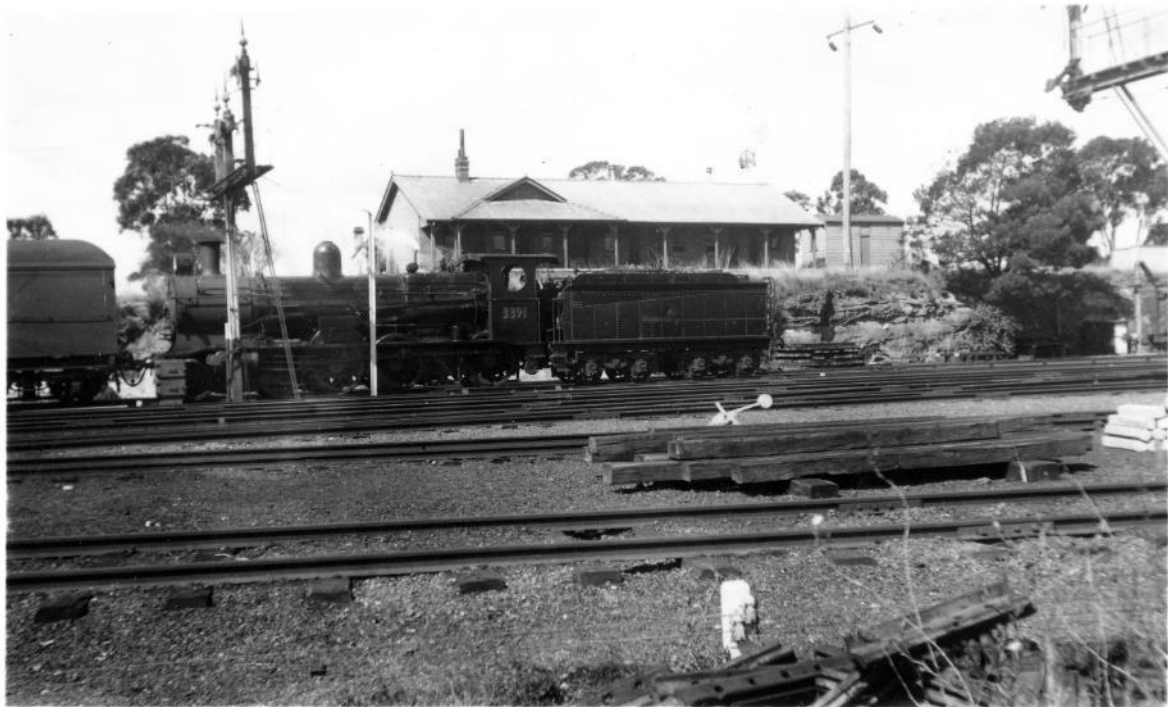
***Undated image of the Barracks prior to the enclosure of the verandah. Image taken pre-electrification (Source: Australian Railway Historical Society (ARHS) NSW, Image ID 012109).***

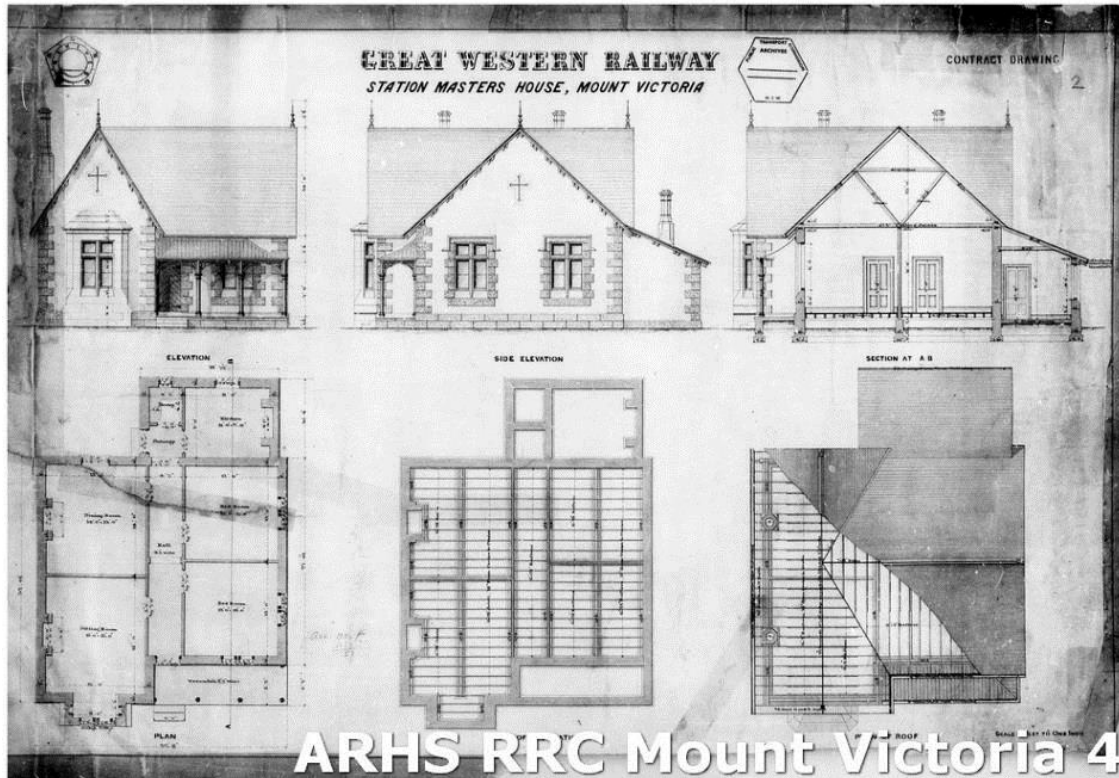
**1867 plan of the Station Master's Cottage (Source: Australian Railway Historical Society (ARHS) NSW)**

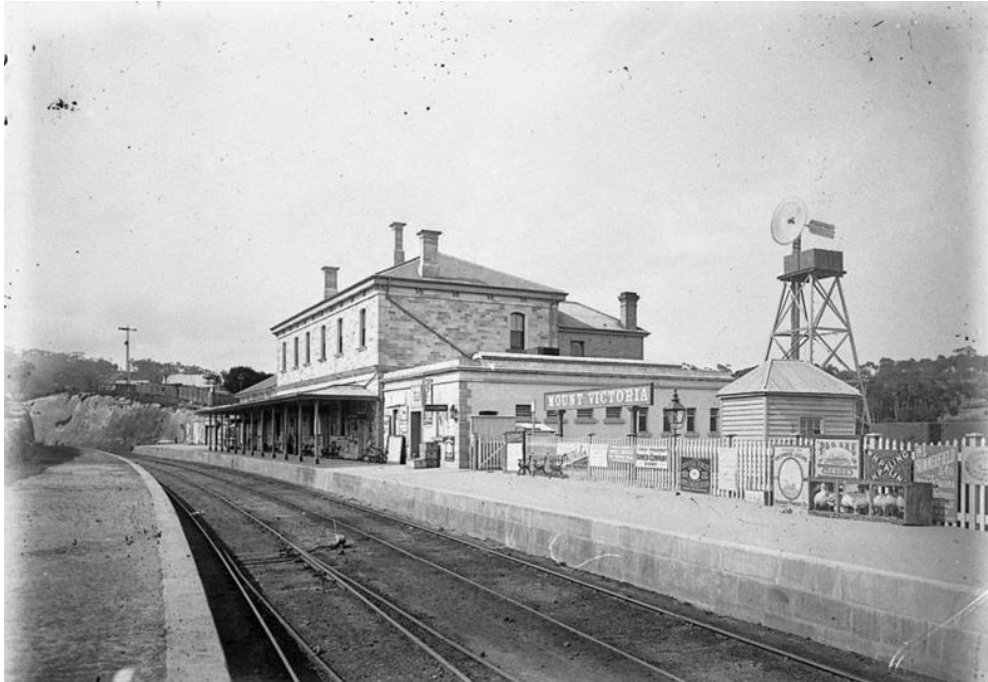
***1900s photograph of Mount Victoria Station showing the first-floor addition and sandstone platform (Source: Hall Collection: Photographs of Sydney Streets, Buildings and People, 1900s-1930s – State Library of NSW, Call Number ‘Home and Away – 35265’)***

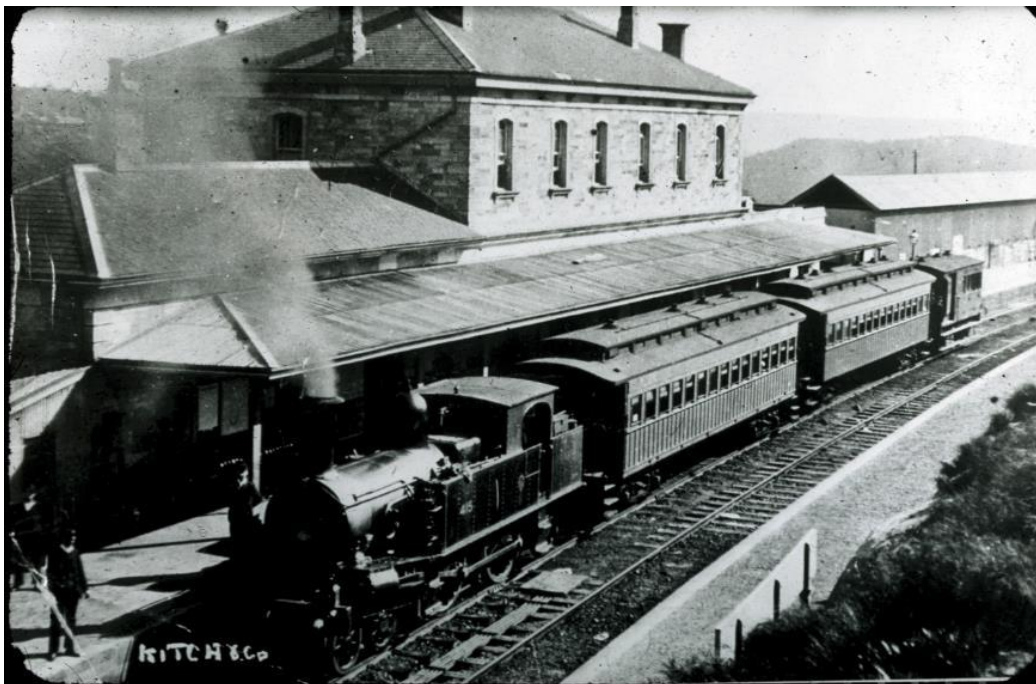
***1903 photograph of Platform 2 station building from a high vantage point prior to the construction of the footbridge (Source: Australia Railway Historical Society, Image ID 051240)***

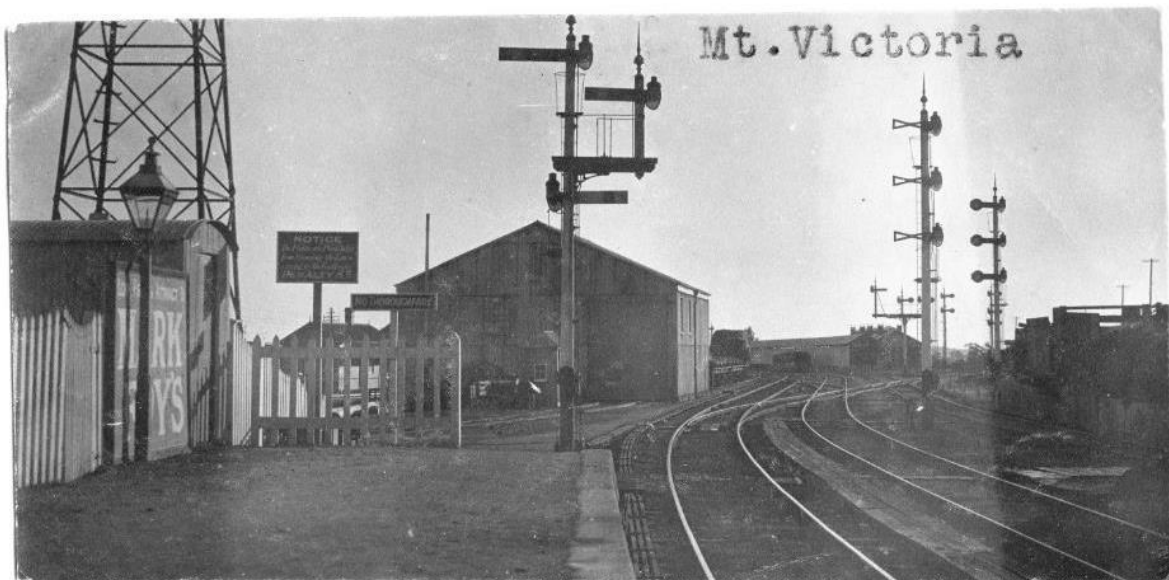
***Pre 1950s (undated) photograph of the railway yard from Platform 2, showing several former yard structures and semaphore signals. (Source: Australian Railway Historical Society (ARHS) NSW, Image ID 00786).***

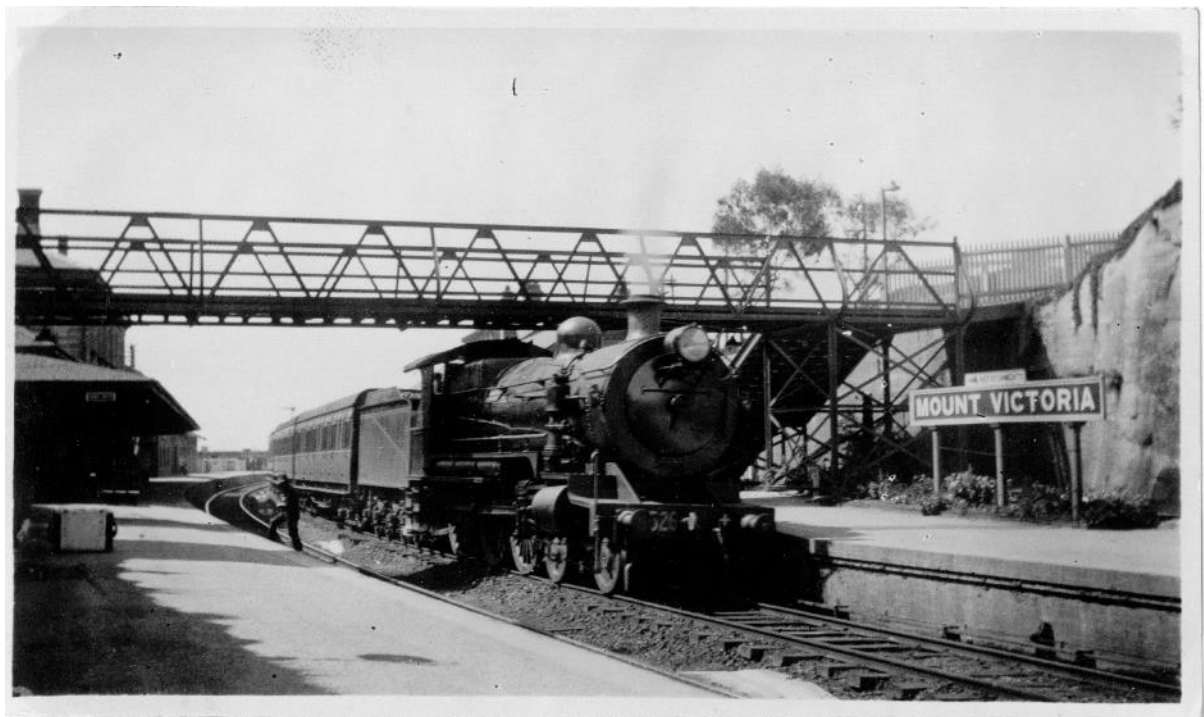
**Undated photograph of the footbridge from Platform 2, taken pre-electrification (Source: Australian Railway Historical Society (ARHS) NSW, Image ID 012367).**
