FINAL ARCHAEOLOGICAL REPORT

Newcastle Annexe SHR 0795
Former Newcastle East Public School
58 Bolton St,
Newcastle, NSW

Volume 1: Report

Archaeological Management & Consulting
Group

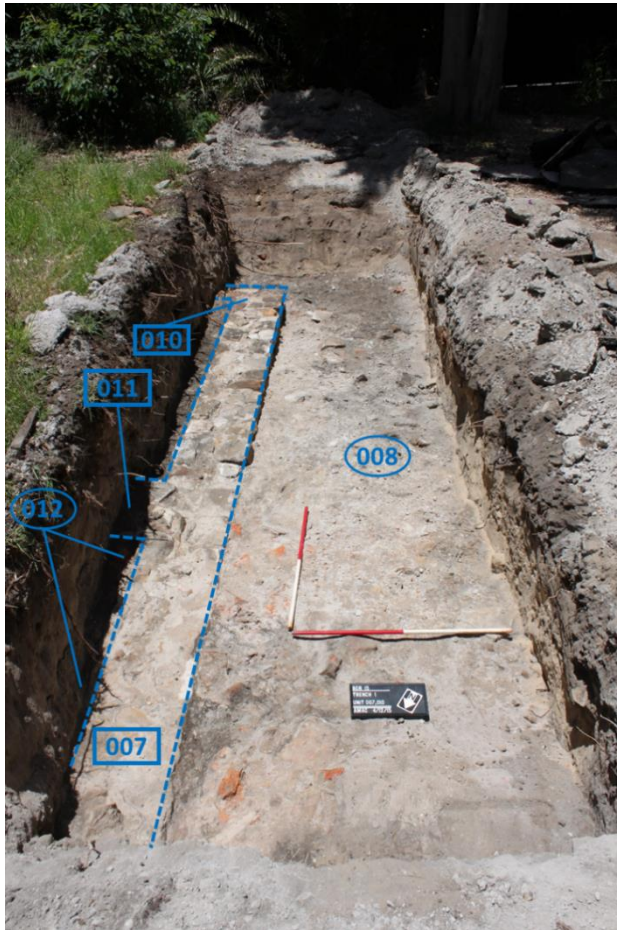
Figure 3.4 Trench 1 after final clean, showing orientation of sandstone foundations [007], [010] and [011]. Facing southeast. AMAC Group (4th December 2015, digital 1805).

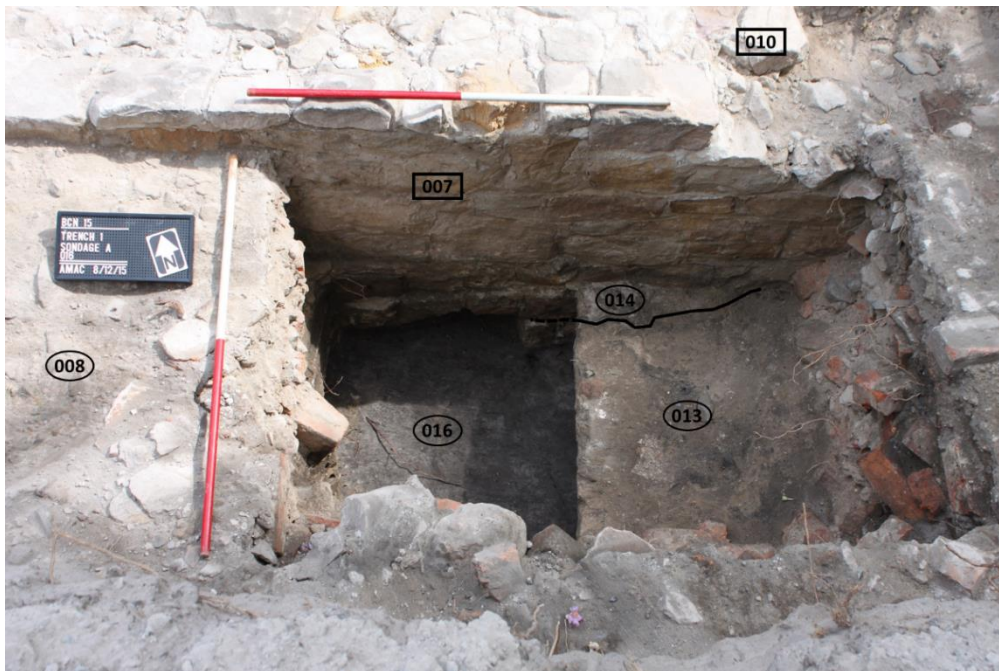
Figure 3.5 Sondage A, showing remnant mortar layer [014] on top of fill [013]. Facing northeast. Note that remnant mortar layer [014] continued further west within the excavated sondage area. AMAC Group (8th December 2015, digital 1956).

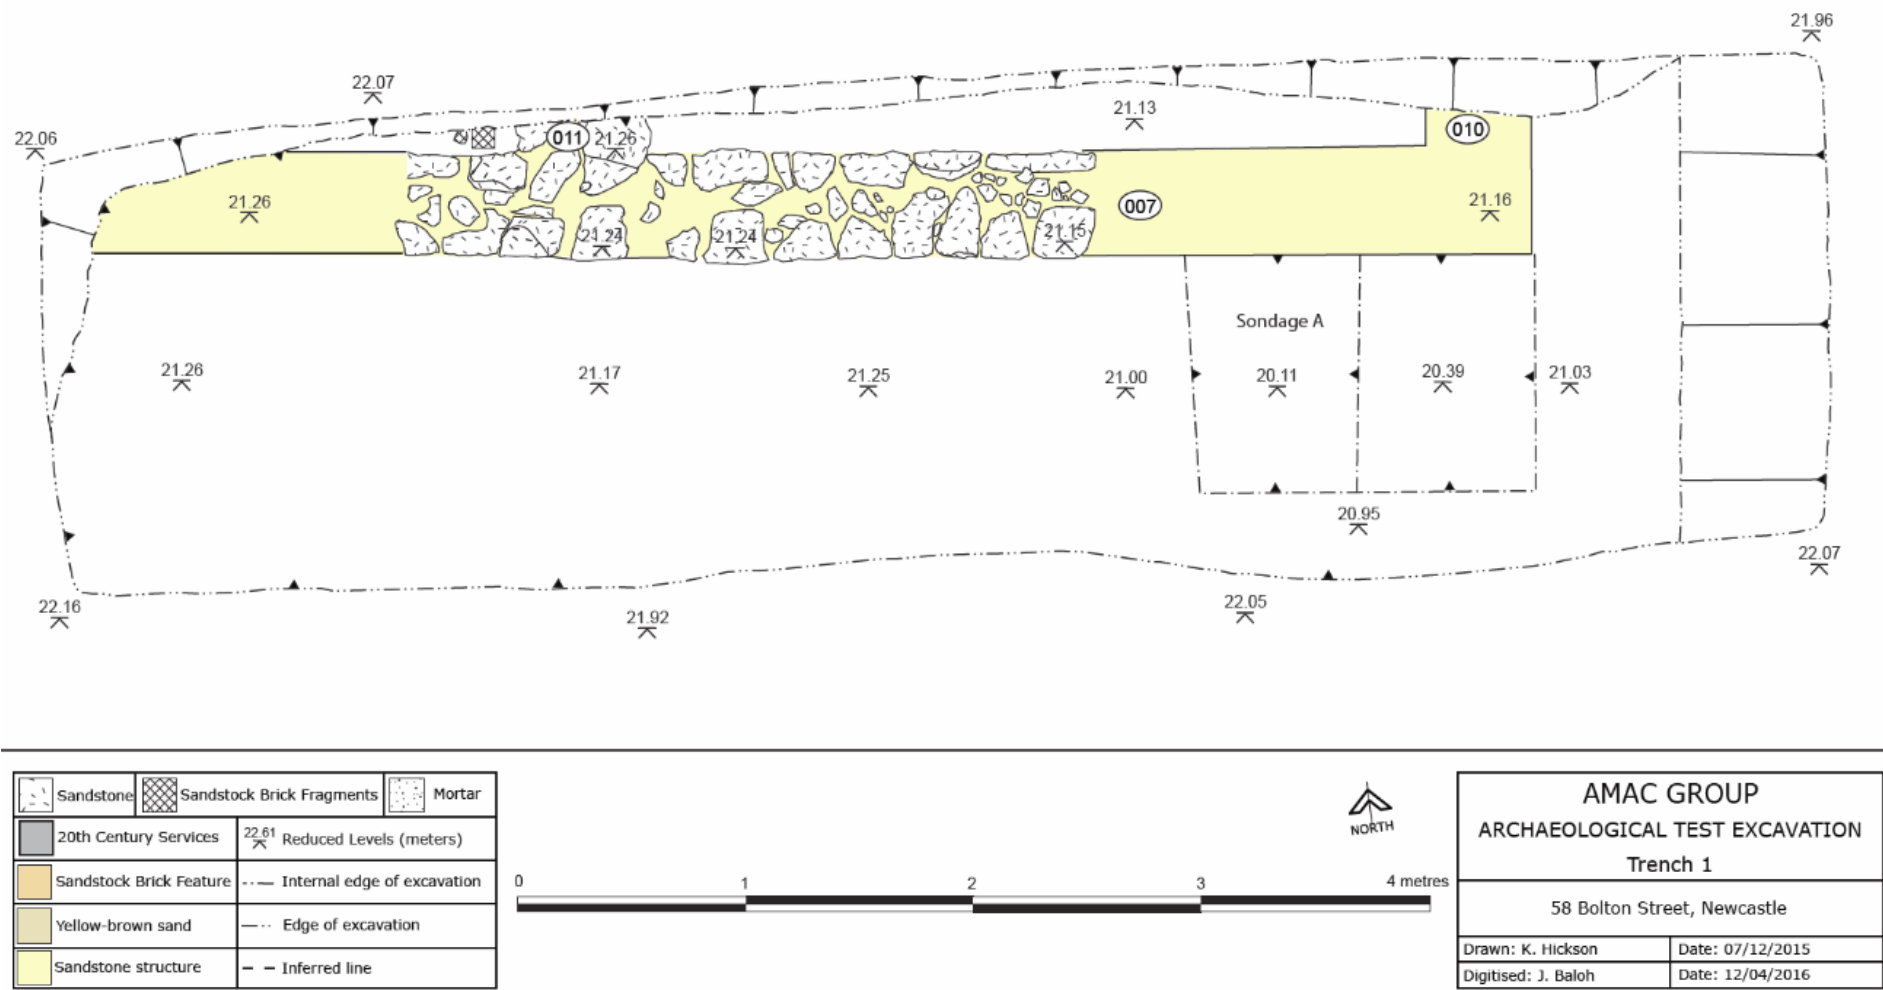
Figure 3.6 Trench 1 Plan.
Original plan by K. Hickson, 2015; Inked by J. Baloh 2016.

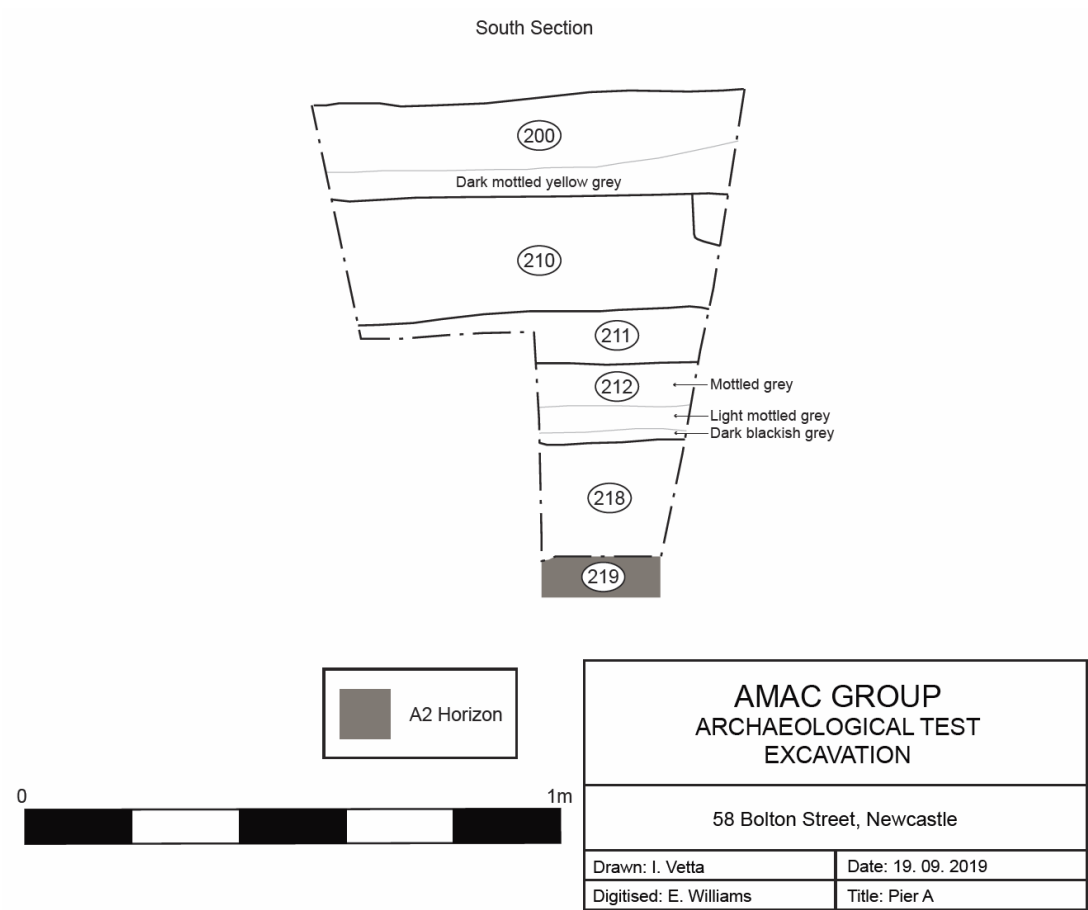
Figure 3.20 Pier A – South Section.
Vetta and Williams.

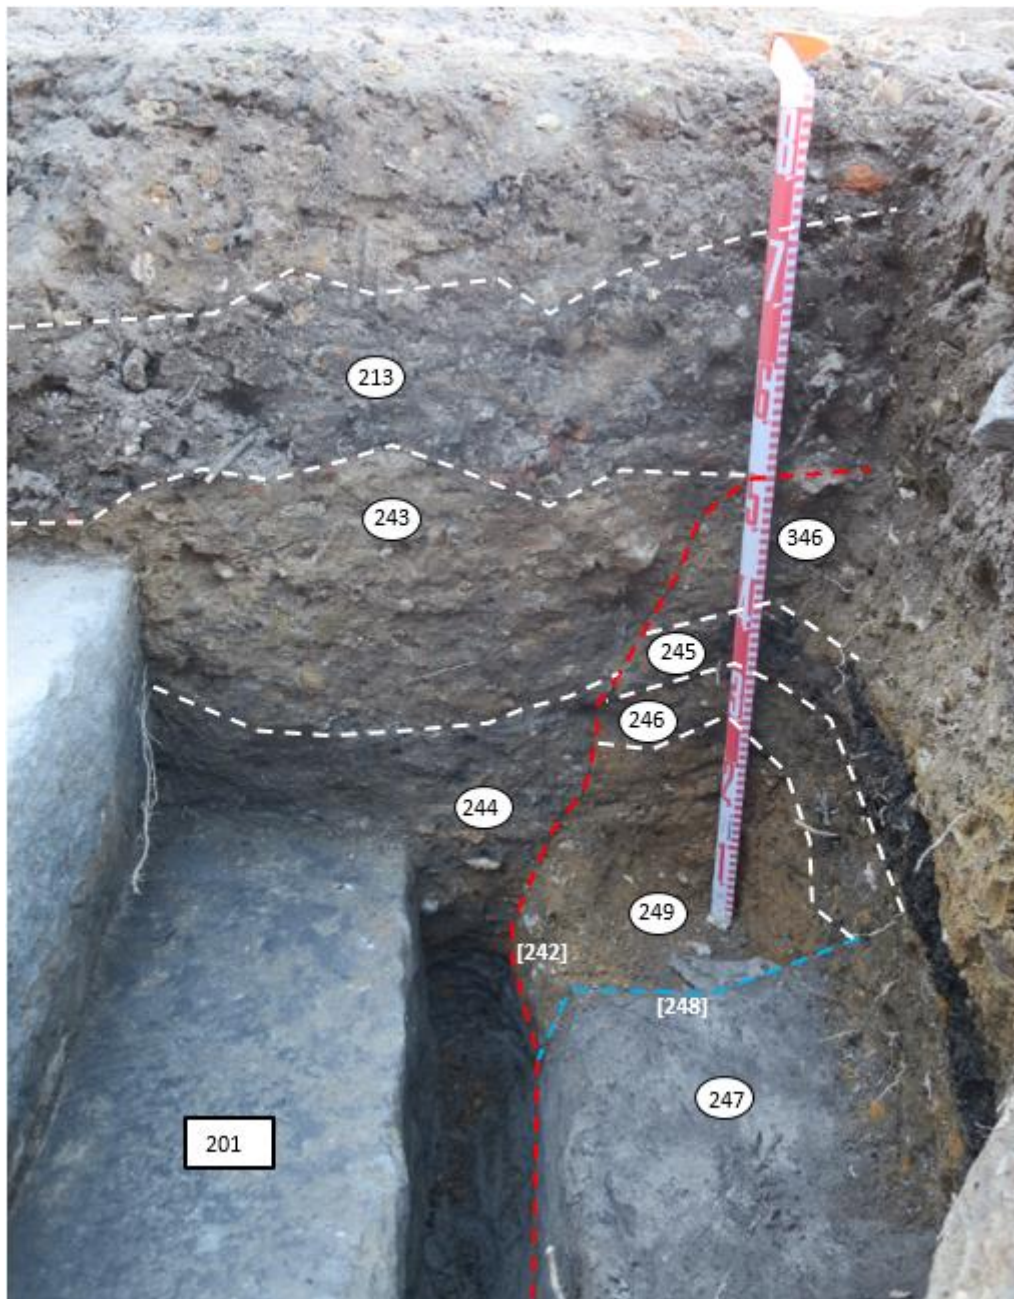
Figure 3.26 Pier B – north section, showing footings [201] and cuts [242], [248].
AMAC Group (20/07/2017, IMG_1162)

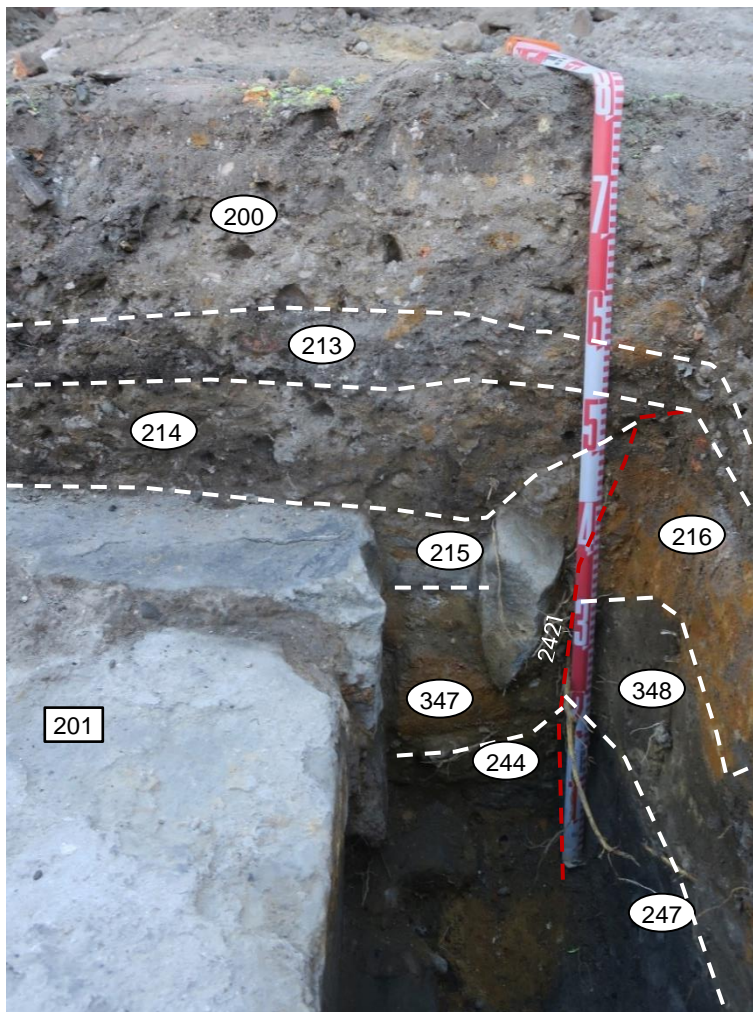
Figure 3.27 Pier B – south section, showing footings [201] and foundation cut [242].

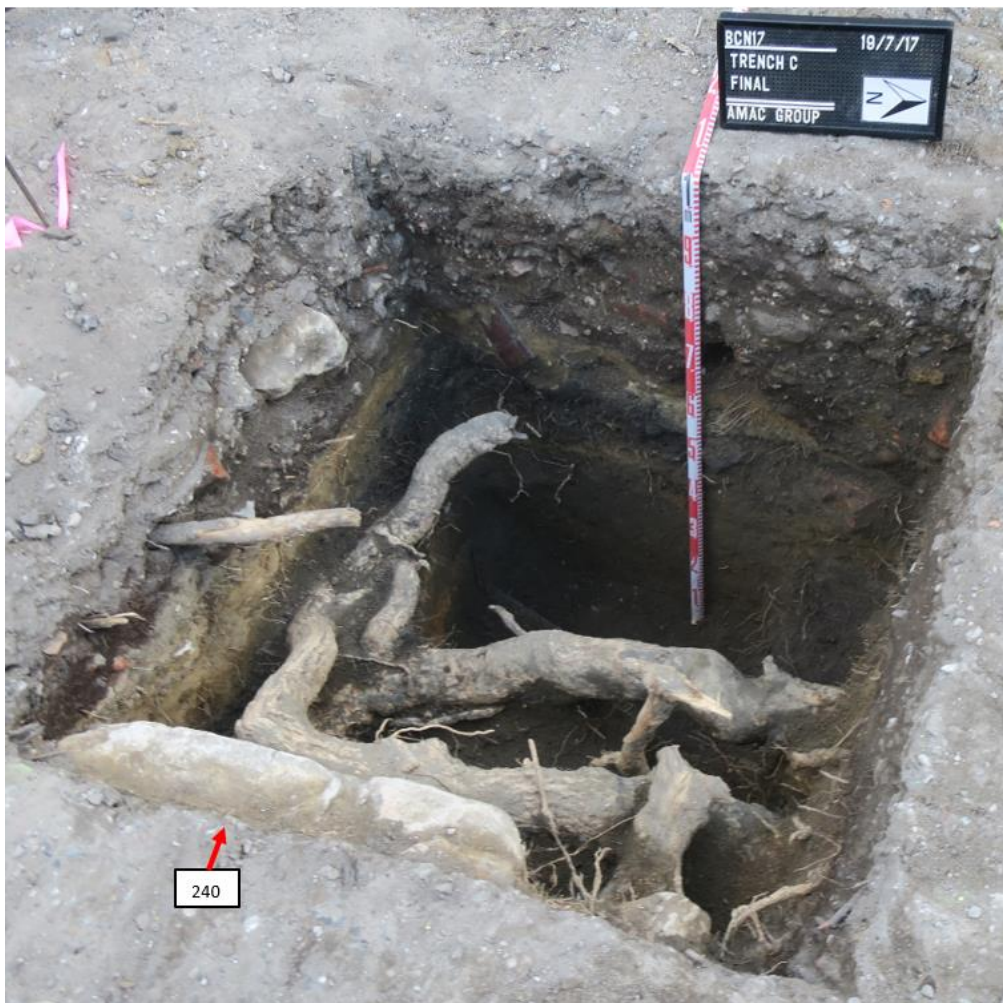
Figure 3.30 Pier C – showing sandstone footing [240], facing west.
AMAC Group (19/07/2017, IMG_0987).

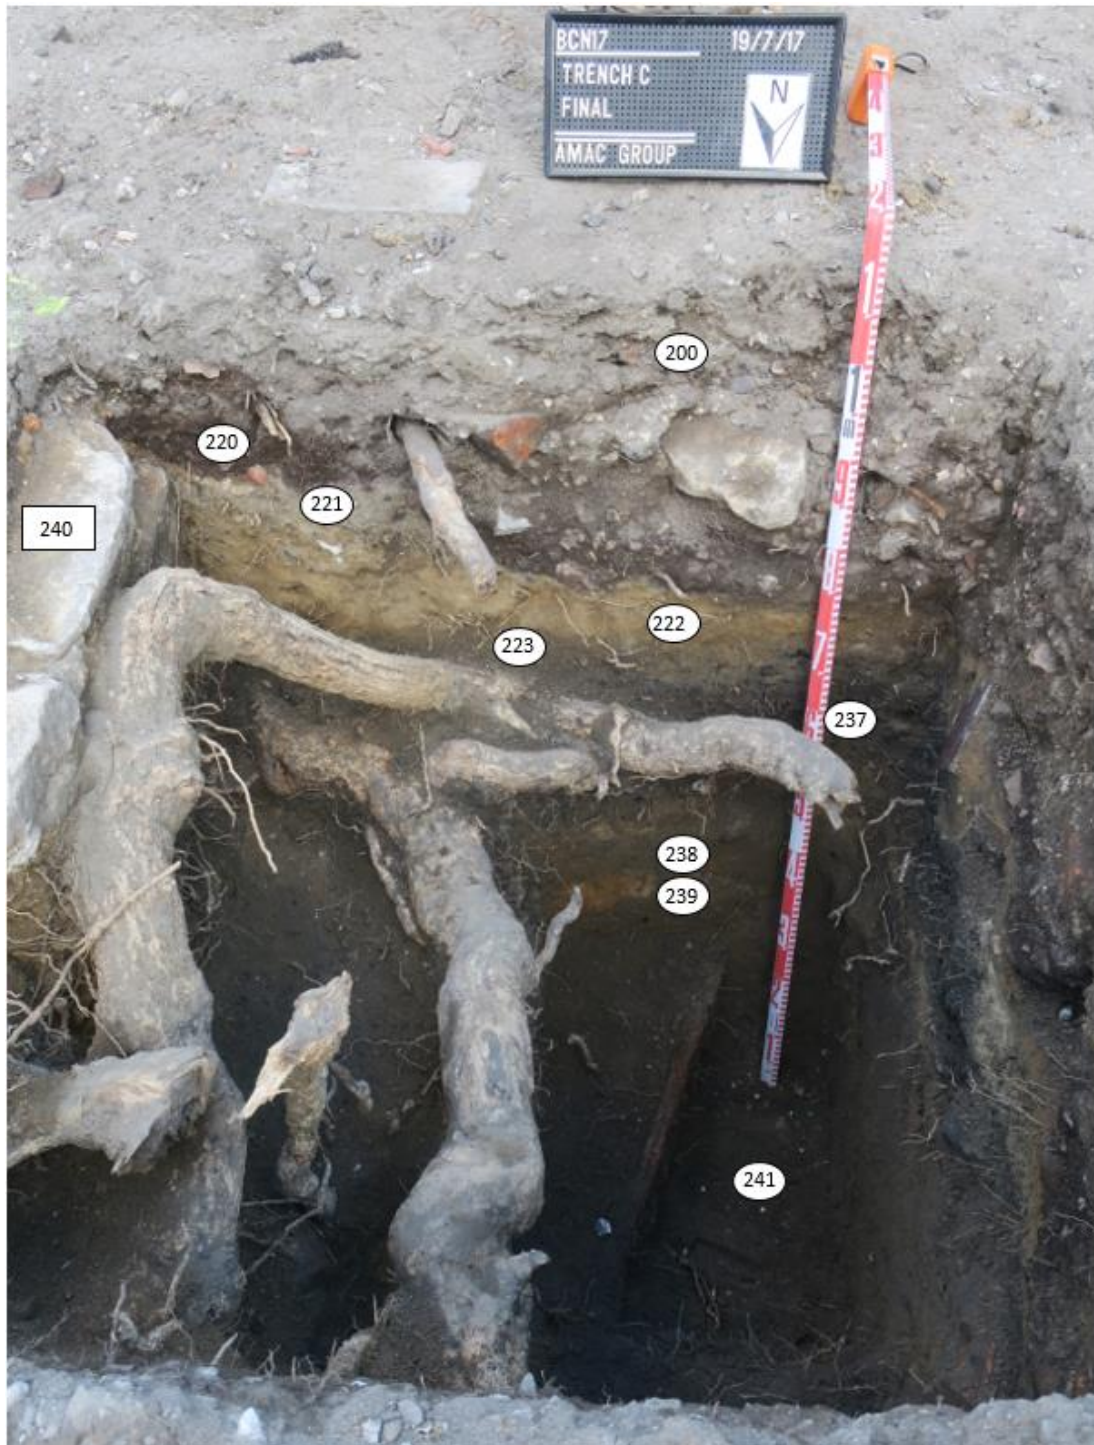
Figure 3.31 Pier C – south section showing footing [240] and fills.
AMAC Group (19/07/2017, IMG_0990)

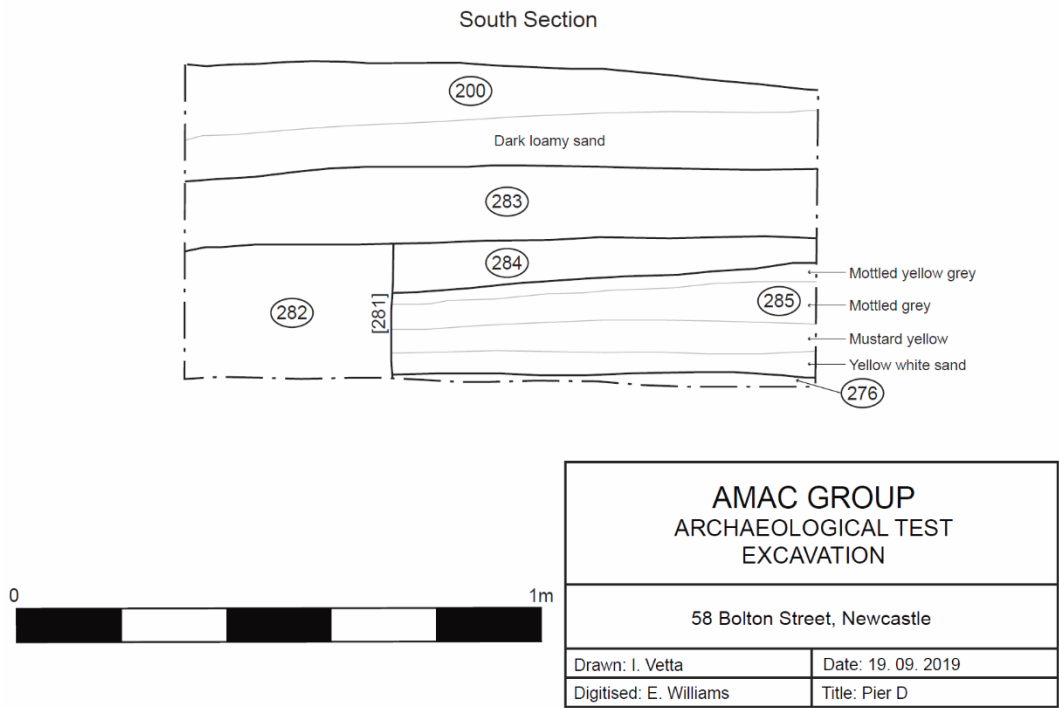
Figure 3.32 Pier D – South Section.
Vetta and Williams.

- Fill [283] is most likely a levelling fill related to the 20th century school yard containing fragments of asphalt.
- Linear trench [281] is most likely a service trench associated with the 20th century use of the school as it cut through earlier demolition fill [284].
- Demolition fill [284] most likely relates to the demolition of the teachers' residence, Structure N. It sits above layers of upcast natural sand, [285], which may have been levelling fill for the teacher's wing (Structure N) or the earlier school building (Structure F), potentially upcast during the excavation for foundations.
- Posthole [274] aligns with posthole [317] in Pier E. It is possible that these features both relate to an early fence line shown on the 1830 plan and therefore predate the c.1845 school.

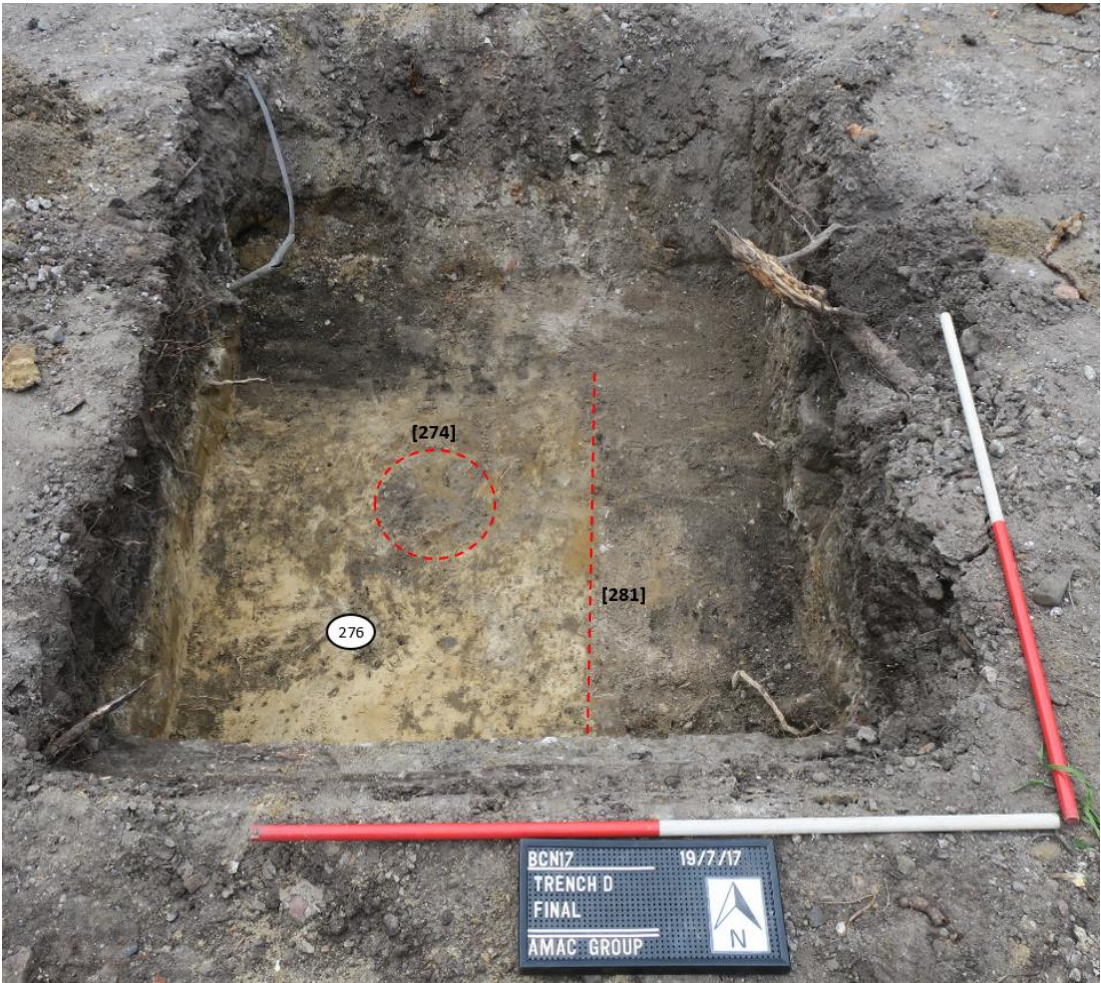
Figure 3.33 Pier D – showing circular cut [274] and linear cut [281], facing north.
AMAC Group (19/07/2017, IMG_0943).

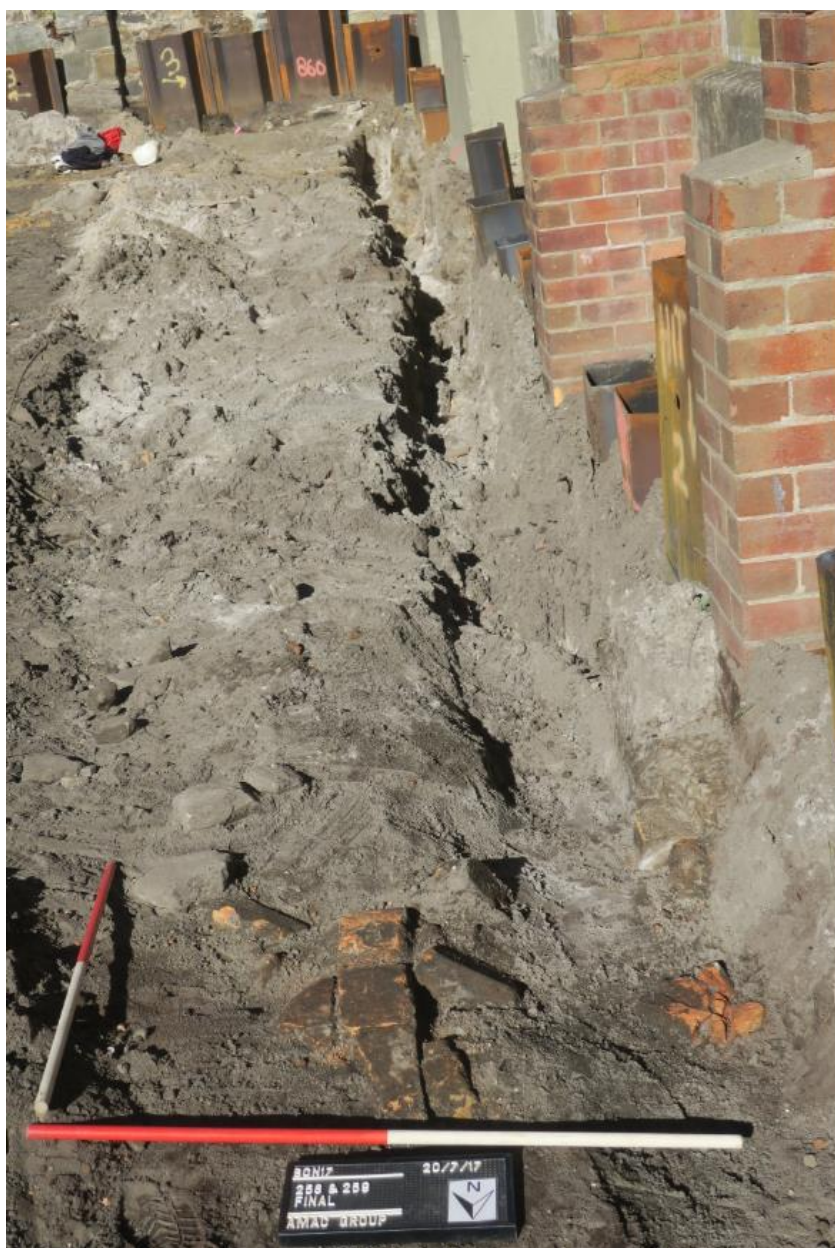
Figure 3.41 Strip F – showing footings [258] and [259], facing south.
AMAC Group (20/07/2017, IMG_1090).

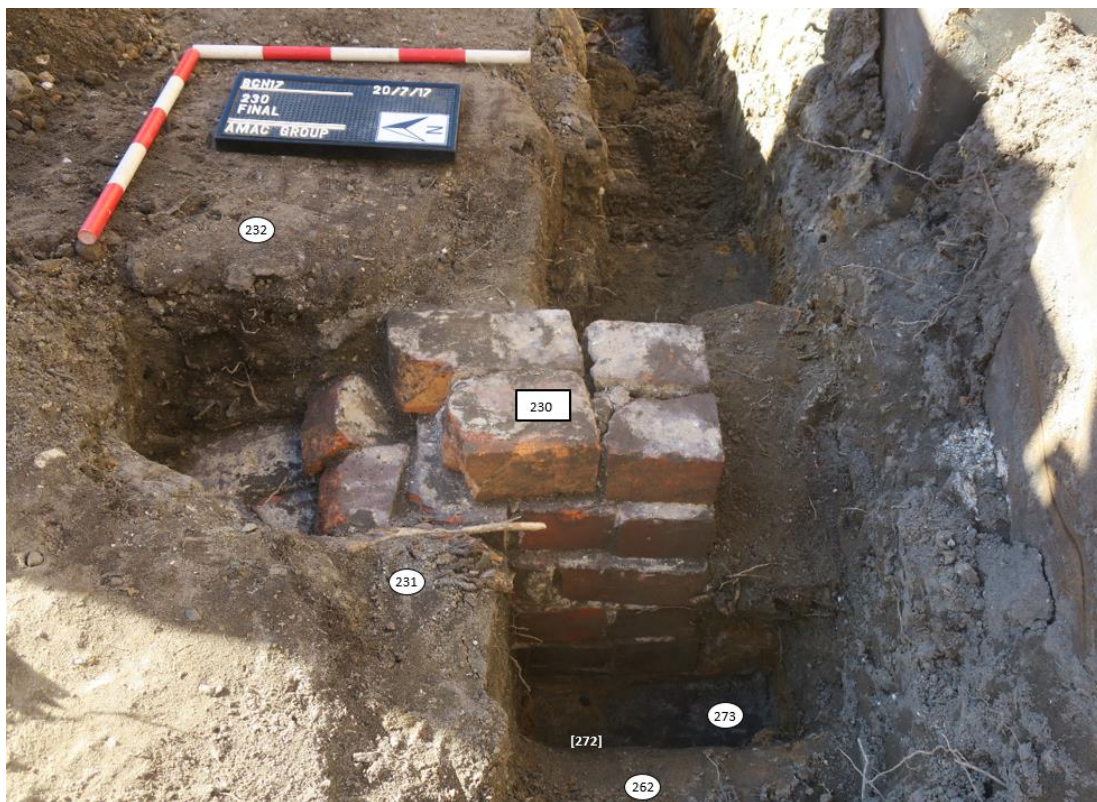
Figure 3.43 Strip G – showing footing [230], facing east.
AMAC Group (20/07/2017, IMG_1101).

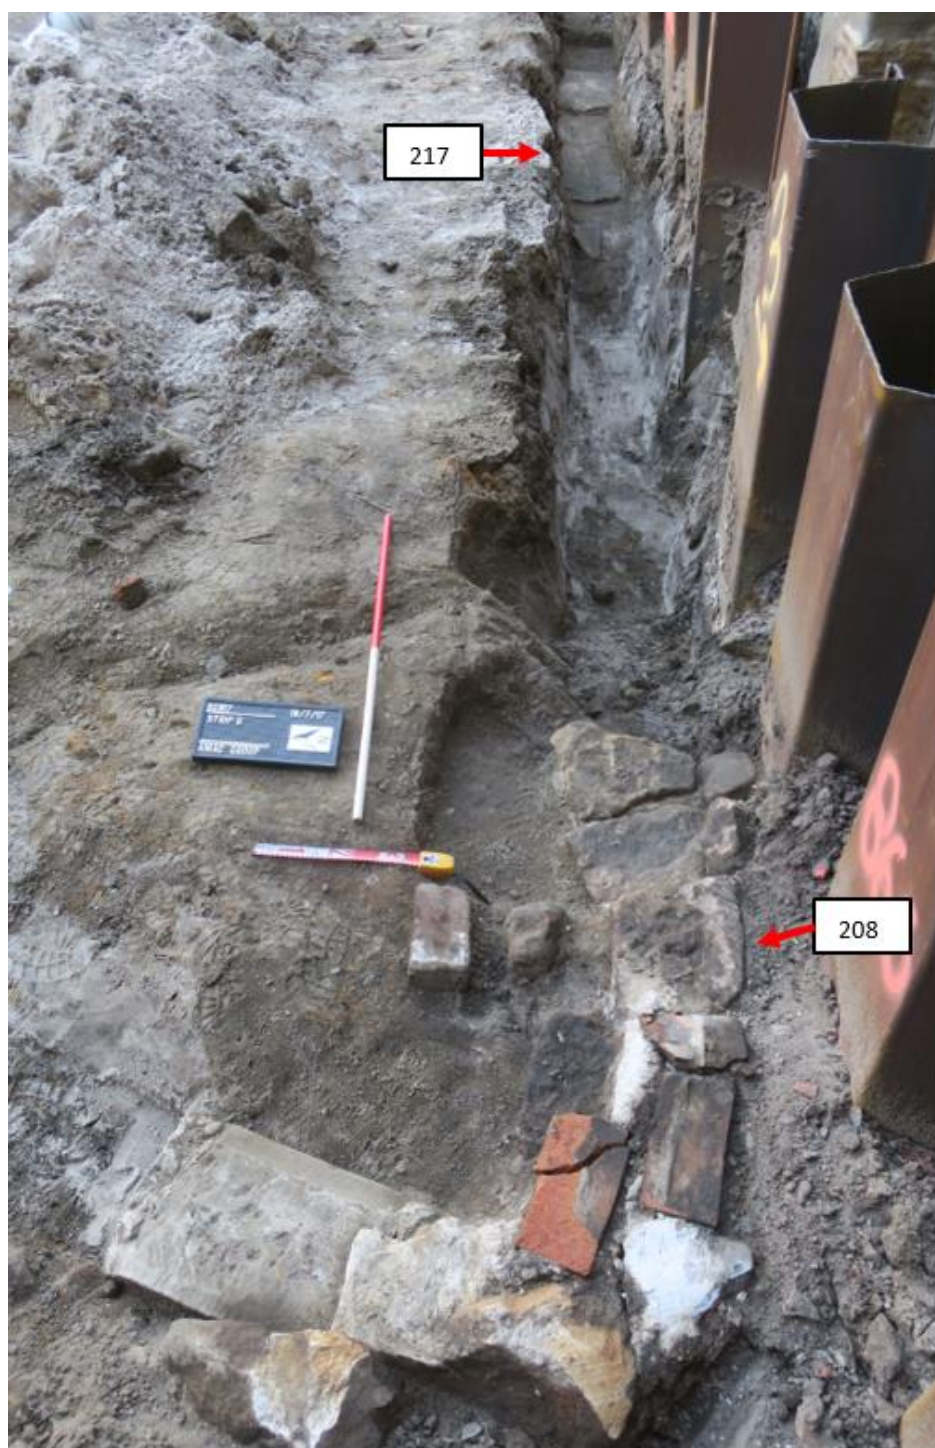
Figure 3.44 Strip G – showing footing [208], facing east.
AMAC Group (18/07/2017, IMG_0868).

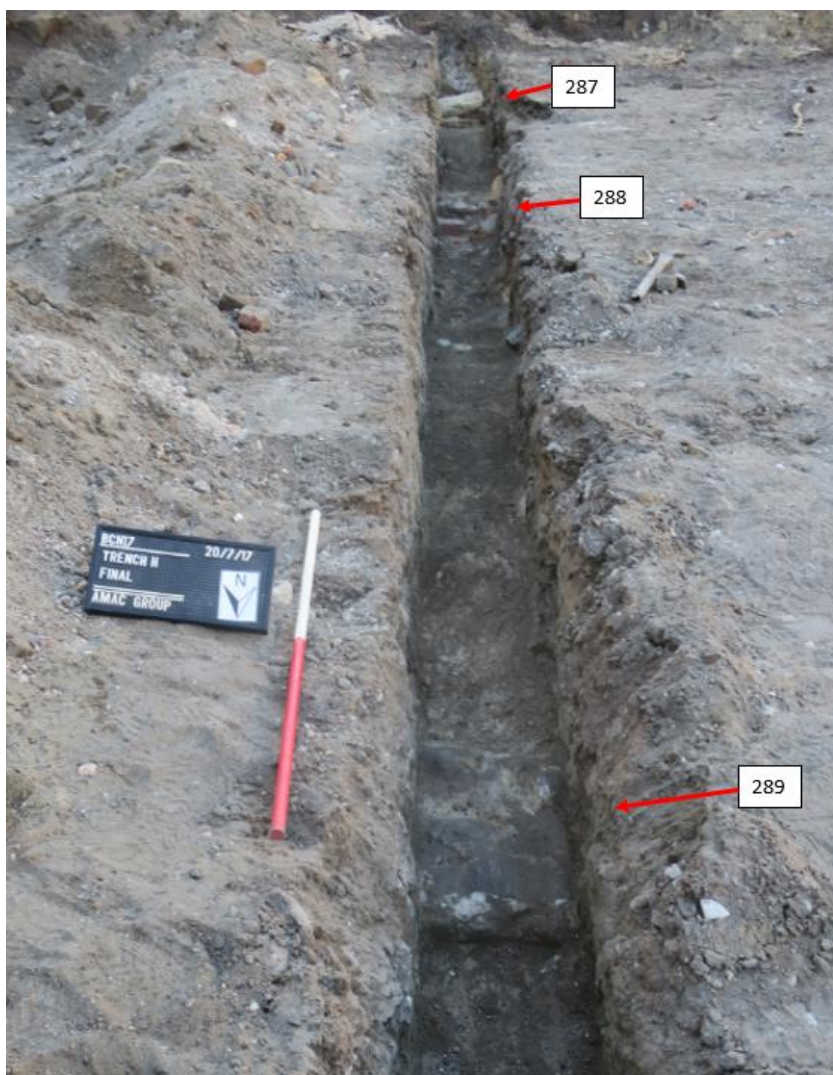
Figure 3.48 Strip H – showing footings [289], [288] and [287], facing south. AMAC Group (20/07/2017, IMG_1047).

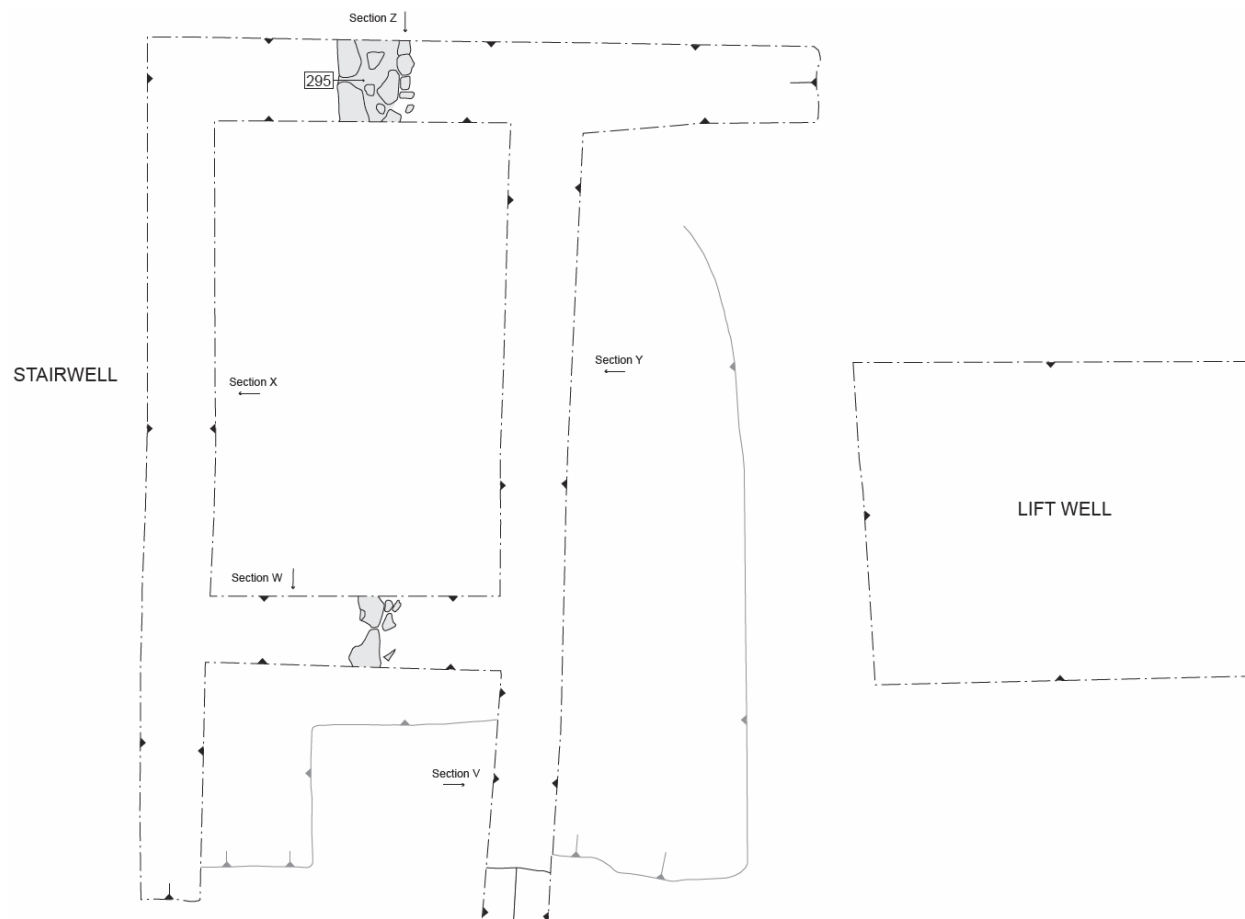
Figure 3.56 Plan of Stairwell and Lift well trenches showing recorded sections.
Hickson and Williams, 2019.

In the eastern part of the stairwell trench, fill [323] was up to 24cm deep and sat above a layer of asphalt [331]. Asphalt surface [331] was 9cm deep was only found eastern trench and can be seen in Section V, Y and Z (Figure 3.57; Figure 3.60-Figure 3.61); this may have been the same as fill [283] identified in Pier D. In the eastern trench, asphalt layer [311] sat above a grey white sand and gravel fill [332] which was 3-5cm in depth and provided bedding for the asphalt [331]. The removal of fill [323] in the eastern trench exposed a mottled brown and white sand [337] which contained some charcoal and was 13cm deep. Fill [337] appeared to be an upcast A2 horizon sand and was cut by service trench [334] which was approximately 61cm wide and contained a dark brown mottled sandy loam fill [335] (Figure 3.60). Only the top 24cm of trench cut [334] was exposed by the work. Fill [337] sat above a mustard yellow sand [336]=[325] which was only partly excavated to a depth of 11cm.

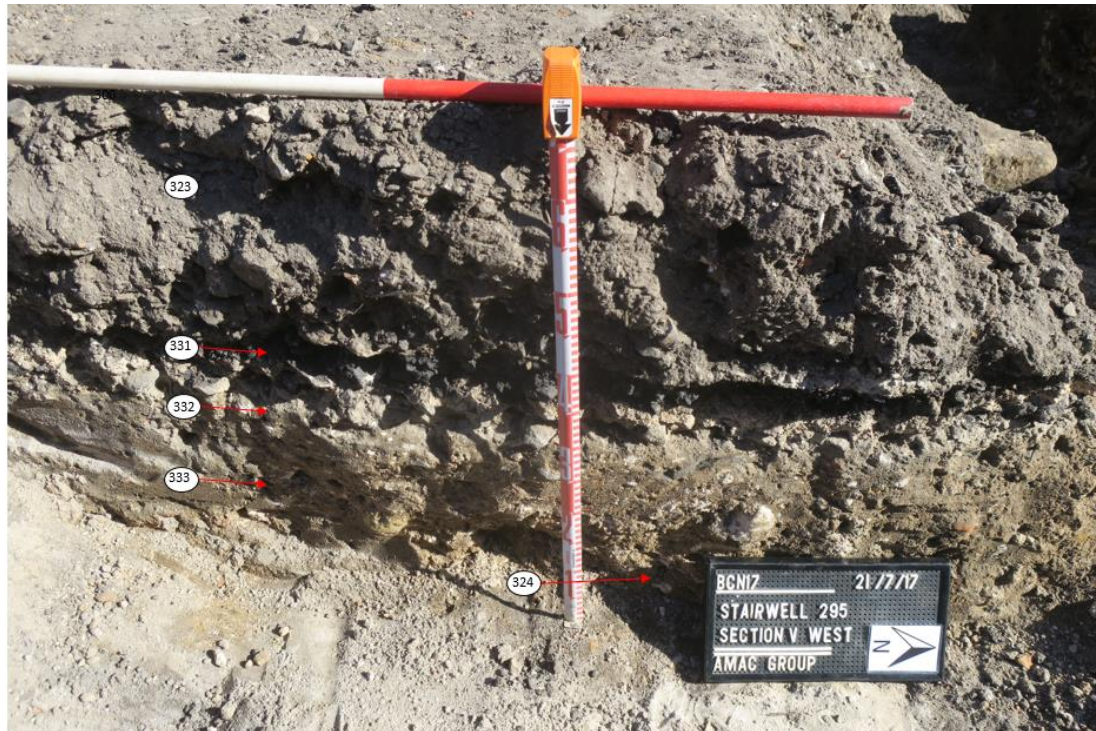
Figure 3.57 Stairwell – Section V (west).
AMAC Group (21/07/2017, IMG_1228).

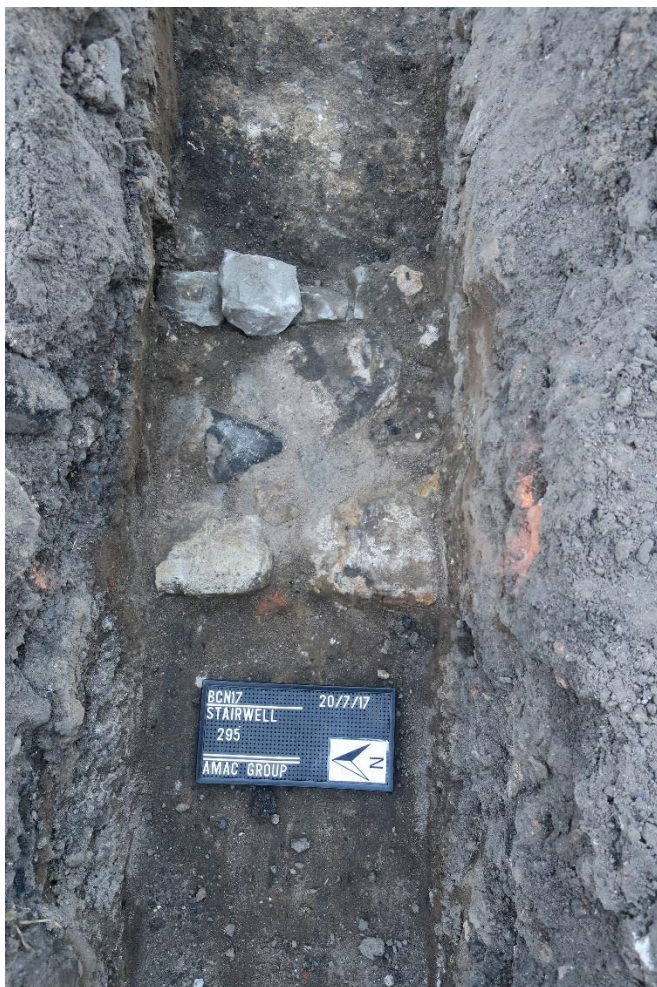
Figure 3.62 Stairwell – Foundation [295], facing east.
AMAC Group (20/07/2017, IMG_1138).

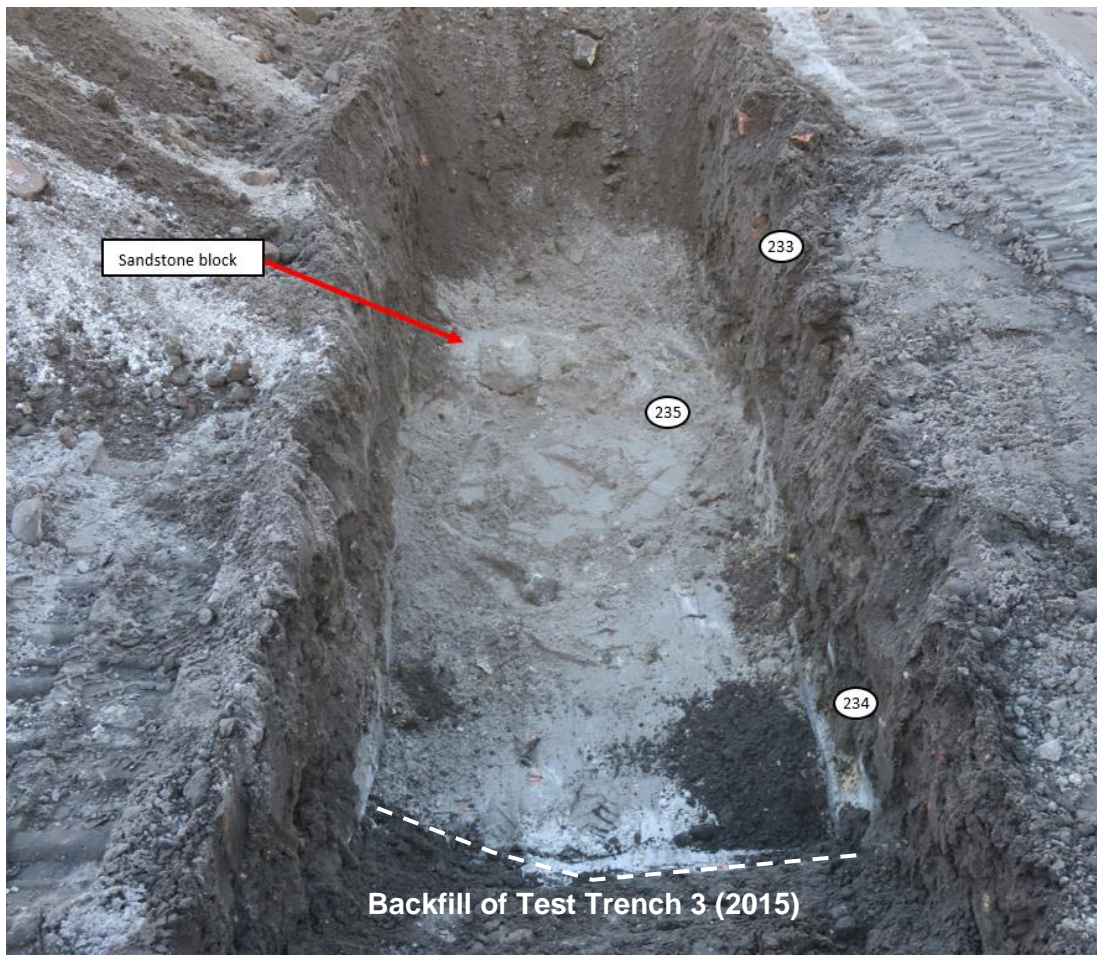
Figure 3.72 Trench P – showing sandstone block and fills, facing south.
AMAC Group (19/07/2017, IMG_0915).

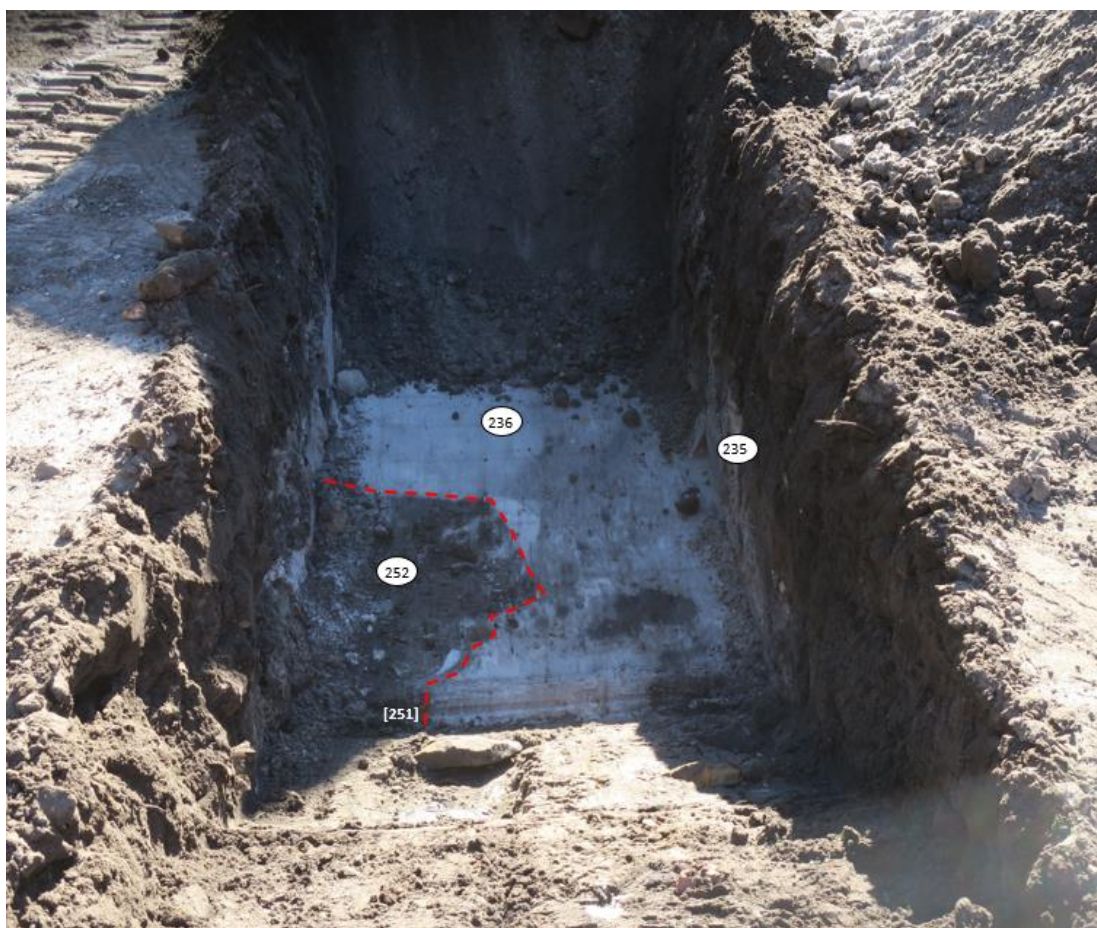
Figure 3.73 Trench Q – showing cut [251] and fills, facing north.
AMAC Group (19/07/2017, IMG_0917).

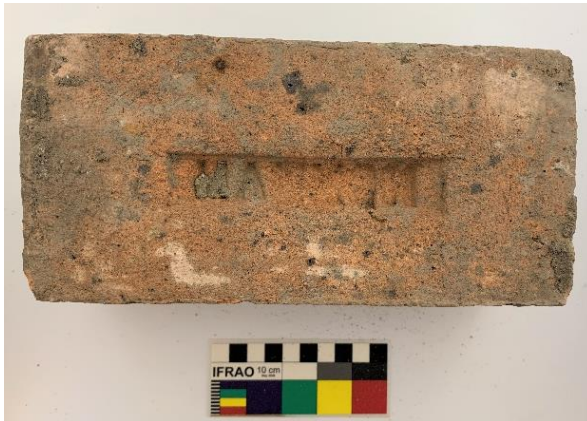
Figure 4.1 'HAMMON' marked brick (BCN17x0189, Context 263)

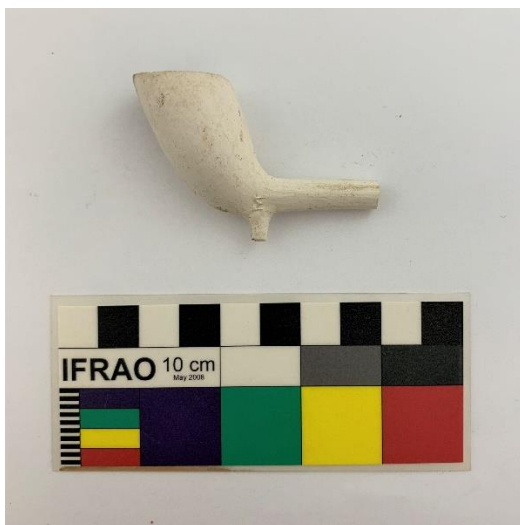
Figure 4.5 'M/G' marked pipe (BCNx0202, Context 200C)
