NSW
Heritage
Office

SS *LADY DARLING* **(1864 - 1880)**

CONSERVATION PLAN

Prepared by Tim Smith and David Nutley
September 1998

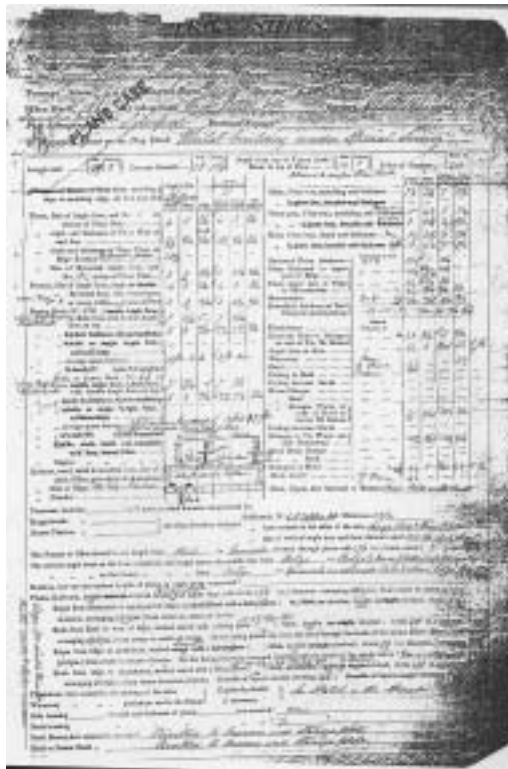
Figure 4: *Lloyds Building Survey Report, 1880. National Maritime Museum, Greenwich. London.*

Both the Lloyds Building Survey report of 1864 and the initial Customs Register entry at the Port Of Liverpool survive, providing valuable information on the vessel's specifications and initial ownership ².

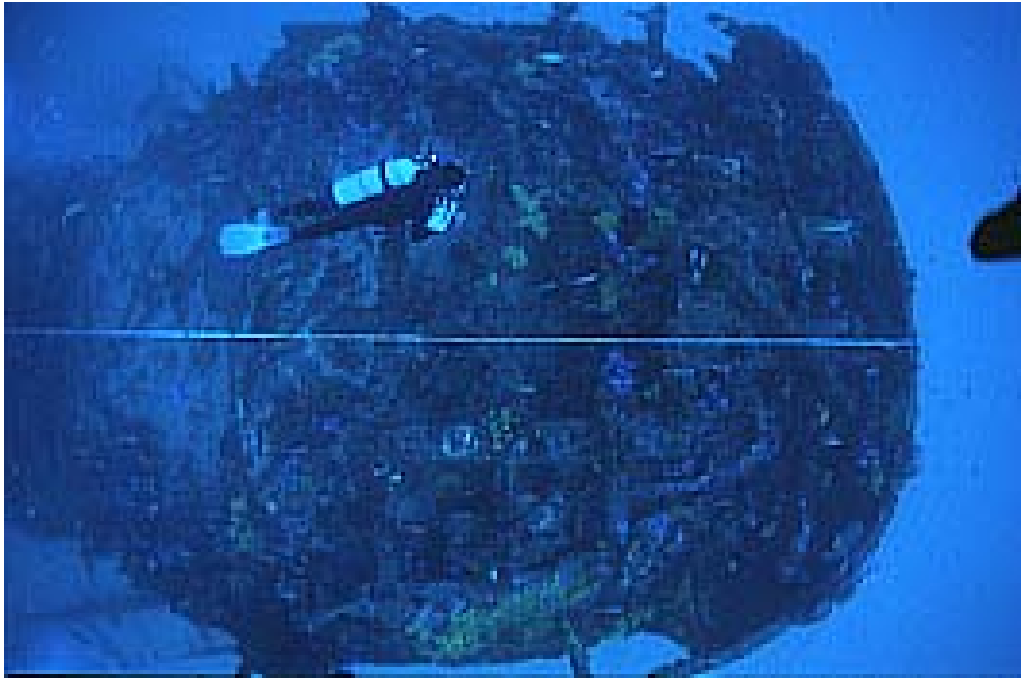
Figure 8: *Maritime Archaeologist, Tim Smith, swimming over the raised stern portion of the hull. Photo: by Andrew Green..*

Typically in line with this scenario, the structurally strong stern of the *Lady Darling* stands intact to near the upper deck level. The hull sides remain to a reasonable height up to the engine room bulkhead. Forward of this bulkhead however, the hull sides have disintegrated to approximately the level of the surrounding sand, the engine room area demarcated only by the still upright engine and boiler. Forward of the boiler, the hull sides are difficult to identify with current sand levels all the way to the bow. Two vertical stanchions are visible forward of the boiler and mark the centreline of the hull. They probably served to support the upper deck. This was the main cargo area of the steamer, and with few structural supports in this region, the hull sides have been severely reduced.

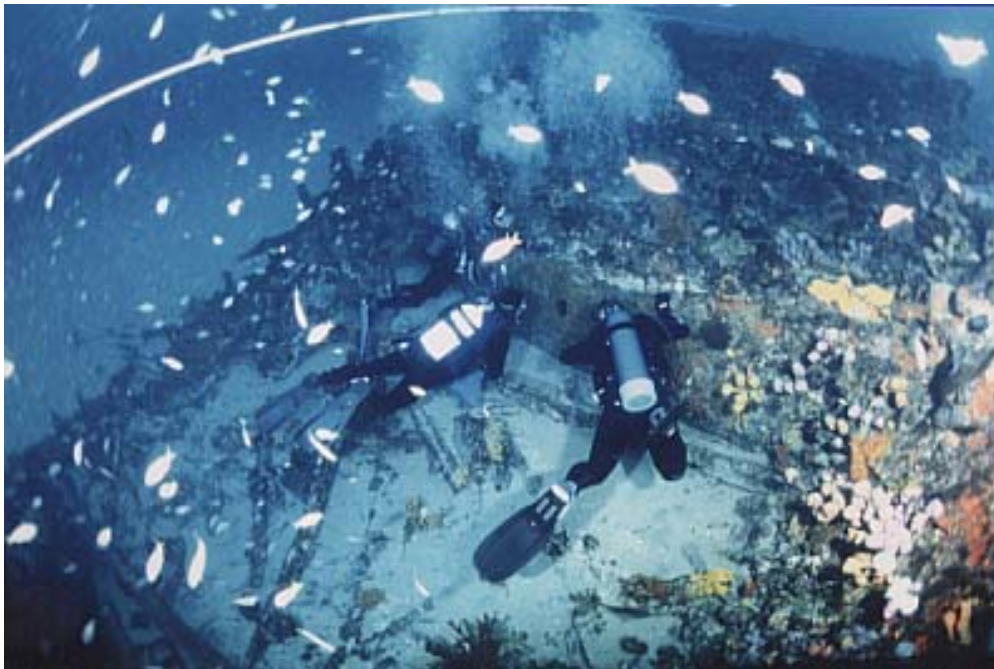
Figure 9: *Archaeologists David Nutley and Tim Smith inspecting the stern bulkhead behind the engine room. Photo: Andrew Green.*

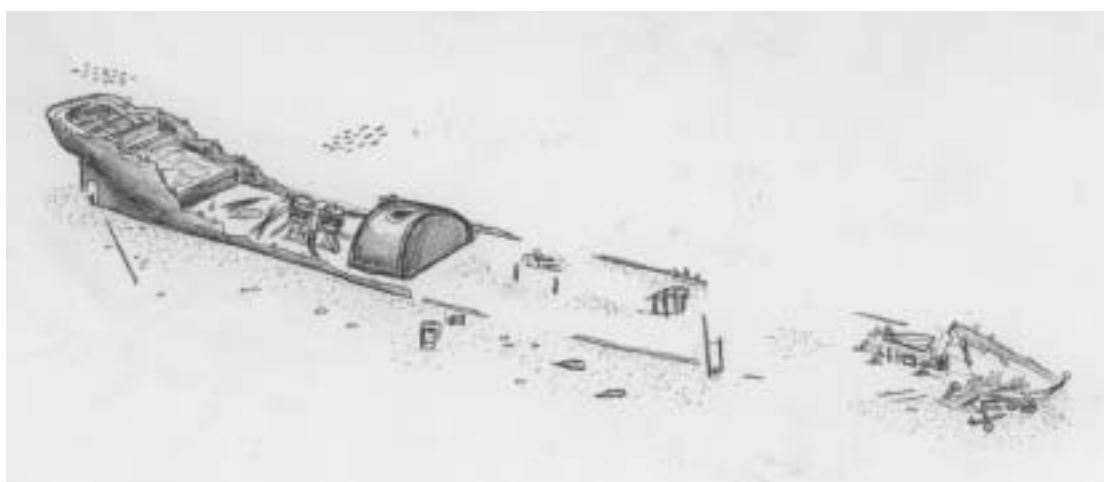
Figure 14: *Initial wreck site sketch prepared by Tim Smith. This is an approximation of the visible features noted at the site.*

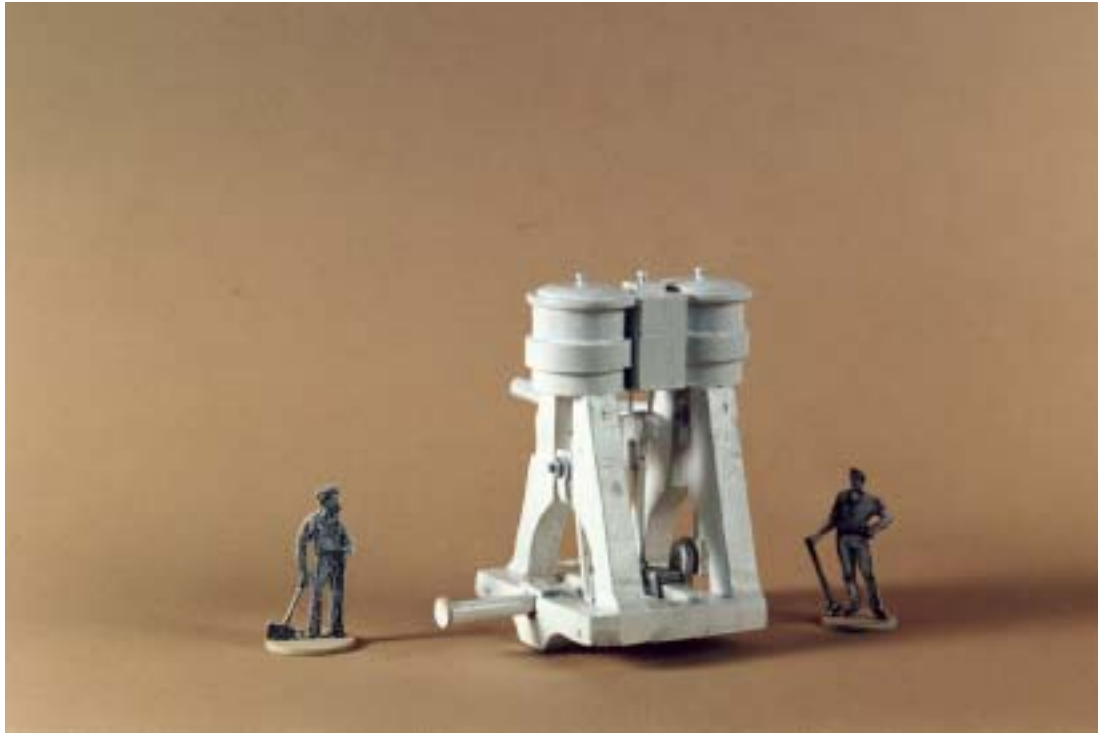
Much of the *Lady Darling*'s engine is buried by sand. This restricts the amount of recording possible but assists in the long term preservation of the item and the context of associated fittings. Shipwreck specialist John Riley has developed a formula for estimating the buried depth of marine engines based on a knowledge of the engine's stroke. From this, he has calculated that the *Lady Darling*'s engines probably stand to a height of about 15 feet, 6 inches (approximately 4 metres). This is based on the engine's specified stroke of 31 inches¹²². This means that just over half the engine is buried under existing sand levels.

Figure 18: *The Engine model constructed by John Riley, based on measurements recorded on site*
Photo: David Nutley.

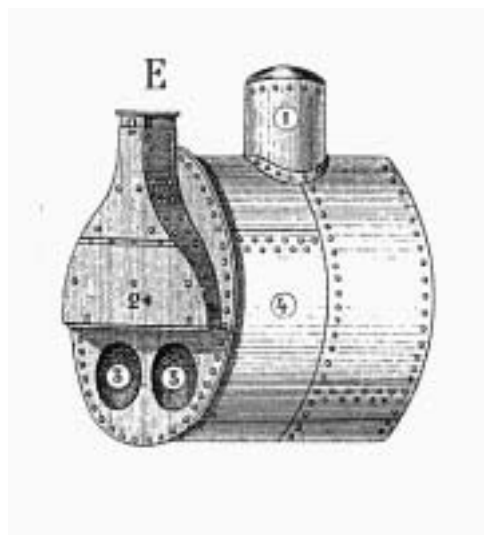
When built in 1864, the *Lady Darling* would have been fitted with a new boiler. Marine boilers of this period were generally of the “Cylindrical” type. Cylindrical boilers were an improvement on the earlier Box boiler which generated a low steam pressure of about 15 pounds per square inch. Having flat surfaces, the Box boilers ¹²³ required heavy internal staying in all three planes to maintain structural strength.

The cylindrical boiler was a development between the Box boiler and the later common Scotch boiler types. They still had a low pressure of about 25 pounds per square inch but they had the advantage of only required stays between the two flat ends. Like the Box boiler, they still used sea water to create steam which required regular service to remove corrosion and build up of impurities. The *Lady Darling's* boiler measures an impressive sixteen feet in diameter, a very large example of its type. Like Box boilers, they only had a relatively short operational life and it is therefore likely that the boiler observed on the seafloor is not the original. It was probably made new to the old design when the engines were reclassified in 1870, or after that date. Although the lower half of the boiler is buried by sand, it is probable that a boiler of this size had three furnaces, the uptake to the funnel exits the top of the boiler from near its centre.

Figure 21: A typical “Cylindrical” boiler of the type visible at the *Lady Darling* wreck site. After Paasch, L: *From Keel to Truck: Marine Dictionary*. London. 1894.

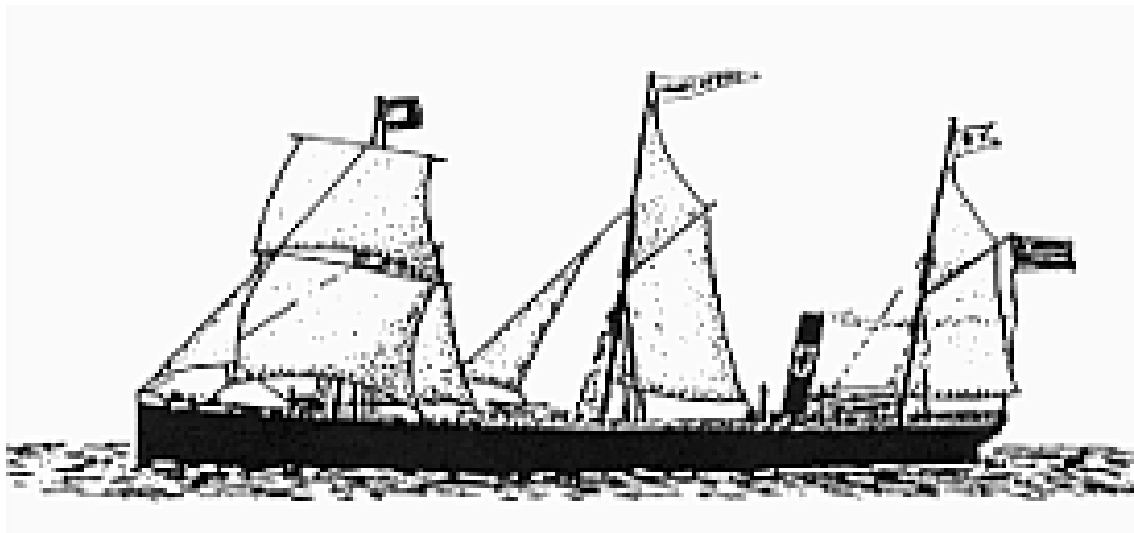
Both constructed of iron, they are rear engine, have three masts, schooner rig and a bridge placed forward of the engine room. They have the same straight stem post which is indicated by the *Lady Darling* wreck site, and are typical of the modern steamers built in this decade of modernisation. They serve as a probable model for reconstructing the profile of the *Lady Darling*, until further evidence can be found.

Figure 23: This is a presumed likeness of the *Lady Darling* based on available information. The collier is the *Mary Nixon* of 1865. C.V. Waine, *The Steam Collier Fleets*.

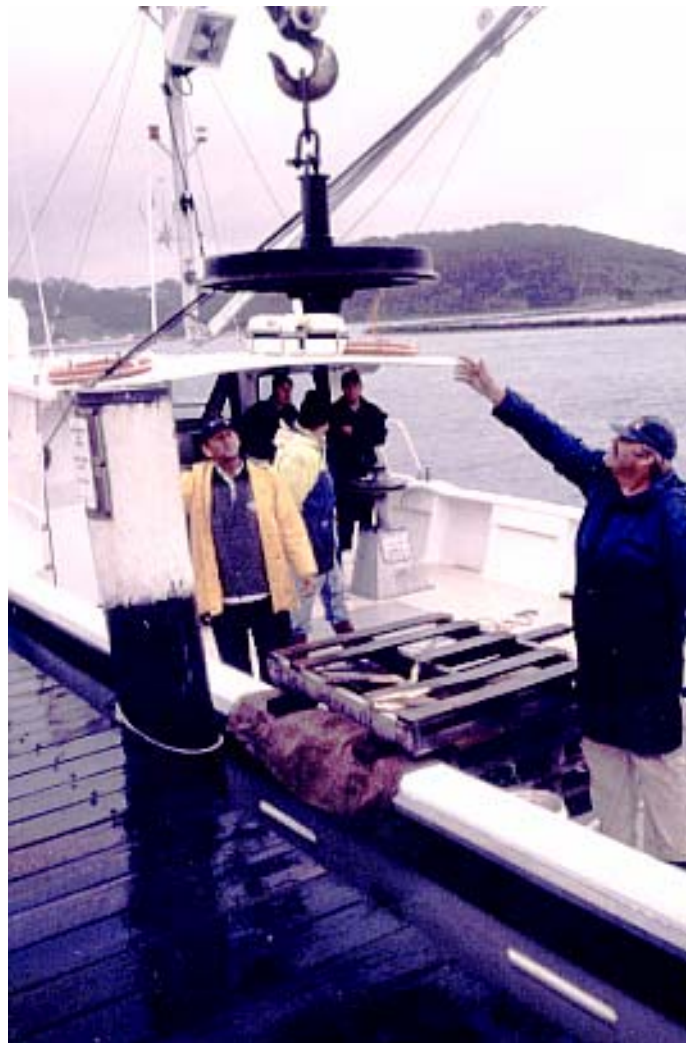
Figure 24: *Mr Bert Elswyk (in yellow), co-reporter of the wreck site, overseeing the placement of a railway wheel to be used as a mooring at the wreck.. Photo: David Nutley.*
