ARCHAEOLOGICAL TEST EXCAVATION REPORT

RESEARCH DESIGN & EXCAVATION METHODOLOGY

**13 Lower Fort Street
Dawes Point
NSW**

May 2018

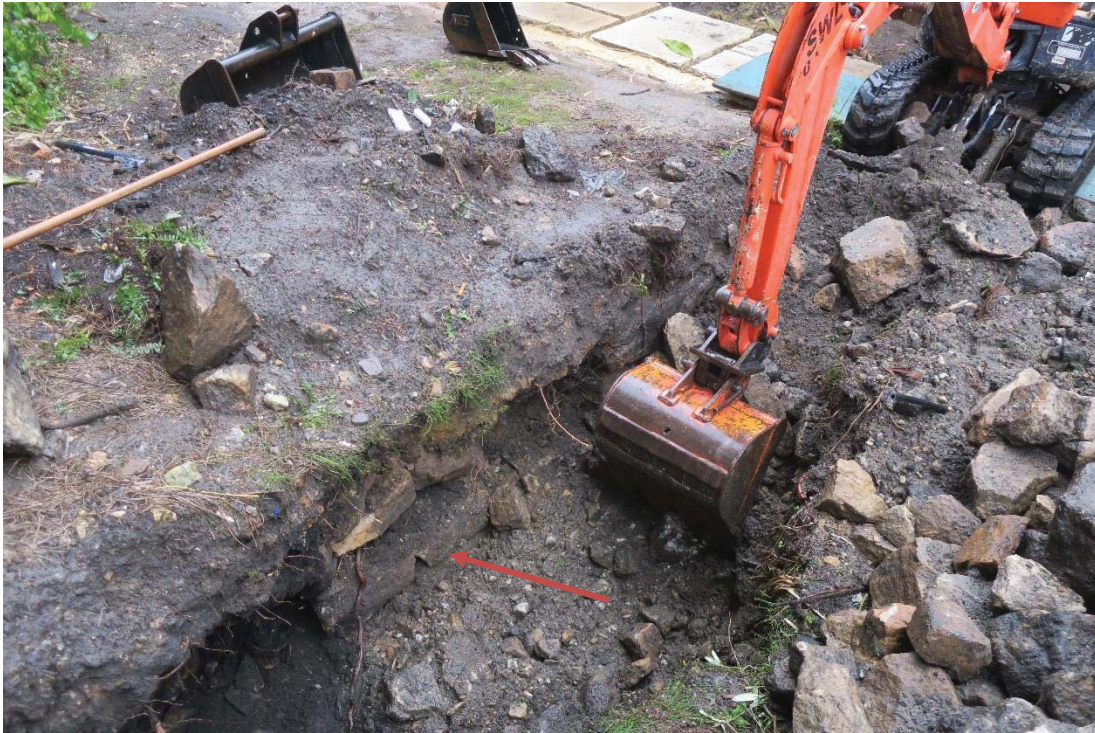
The surface of the yard was covered in turf and topsoil [001]. This modern topsoil contained a significant amount of building material fragments including dry-press brick and sandstone fragments in a dark grey-brown sandy loam, 10-35cm in depth. Directly below topsoil [001] was a mottled orange sand and sandy loam levelling fill [002], approximately 7cm in depth, and containing fragments of ironstone and sandstone (Figure 3.4). Fill [002] sat above a rubble fill [003] consisting of 85% sandstone fragments (10-30cm in size) and several pieces of a ceramic service pipe (Figure 3.5-Figure 3.6). This fill was extremely loose and appears to have been used as packing for the early 20th century retaining wall that runs to the rear of the site (Hickson Rd retaining wall). Excavation of this fill ceased at approximately 65-70cm due to the quantity of sandstone being removed and the possibility of section collapse. At the cessation of excavation of works in Trench 1, a sandstone wall [004] (discussed below) was identified below fill [003] in the southeast section of the trench oriented southwest-northeast. It was apparent that the upper courses of this wall had been removed as well the northeast end by robber trench [017], a negative interface from the removal of the sandstone blocks; for this reason fill [003] both sat above wall [004] as well as butting up against it. In order to expose more of wall [004], the trench was extended to the southeast (see Figure 3.6 and Figure 3.3).

Figure 3.6 Excavation of [003] in Trench 1, facing south
Wall [004] is visible in section (red arrow). AMAC 0621, 12/07/17

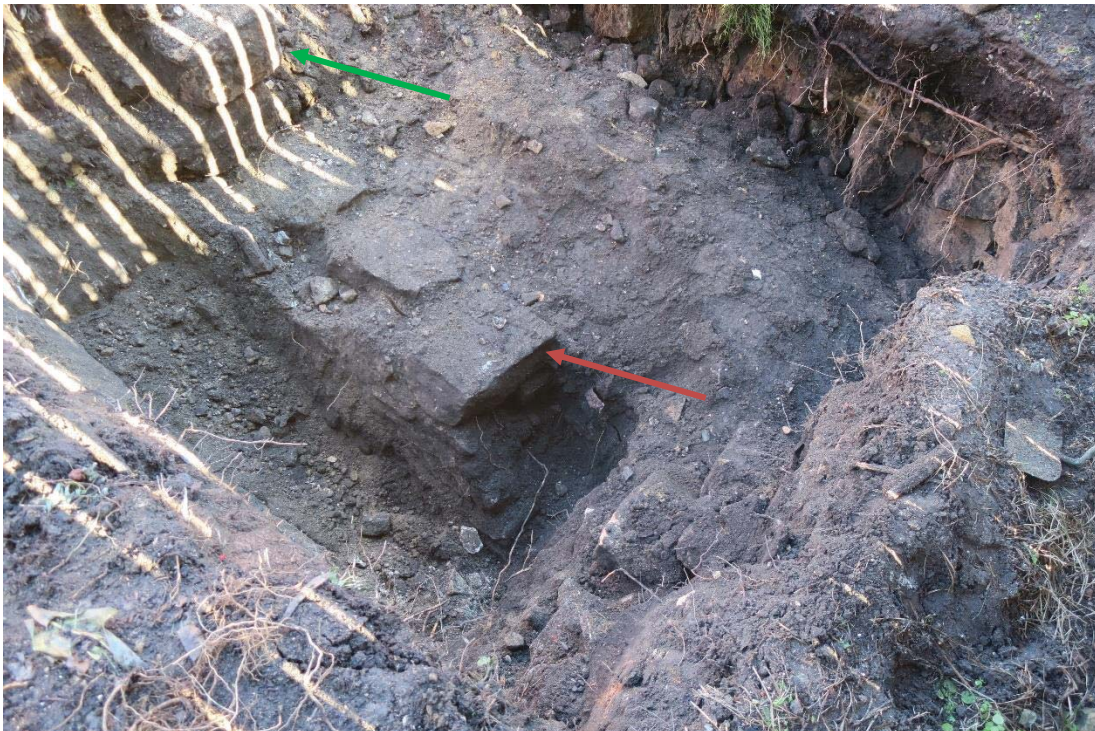
Trench 1 Extension consisted of expanding Trench 1 by a further 75cm in width along the southeast side (Figure 3.7).

Figure 3.7 Excavation of Trench 1 Extension, facing west.
Walls [004] (red arrow) and [005] (green arrow) are visible. AMAC 0645, 13/07/17

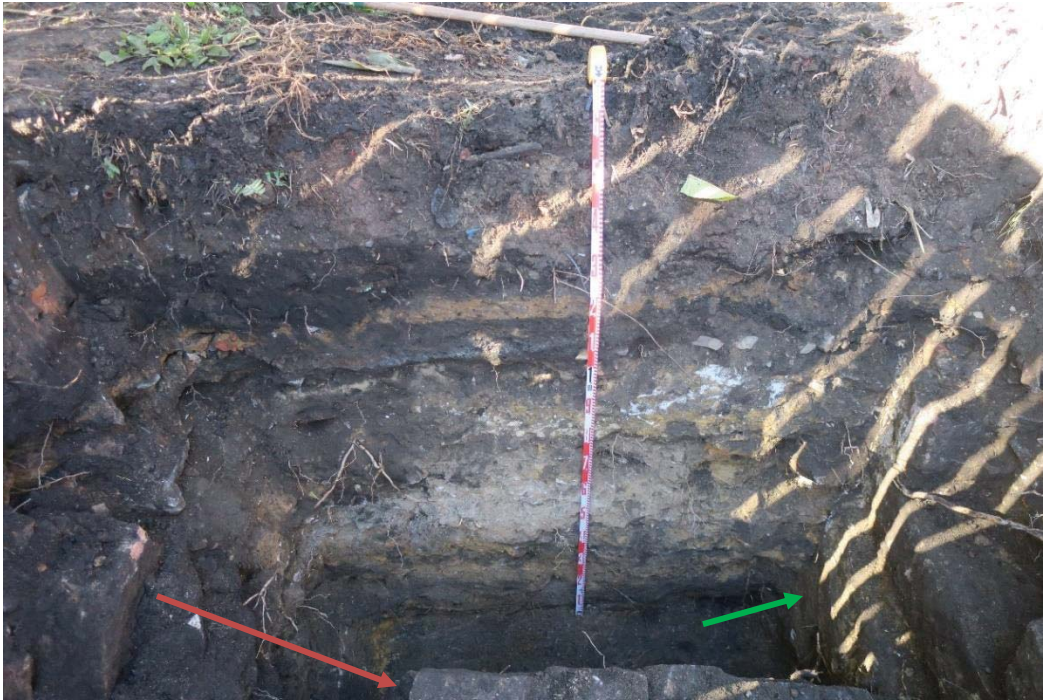
Figure 3.8 Southeast section, Trench 1 Extension, facing southeast
Walls [004] (red arrow) and [005] (green arrow) are visible. AMAC 0649, 13/07/17

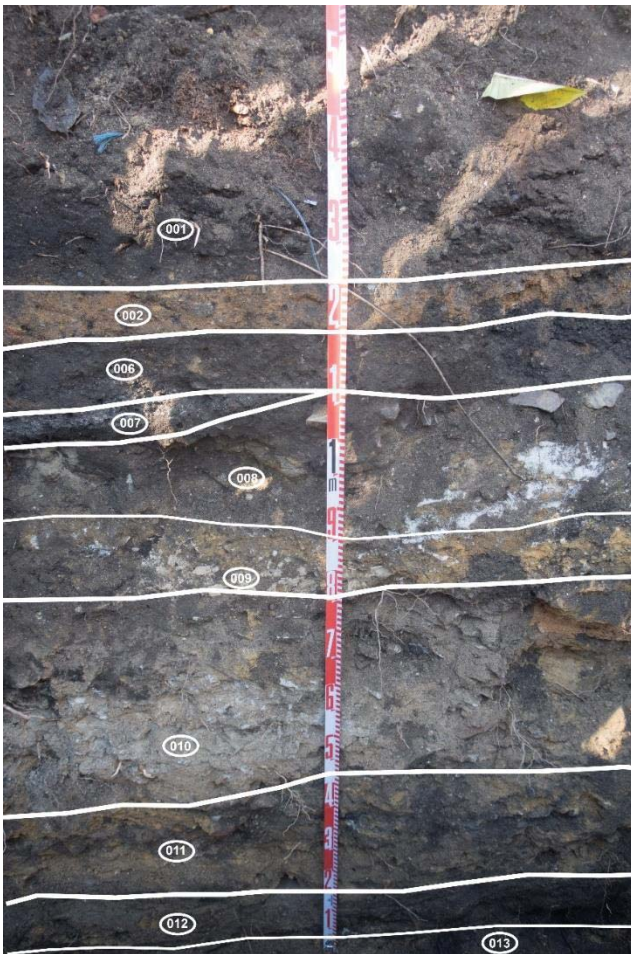
yellow sand [011], which contained fragments of sandstone and was 37cm in depth. This fill may have been used as packing for wall [004]. Directly below fill [011] was a thin layer of dark grey brown sand [012]. Deposit [012] consisted of a dark grey brown loamy sand, 2-3cm in depth, with few inclusions and sat directly above bedrock [013] (Figure 3.8-Figure 3.9). It is likely that deposit [012] is a remnant natural soil and ran below walls [005] and [004].

Figure 3.9 Detail of southeast section, Trench 1 Extension, facing southeast
AMAC 0647, 13/07/17

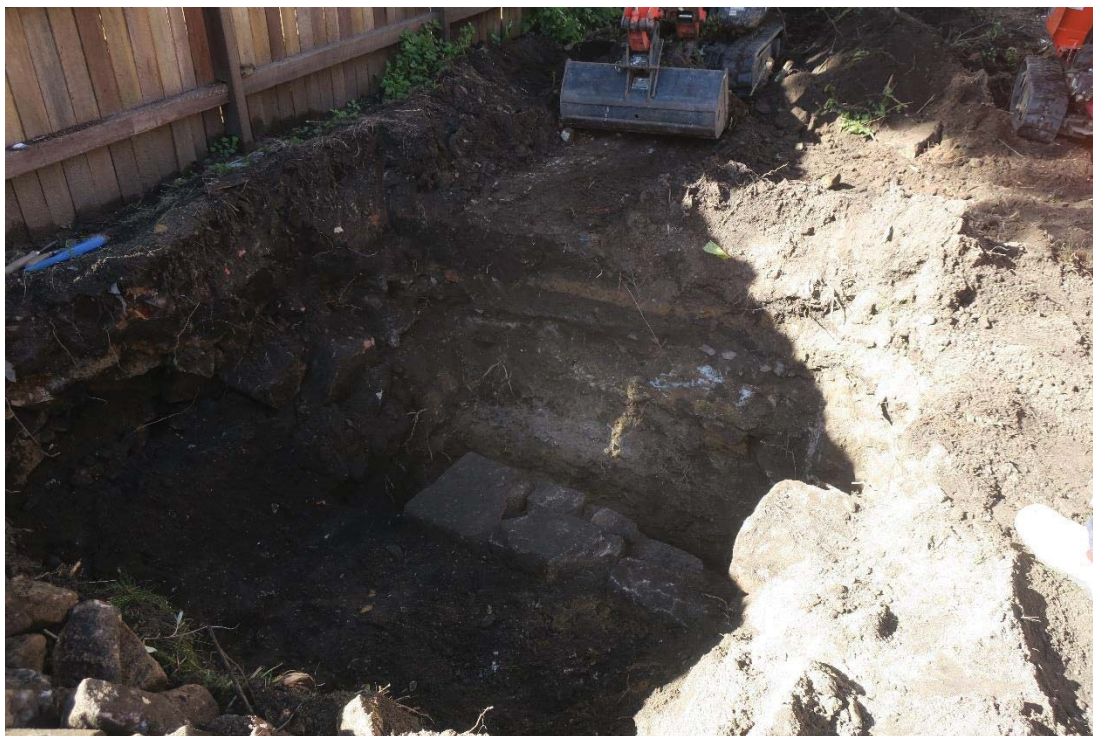
Upon exposure of part of wall [005], Trench 2 was placed to further expose this wall and uncover a possible return wall to the southwest. For this reason, Trench 2 was placed slightly overlapping Trench 1 at the southwest end. The Trench measured 200cm x 220cm from the southeast boundary of Trench 1 extension with an additional area of 75cm x 90cm adjoining Trench 1 extension to the southwest (Figure 3.10).⁴⁸

Figure 3.10 Start of Excavation, Trench 2, facing east
AMAC 0659, 13/07/17

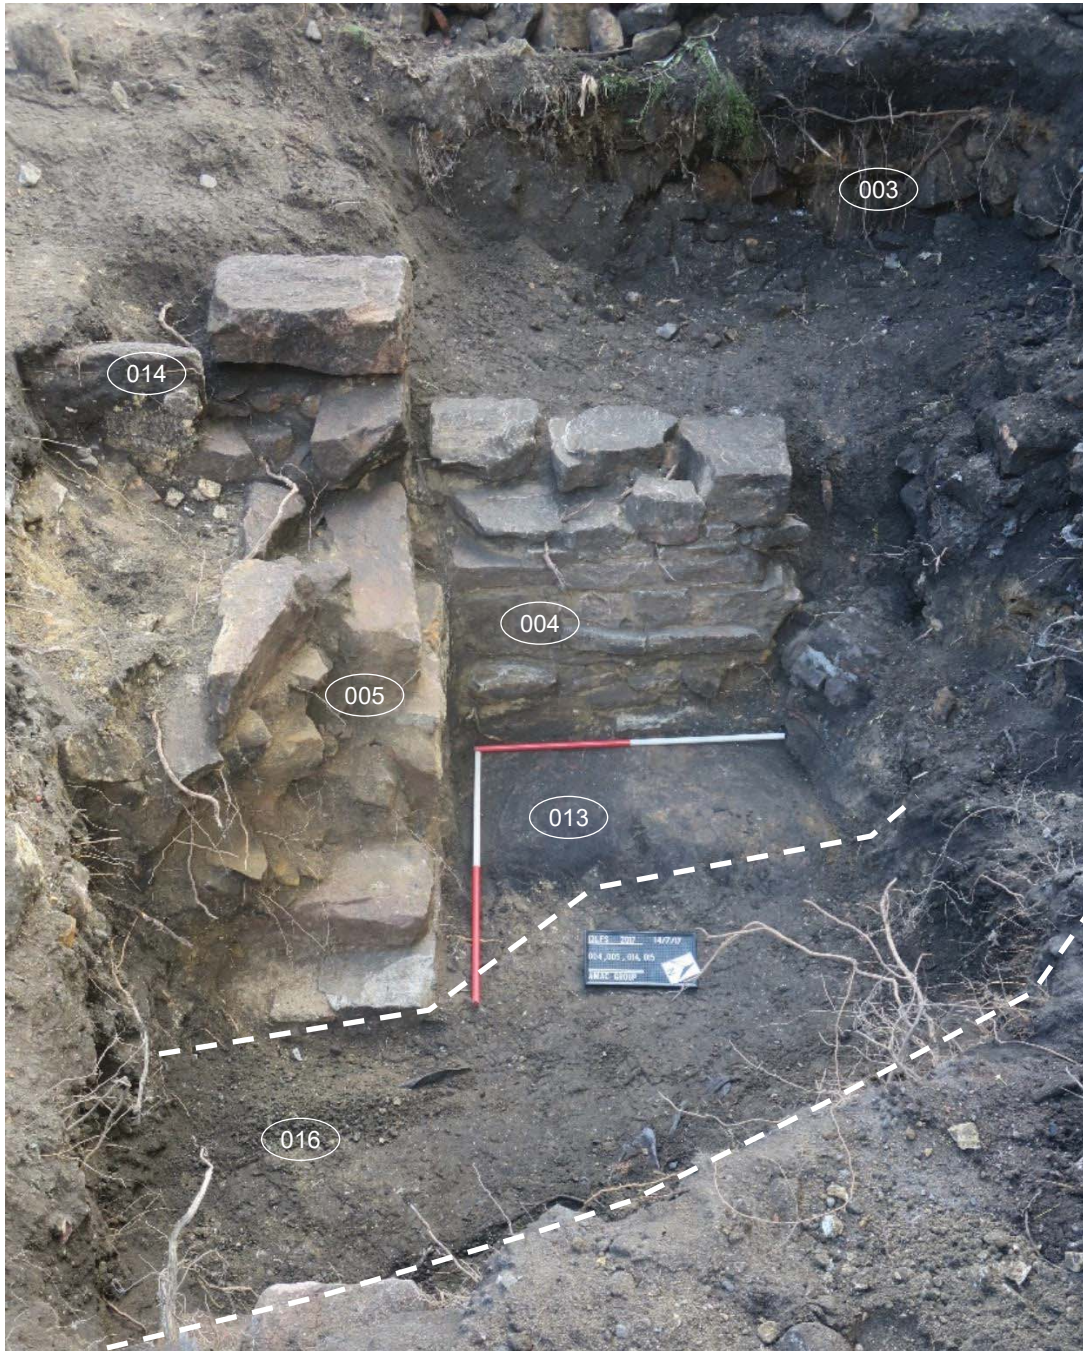
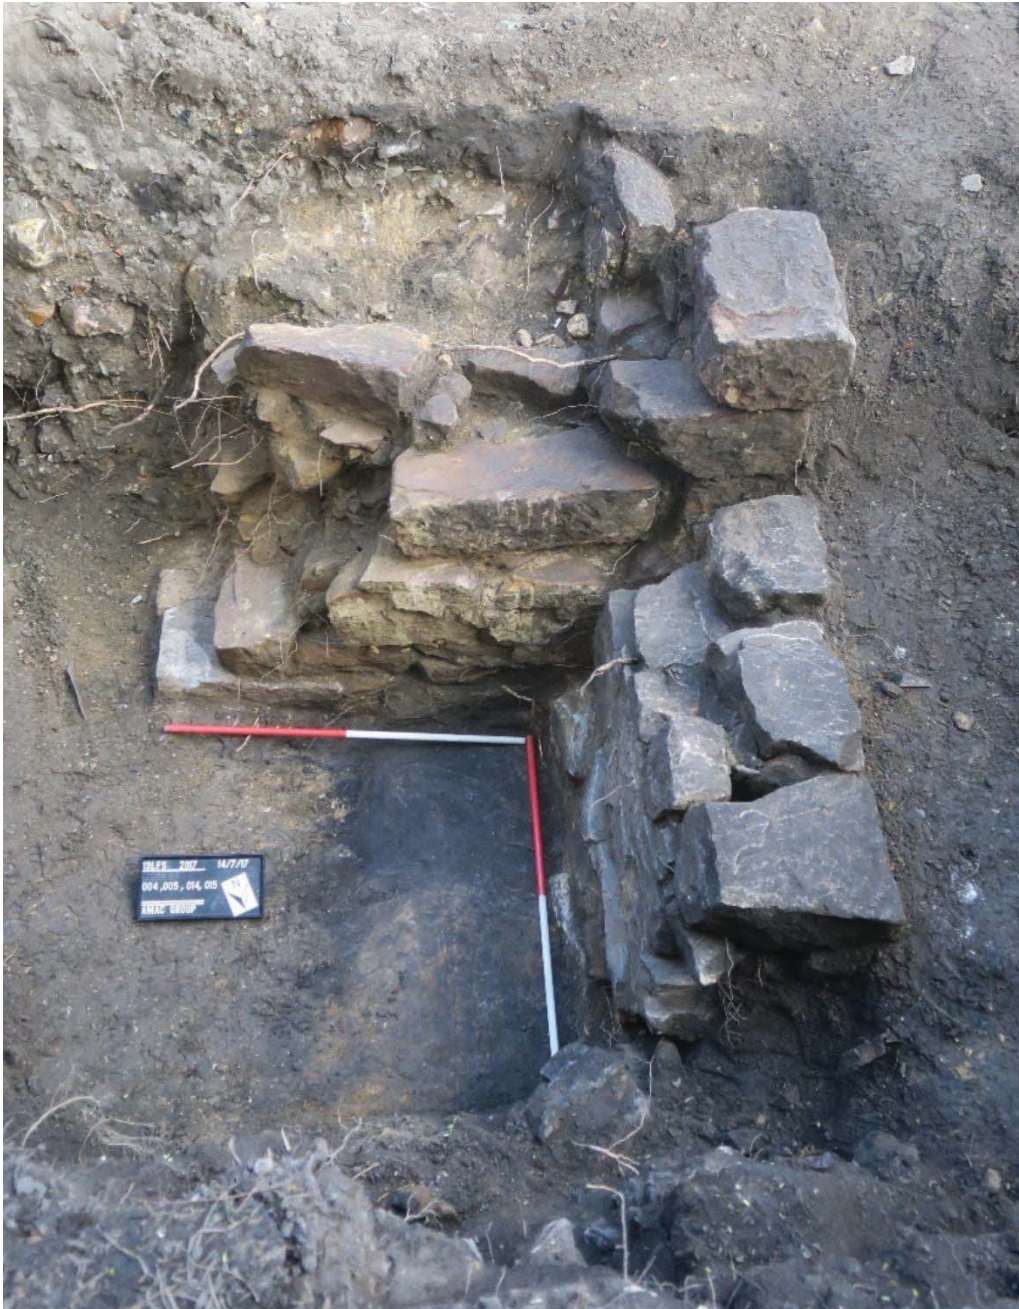
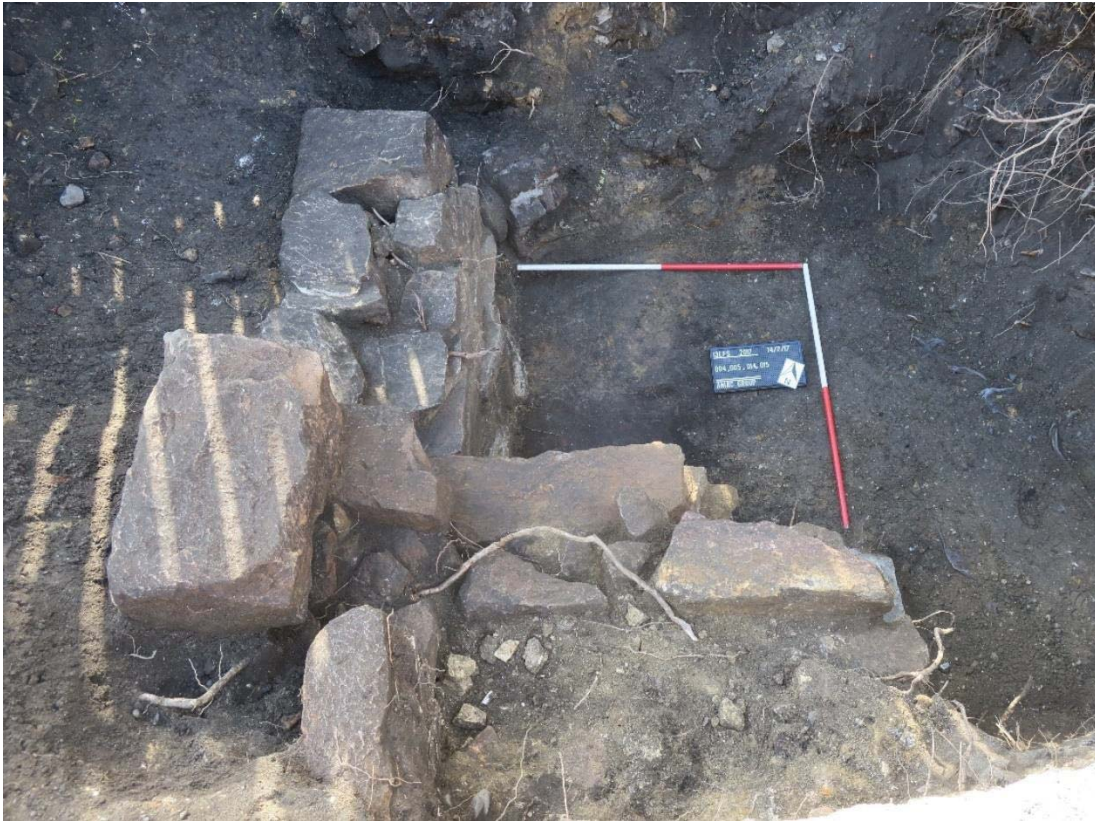
During the course of this test excavation, three relics in the form of sandstone walls, were exposed. Walls [005] and [014] were bonded together running perpendicular to each other, 47cm in width (wall [005] was 50cm wide at its foundation) and standing to a height of over 100cm (Figure 3.11-Figure 3.13). Both walls were constructed of up to eight courses of roughly cut sandstone blocks bonded with a mustard grey shell lime mortar. The outer façade of [005] was clearly rendered with a similar mortar coated with a coarse lime finish (Figure 3.17). This render was very fragile and flaked easily off the wall. Render was also evident on the interior of wall [014] however this was left unexposed to preserve the finish (Figure 3.20). Wall [005] was significantly disturbed by cut [015] which had removed over 1m of the length of the wall within Trench 2. The continuation of wall [005] was only partly exposed within the southeast section of the trench on the other side of the cut (Figure 3.16). It is clear that wall [004] post-dated walls [005] and [014] as the render on the façade of [005] was present in the gap between [005] and the abutting wall [004] (Figure 3.19).

Figure 3.11 Final Trench 2, Trench 1 extension, and Trench 1, facing northwest.
AMAC 0672, 14/07/17

Figure 3.12 Final Trench 2, Trench 1 extension, and Trench 1, facing southwest.
AMAC 0677, 14/07/17

Figure 3.13 Final Trench 2, Trench 1 extension, and Trench 1, facing northeast.
AMAC 0697, 14/07/17

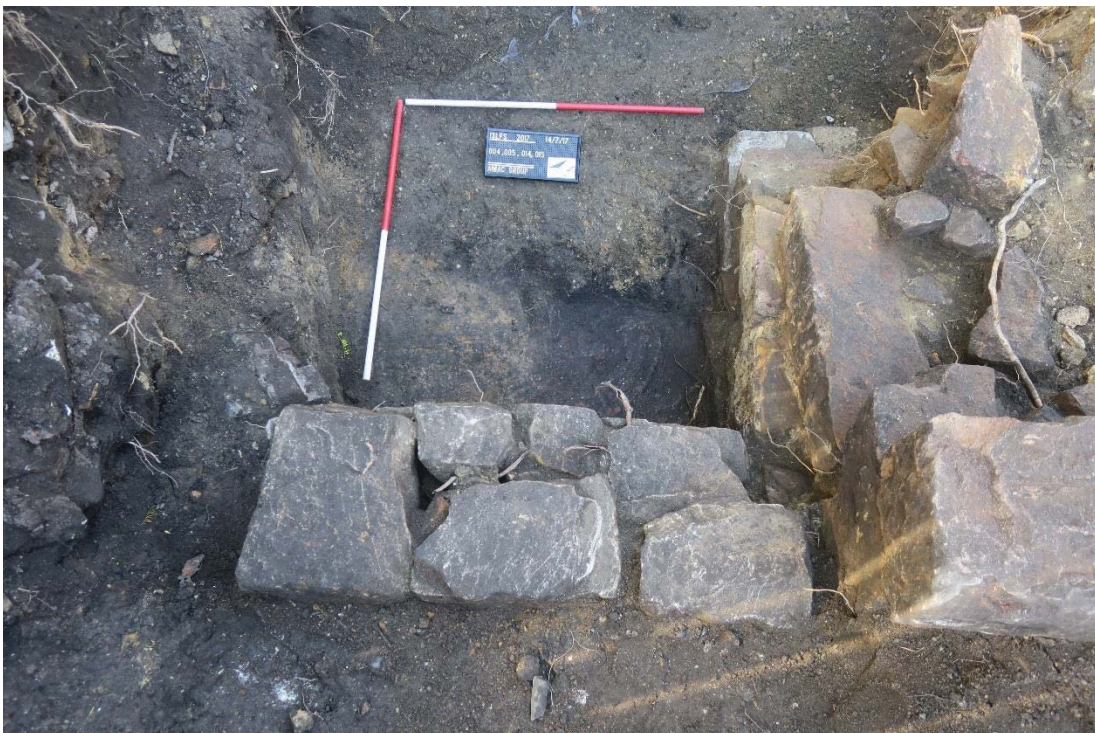
Wall [004] has been interpreted as a retaining wall (Figure 3.14; Figure 3.18). The foundation course of this wall was wider than the rest of the wall at a full width of 50cm tapering in to only 35cm in width by the upper course. This wall was constructed of up to eight courses of roughly cut irregular sandstone blocks, using far thinner blocks than the neighbouring walls [005] and [014]. Although no bonding was evidence on the surface, in section a yellow-grey shell lime mortar was identified. Only a 108cm length of this wall survived within the trench, with the northeast end robbed away, either by robber trench [017] or by the continuation of the disused service trench [015]. Wall [004] survived to a height of approximately 80cm and it is clear that the upper courses were robbed away by [017].

Figure 3.14 Final Trench 2, Trench 1 extension, and Trench 1, facing southeast.
AMAC 0708, 14/07/17

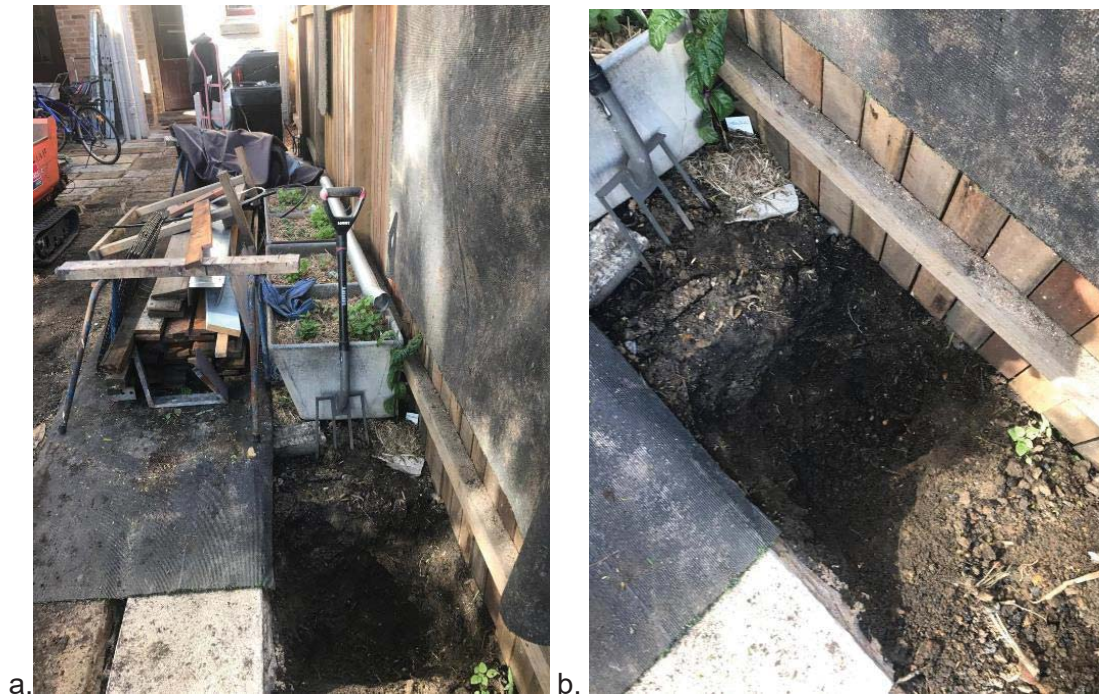
Hole	Description	Image
1	Topsoil excavated, some sandstone rubble exposed Hole abandoned due to proximity to Durham cottage. Relocated 1.4m west (Hole A)	Figure 3.26
2	Only topsoil excavated, no relics exposed.	Figure 3.27
3	Topsoil excavated, top of degraded bedrock exposed.	Figure 3.28
4	Topsoil excavated, contains modern debris	Figure 3.29

Figure 3.27 Hole 2 – excavation of topsoil
a. Facing southeast b. facing south. J.Baloh, 14/07/17

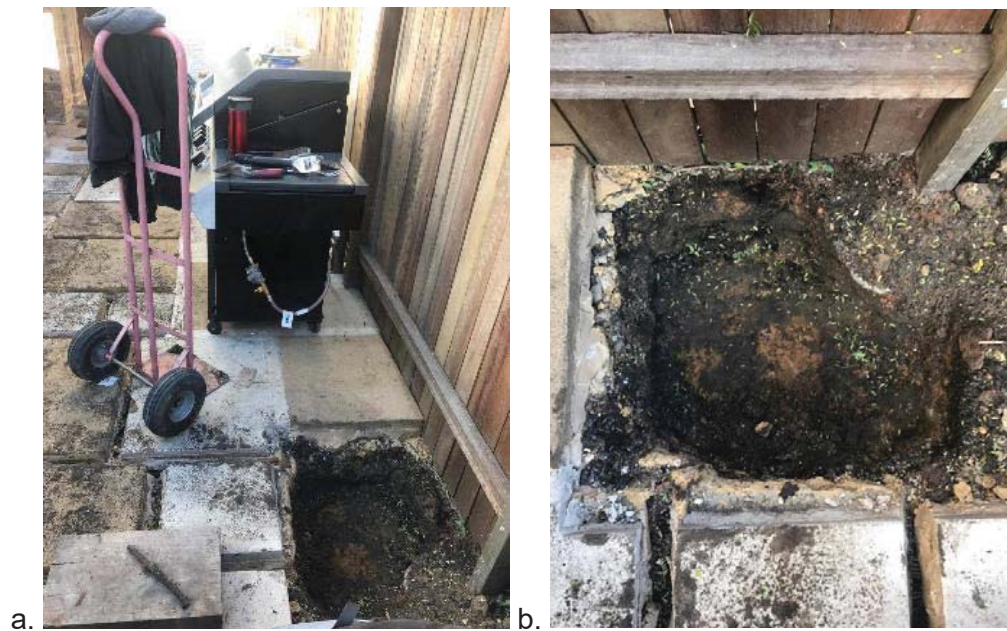
Figure 3.28 Hole 3 – excavation of topsoil – bedrock exposed
a. Facing south b. facing southwest. J.Baloh, 14/07/17

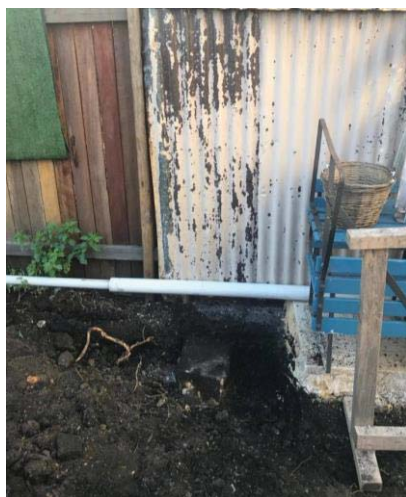
Figure 3.30 Hole 6
J.Baloh, 14/07/1

5	Topsoil excavated, remnant concrete surface found in section, 20 th century	Figure 3.29
6	Topsoil excavated, modern footing exposed	Figure 3.30
7	Bedrock exposed – not photographed	
A	Topsoil excavated – sandstone fragments consistent with fill [003] – Replaces Hole 1	Figure 3.31
B	Topsoil excavated	Figure 3.32
C	Topsoil excavated	Figure 3.33

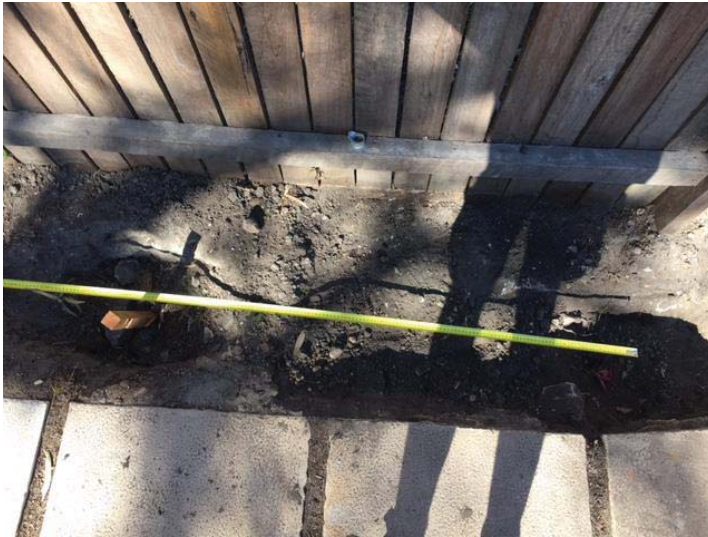
Figure 3.31 **Hole A - topsoil**
Provided by K.Rees

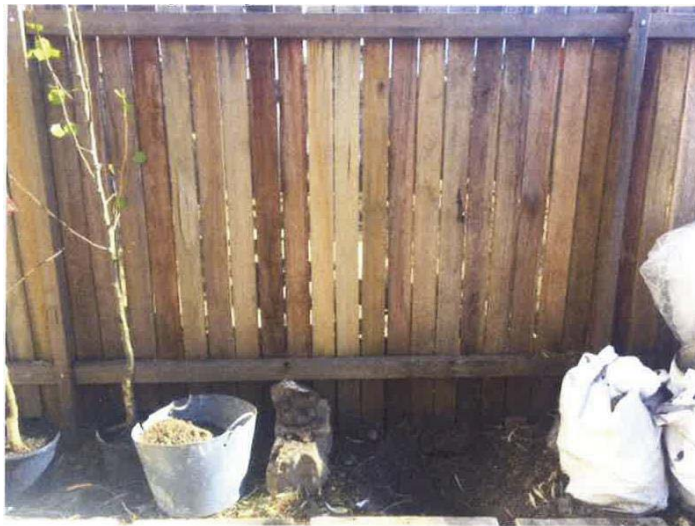
Figure 3.32 **Hole B - topsoil**
Provided by K.Rees

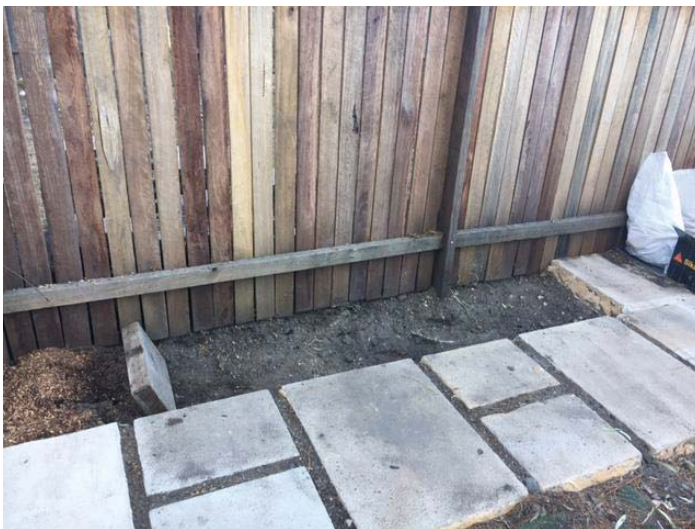
Figure 3.33 **Hole C - topsoil**
Provided by K.Rees
