Sydney Opera House—Lift 36
Historical Archaeology Excavation Report
Report prepared for Sydney Opera House
May 2019

The Sydney Opera House (SOH) is undertaking accessibility upgrades and other venue improvements on the Joan Sutherland Theatre. These include works on Lift 36 (Figure 1.1) that have the potential to impact historical archaeological deposits, structures and/or relics.

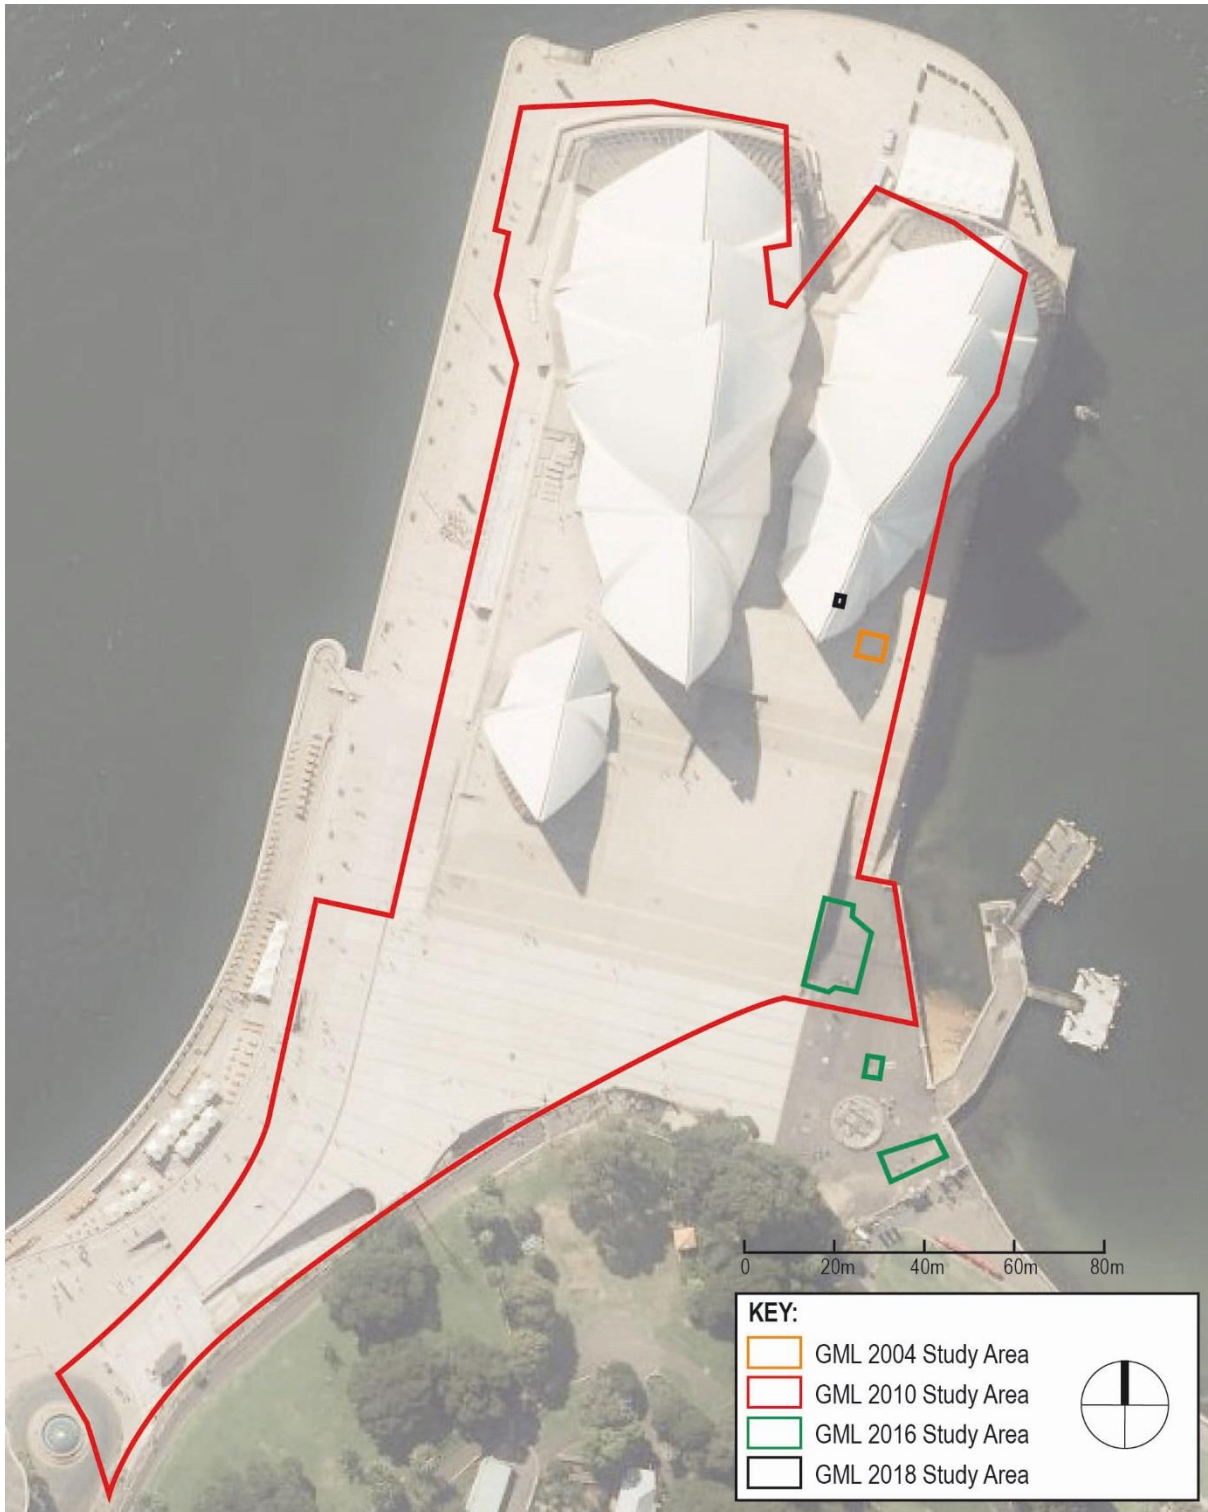
Figure 1.1 Sydney Opera House aerial, with the location of relevant archaeological excavations. The location of Lift 36, and the 2018 archaeological work is shown. (Source: Google Earth Pro, 2018, with GML additions)

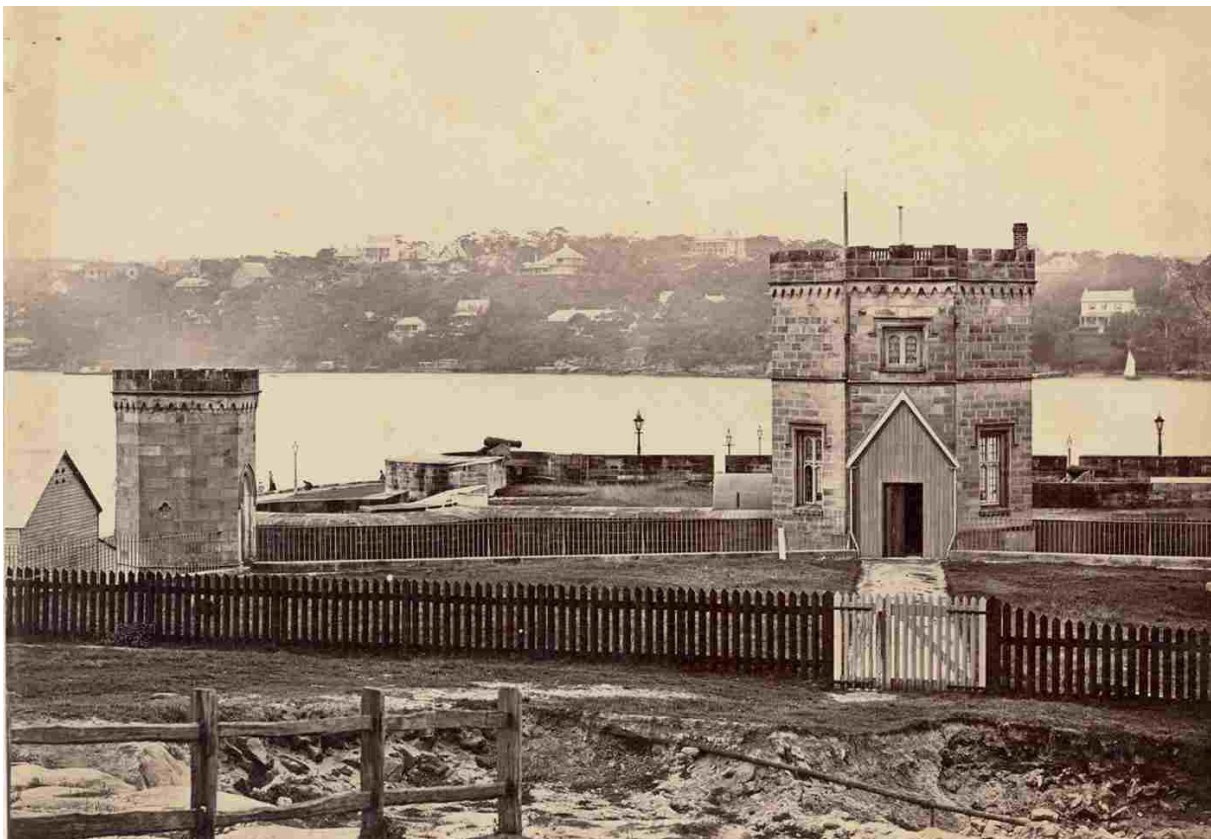
Figure 2.3 View north into and across the terreplein at Fort Macquarie. Lift 36 is located out of frame to the right. (Source: State Library of NSW, SPF/121)

The terreplein and bastions (Figure 2.3) show a flat level surface across the internal space of the fort, with the 1.5m drop between the top of the external bastion wall and terreplein. A stone surface adjacent to parts of the western wall abuts a flat grassed area.

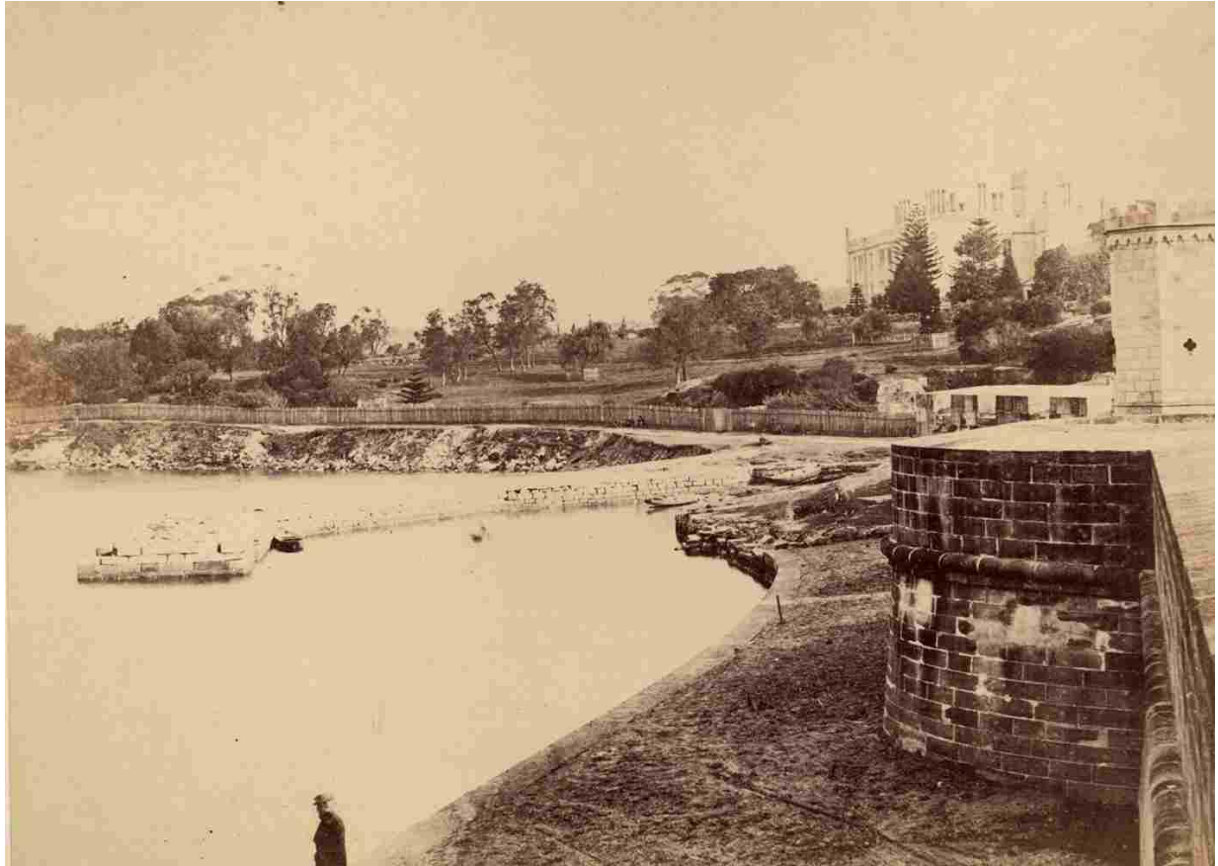
Figure 2.4 Eastern side of Fort Macquarie, facing south, showing the height of the external buttress ashlar sandstone wall, and the low seawall, with the esplanade defining the extent of land reclamation. (Source: State Library of NSW, FL1227860)

The external buttress wall (Figure 2.4) comprises uniform sized sandstone blocks; the lower two thirds are thicker at the base, sloping slightly inwards to a curved course, approximately level with the terreplein, above which the wall becomes vertical. An early seawall with tidal floodplain can be seen outside the fort, creating the 1860s esplanade around the fort.

- The wall's sandstone blocks had a variable thickness, being 0.63m wide at the deepest recorded point, and 0.53m wide at the top (three courses apart). This could result in the external wall's slope observed in historical photographs (Figure 2.4).

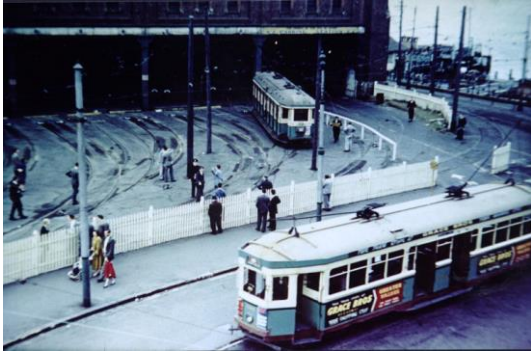
Figure 2.5 Entrance to the Tramcar House. The eastern tram tracks are blocked by a permanent wooden post and rail fence. (Source: City of Sydney Archives 044/044481)

Photographic evidence of the tramcar shed is limited except for distant views to the southern entrance. The tram shed was constructed on a level surface, with reclaimed land on the eastern and western sides. Four sets of tram tracks entered the shed, although a permanent wooden post-and-rail fence blocked one set (Figure 2.5). This fence appears to have prevented tramcar access into the eastern tracks of the shed.

However, use of the pit specifically for servicing trams is tempered by two factors. Firstly, the width of the pit is wider than a tram (note the width of the pit in the figures below)—if used as a tram service pit, there should have been internal wall features allowing tracks to extend over the pit. Secondly, the tram tracks on the eastern side of the Tramcar House had been blocked off and may not have been used by trams, this can be seen in Figure 2.5.

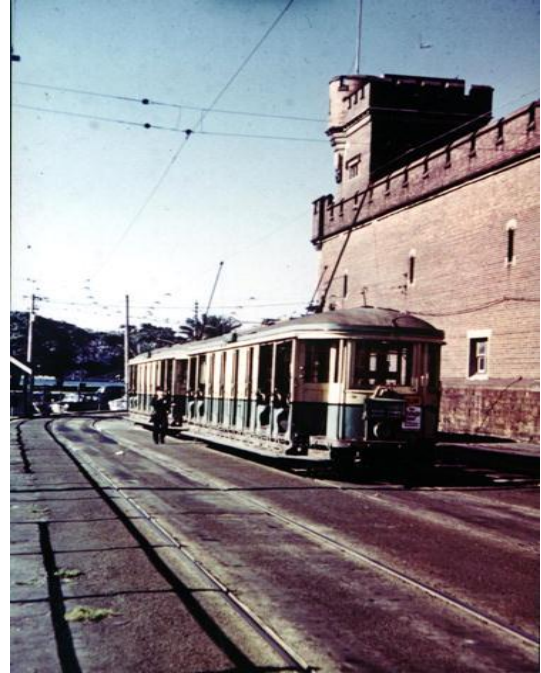
Figure 2.6 Western external side of the Tramcar House with sandstone foundations to ~1.5m. (Source: City of Sydney Archives 044/044475)

Materials used to manufacture the building were brick and faced sandstone (Figure 2.6 and Figure 2.7). The sandstone has a height of around 1.5m, above which an internally buttressed red-brick wall was constructed.

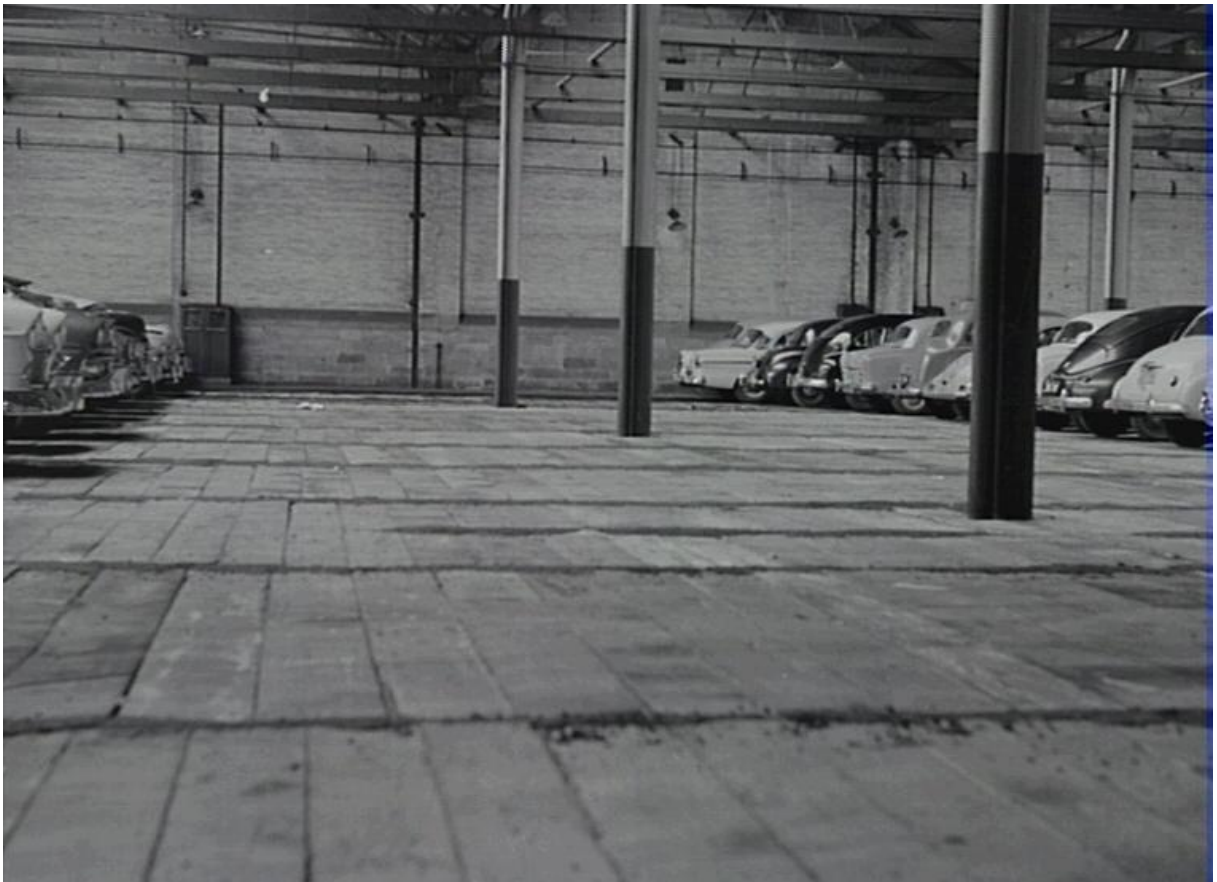
Figure 2.7 Internal view within the Tramcar House following closure of the tram system and use as a carpark. The floor is either wooden or concrete slats. The external lower sandstone wall is clearly visible at the height of the car roofs. (Source: City of Sydney Archives 101/010405 NSCA CRS 48-405)

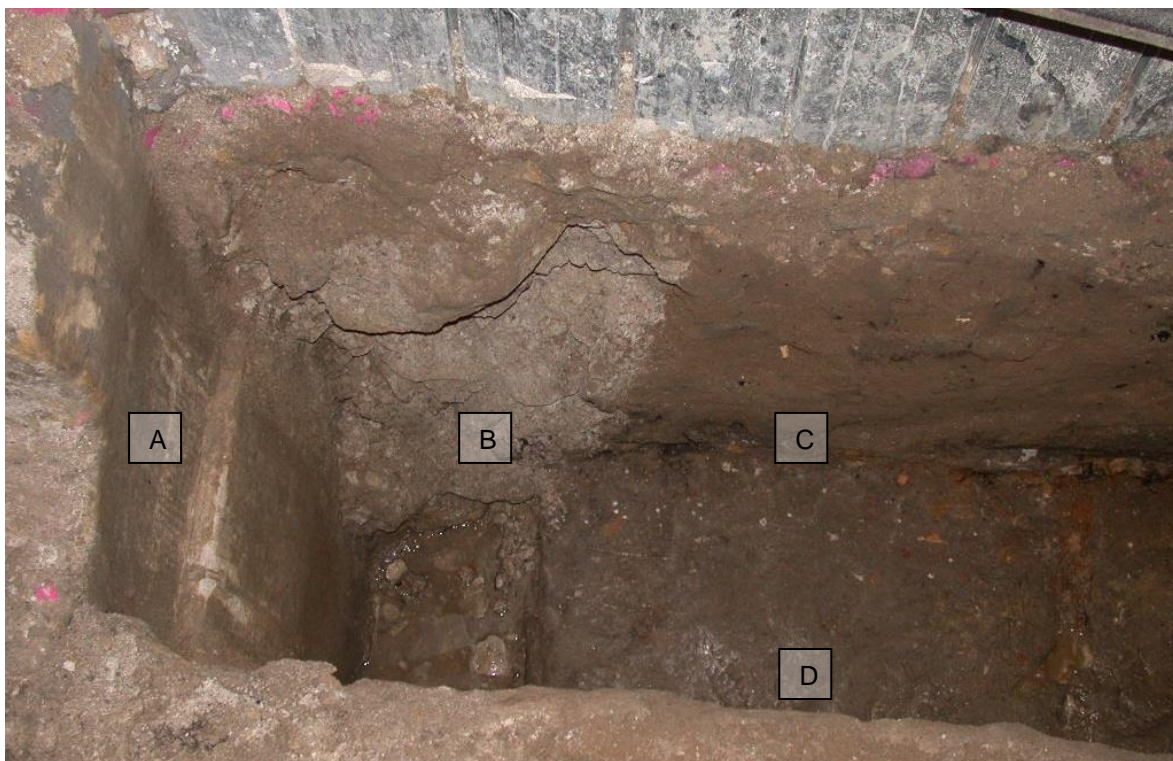
Figure 2.11 Fort Macquarie wall [A] external face, with the construction trench comprising a crushed sandstone fill [B], cutting a loose sandy deposit with artefacts [C] over a dark brown deposit [D]. (Source: GML 2004)

- A sandstone wall (the external wall of Fort Macquarie), orientated north–south, with ashlar blocks bonded with a fine mortar with no identifiable shell inclusions (Figures 2.11 and 2.12, context [A]⁹).

- East of the wall (external to the fort) was:
 - a construction trench cut with a crushed sandstone rock mixed with a sterile loose sandy deposit (Figure 2.11, [B]). This ended on cut sandstone bedrock (RL 0.53m). The construction trench had cut a natural sandy layer [C];

- a loose sandy deposit with artefactual material dated between 1839–1904 (Figure 2.11, [C]), which was over;
 - a dark brown deposit (Figure 2.11, [D]), containing evidence of vegetation including grass reeds, which was over;

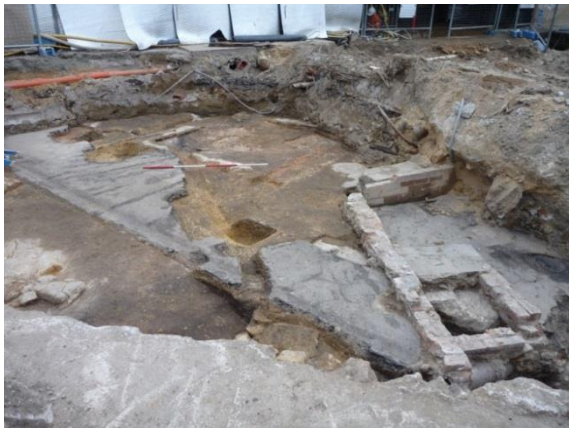
Figure 2.13 View looking northwest showing the structural remains identified in the southern half of the loading dock. This area comprises the eastern shoreline between the Tramcar House and the boat slip. Photo scale: 2m. (Source: GML 2012)

The evidence of the 1902 Tramcar House phase included the upper external bitumen surface to the Tramcar House [034=083] constructed over a thick layer of grey-brown fill [076] consisting of demolition material, stone rubble and sporadic artefacts (Figure 2.13). The RL of these features was 2.96m AHD; this report has extrapolated this height as the surface level associated with the tram lines and internal to the Tramcar House. The substantial thickness of this fill—measuring between 200mm and 1.2m—indicates that it was used for levelling for the construction of the Tramcar House complex. The upper [034=083] and lower [058] bitumen/asphalt levels were separated by a retaining wall [048=161] constructed of two to three courses of dressed sandstone blocks; these could be re-used sandstone blocks from Macquarie Fort. A portion of a brick platform with four steps [050] extended northeast–southwest. The steps were also constructed of dry-pressed bricks and covered with a concrete render (Figure 2.14).

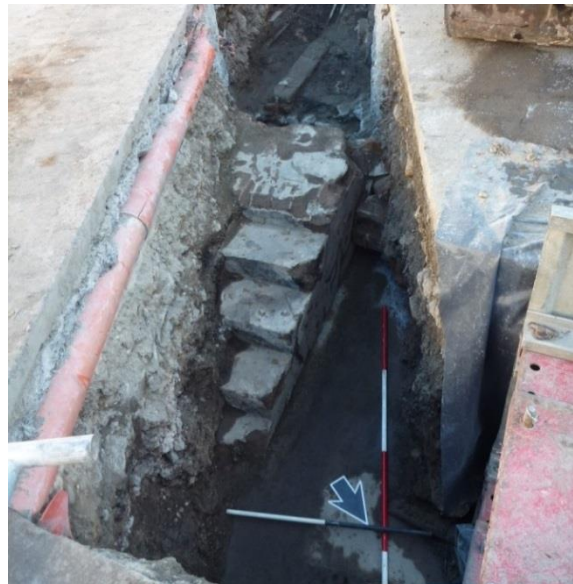
Figure 2.14 Concrete and dry-pressed brick steps [050] and platform are associated with the former waiting room at the shoreline end of the boat harbour/slip. (Source: GML 2012)

Context 15—the poured concrete steps. Three treads are present, two fully exposed inside the trench and both measuring 230mm; three risers are visible, measuring 140mm, 220mm and 220mm (bottom to top). The concrete steps have been poured after the two concrete floor surfaces [18 and 19], in a single pour. The sandstone steps [16] form the base for the concrete steps. These steps are similar in construction to those observed in GML 2016 (Figure 2.14), although the other concrete steps were poured over dry-pressed bricks.

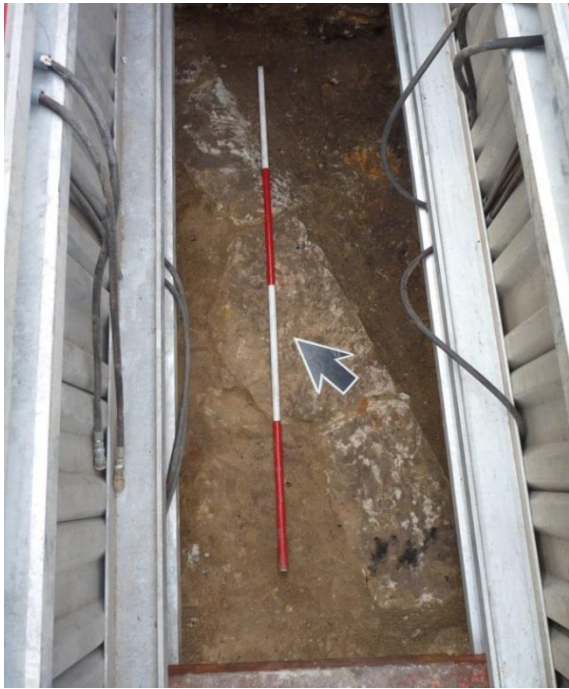
Figure 2.15 A section of sandstone footing [077] believed to be part of the Fort Macquarie buttress wall was revealed in the north section of the piling trench. Photo scale: 2m. (Source: GML 2012)

Fort Macquarie's eastern buttress wall comprised a sandstone alignment [077] orientated north–south (Figures 2.15 to 2.18). The alignment formed a footing that consisted of rectangular sandstone blocks measuring 350mm–500mm wide. The stone blocks were bonded with fine yellow shell mortar with charcoal. More of the same footing was found during the excavation for the services plenum for the eastern boardwalk (Figures 2.16 and 2.17). This portion [200] represented the northern extension of footing [077]. Portion [200] was only 1.7m long, but with intact width inclusive of the construction trench [202]. The sandstone consisted of a double row of sandstones measuring 650mm wide. The overall width, inclusive of stone rubble packing [201] within the construction trench, was 1.23m. The stone rubble packing [201] was set in sand, which also contained sporadic artefacts (roofing tiles, animal bone and sandstock brick fragments). The large stone blocks used for construction measured 390mm x 800mm x 250mm, and 440mm x 650mm x 250mm. Small stone and terracotta roofing tile fragments were used to fill in the gaps between the joints (Figure 2.18).

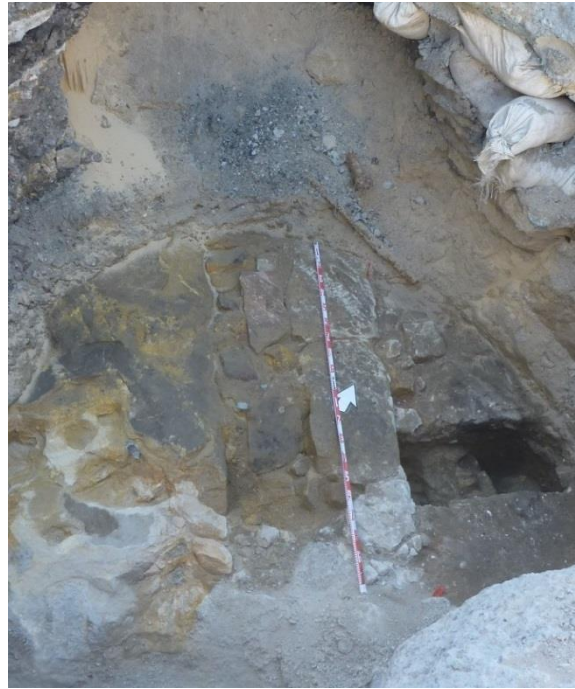
Figure 2.16 The north extension of sandstone footing [077] marked as context [200] provided a glimpse of the size of the Fort Macquarie buttress wall. (Source: GML 2013)

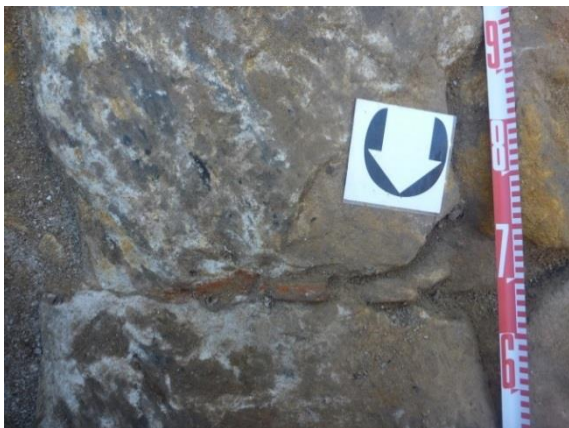
Figure 2.17 A detail in footing [200] showing the use of terracotta tile fragments for packing between the stone block joints. (Source: GML 2013)

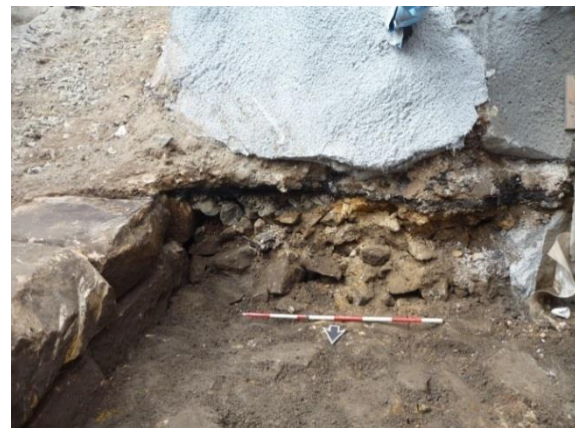
Figure 2.18 The south section of the substation exhaust plenum shows the reclamation rubble fill and the line of asphalt surface. Photo scale: 1.4m. (Source: GML 2014)

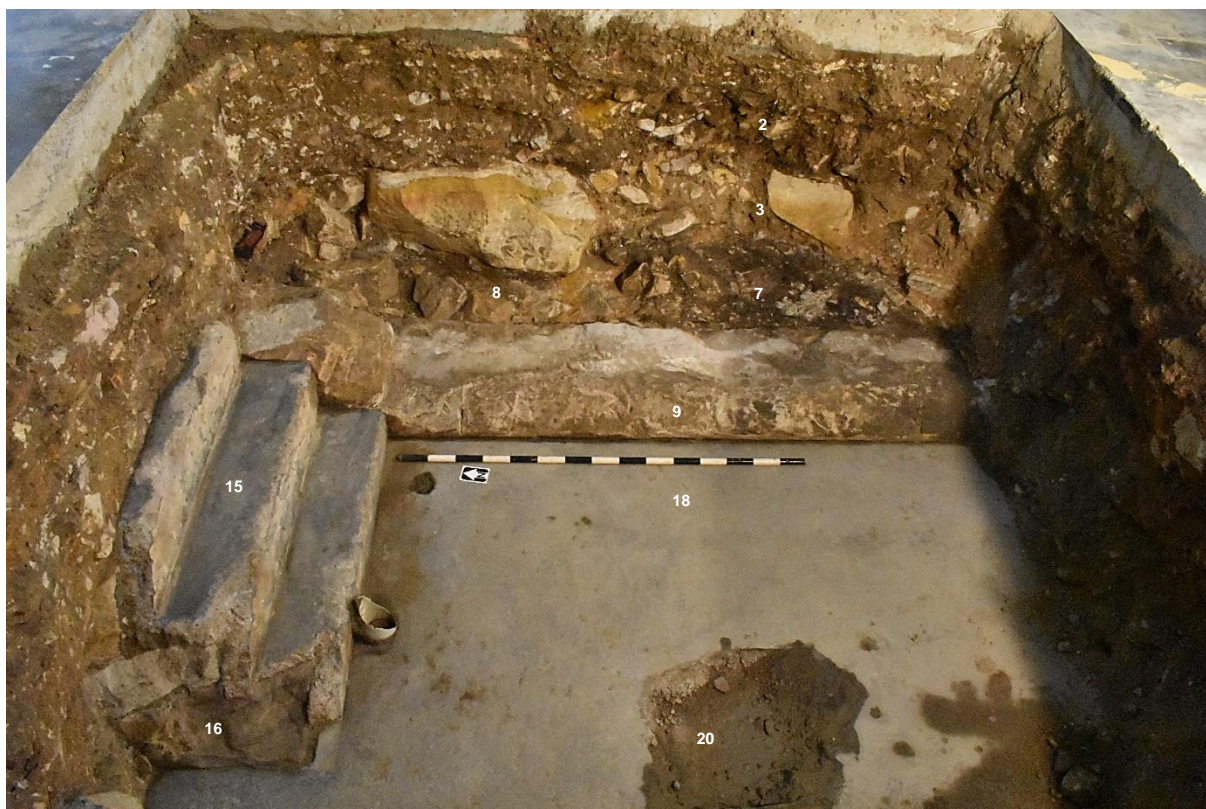
Figure 3.5 Excavation phase 1—View east into the trench, showing the concrete surface abutting the cut stone wall. The concrete covering the steps and wall is visible. A variety of fills are evident in the section face. (Source: GML 2018)

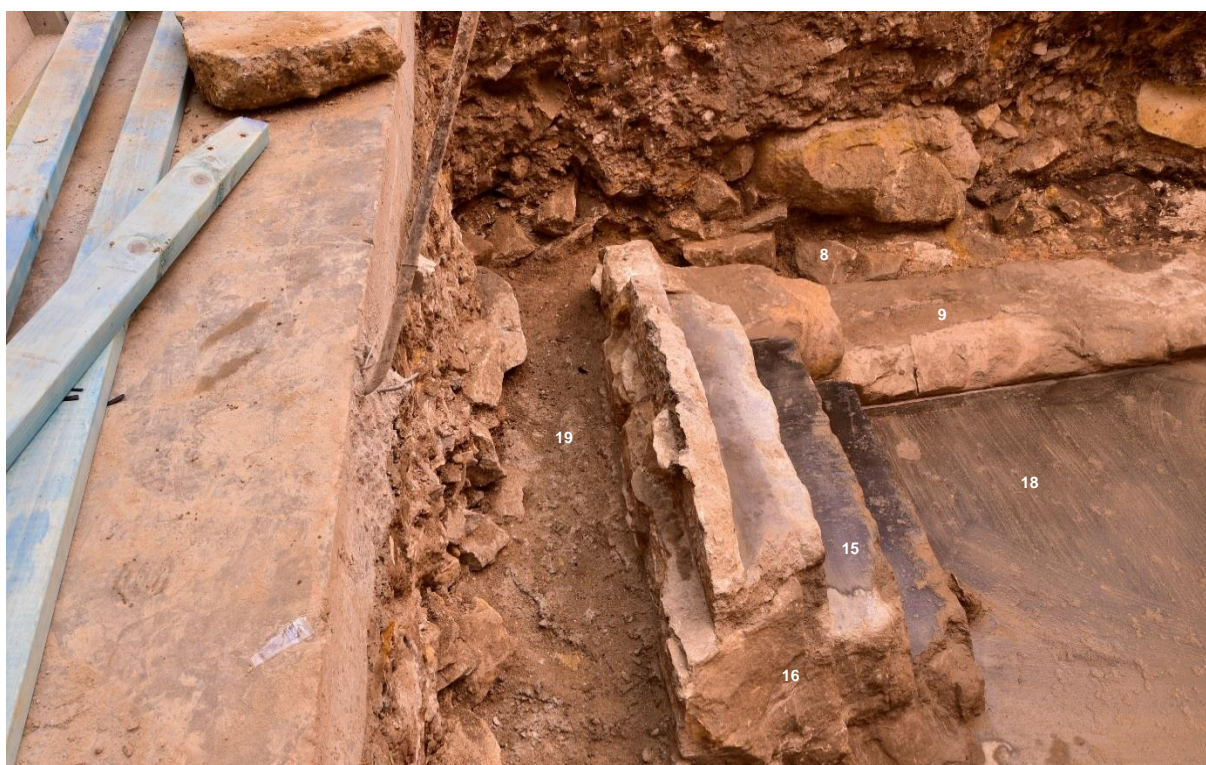
Figure 3.6 Excavation phase 2—View east into the trench, showing the full remnant extent of the steps, with a surface used to prepare the concrete [19] behind the steps. (Source: GML 2019)

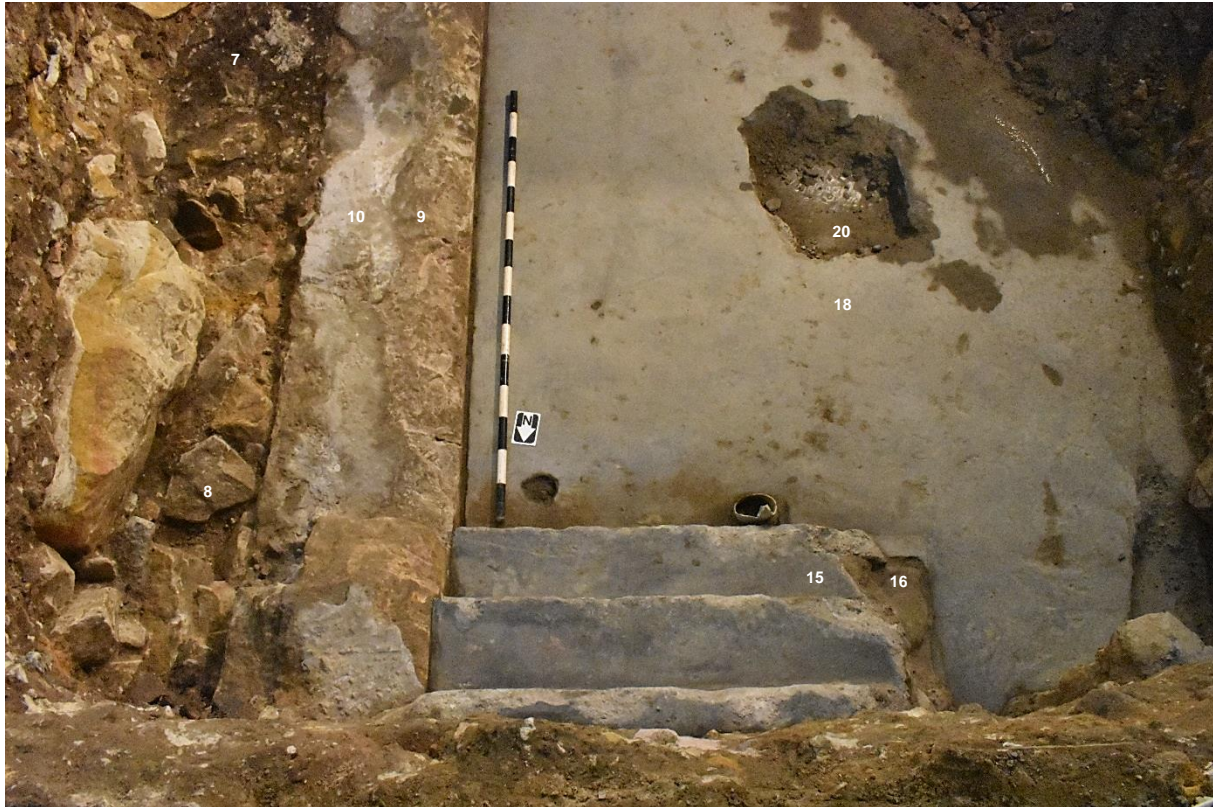
Figure 3.7 Excavation phase 1—View south into the trench, showing the steps and modified sandstone wall with concrete from the Tramcar House phase. Earlier fills can be seen adjacent external to the wall (left). (Source: GML 2018)

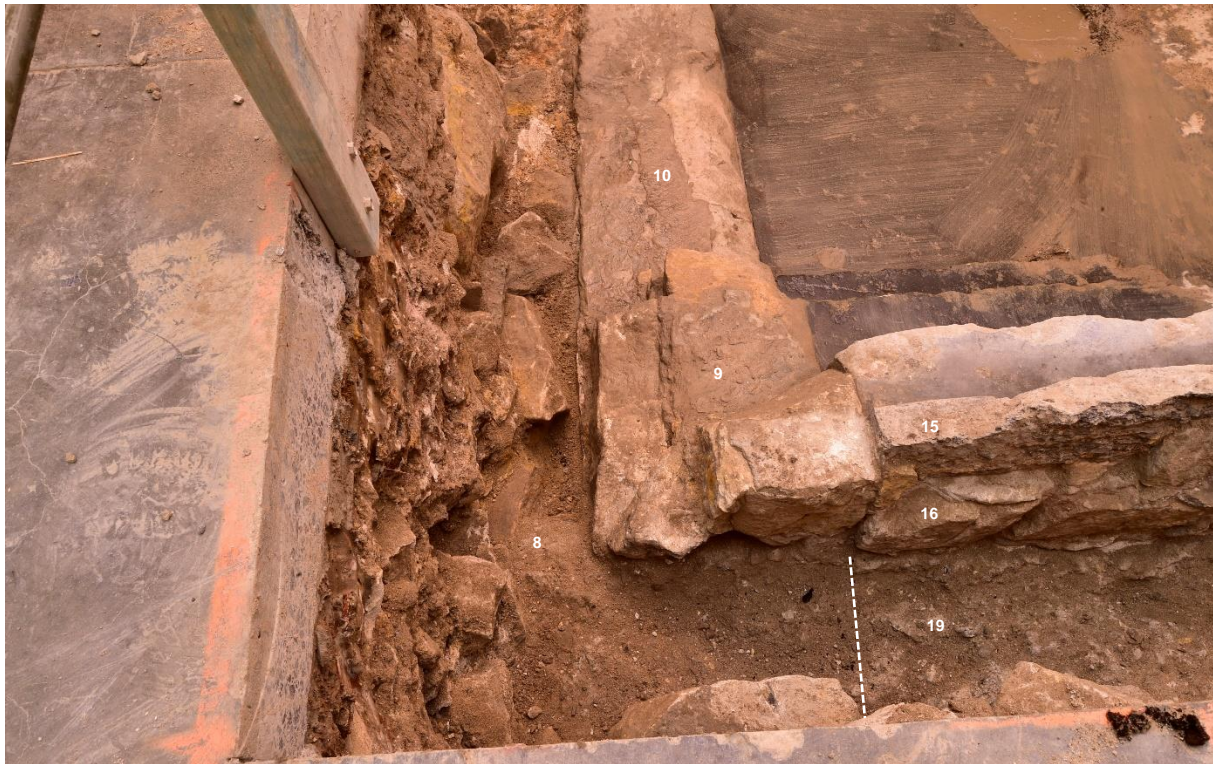
Figure 3.8 Excavation phase 2—showing the full extent of the concrete steps [15], the relationship with the sandstone blockwork to the east (left) of the steps [9], and the surface behind the earlier sandstone steps used for preparing concrete [19]. (Source: GML 2019)

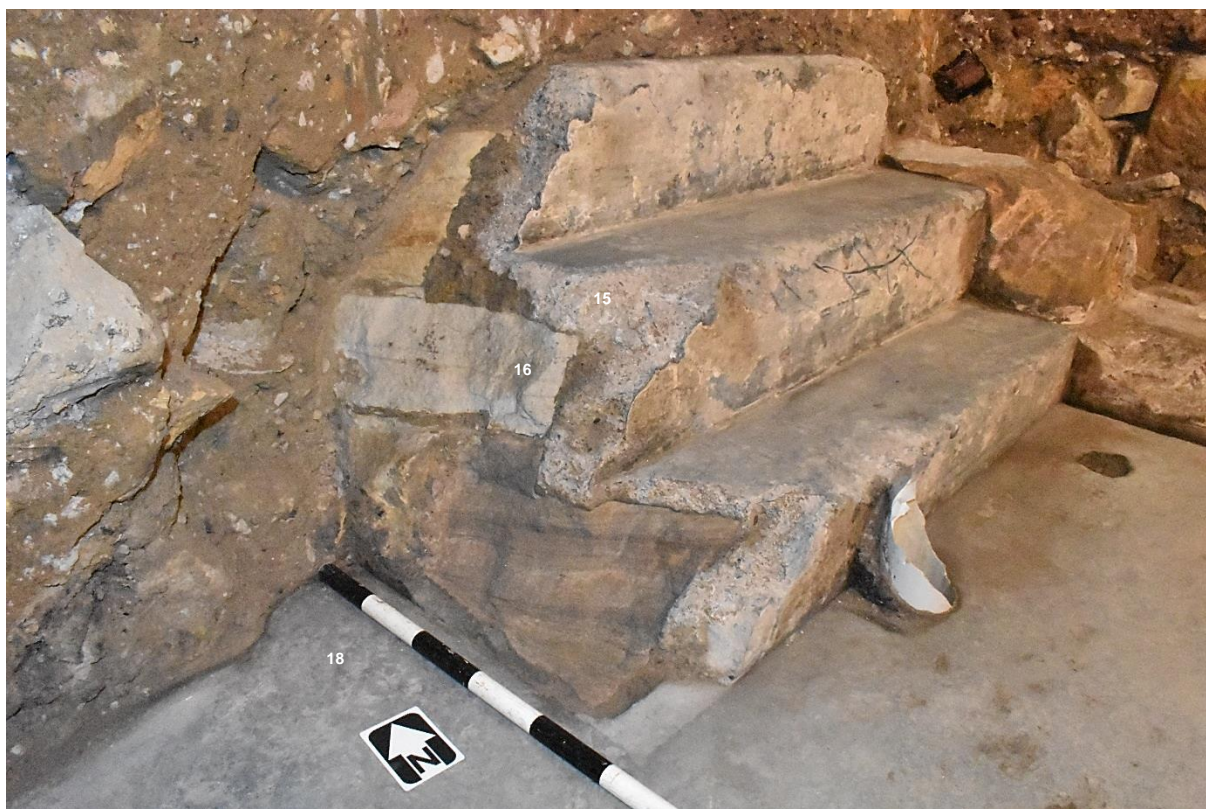
Figure 3.9 Excavation phase 1—View northeast showing the sandstone [16] and concrete steps [15]. The separate sandstone blocks comprising the steps are evident. (Source: GML 2018)

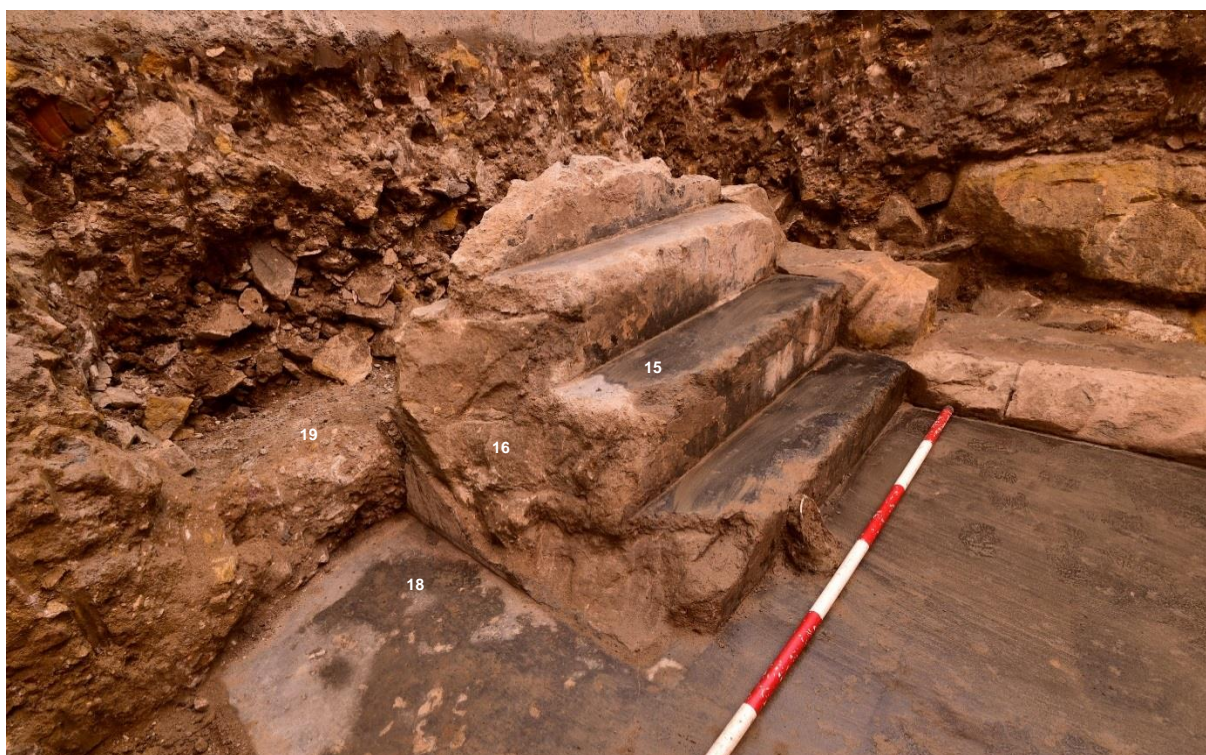
Figure 3.10 Excavation phase 2—full remnant extent of steps [15] and [16]. The preparation area (surface) for the concrete [19] is located behind the sandstone steps, and would have been shovelled across the floor of the room from this location. (Source: GML 2019)

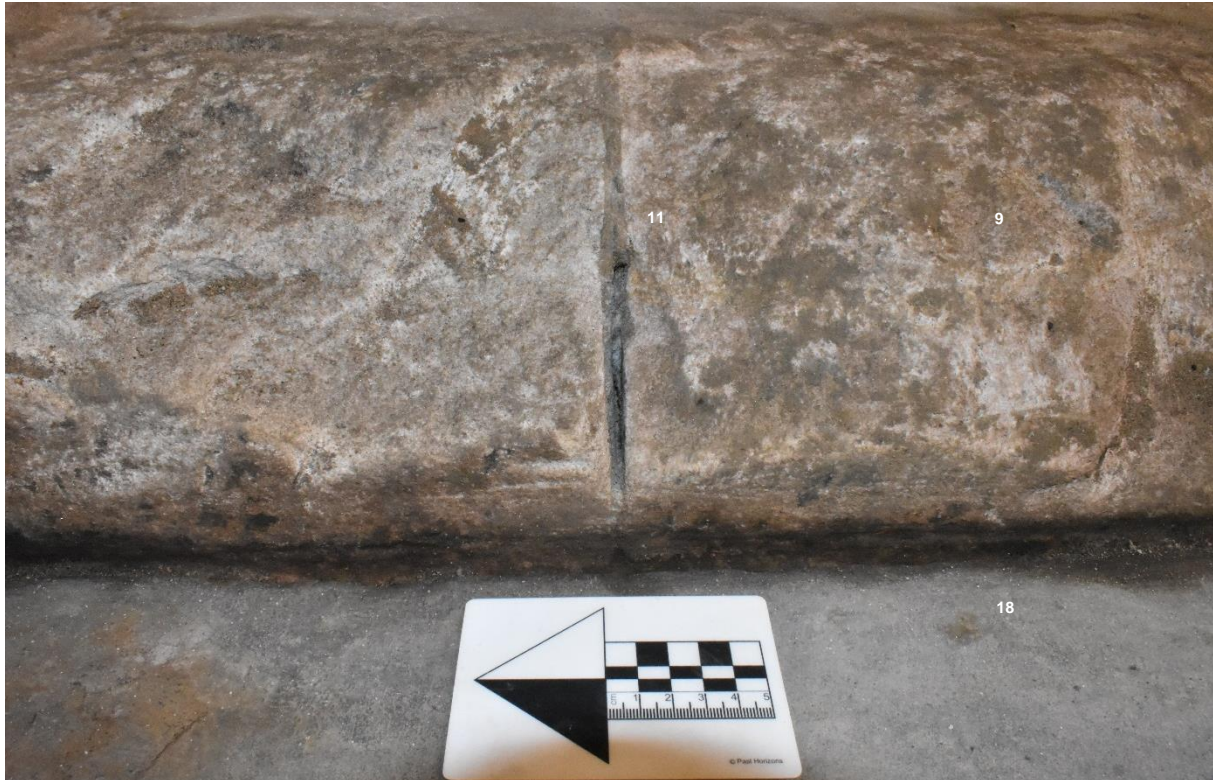
Figure 3.11 Excavation phase 1—Modifications to the sandstone wall [9], with cut-and-fill with concrete [11]. The rough chamfering to create a curved edge is evident. A wear line in the sandstone parallel to the concrete surface can be seen. (Source: GML 2018)

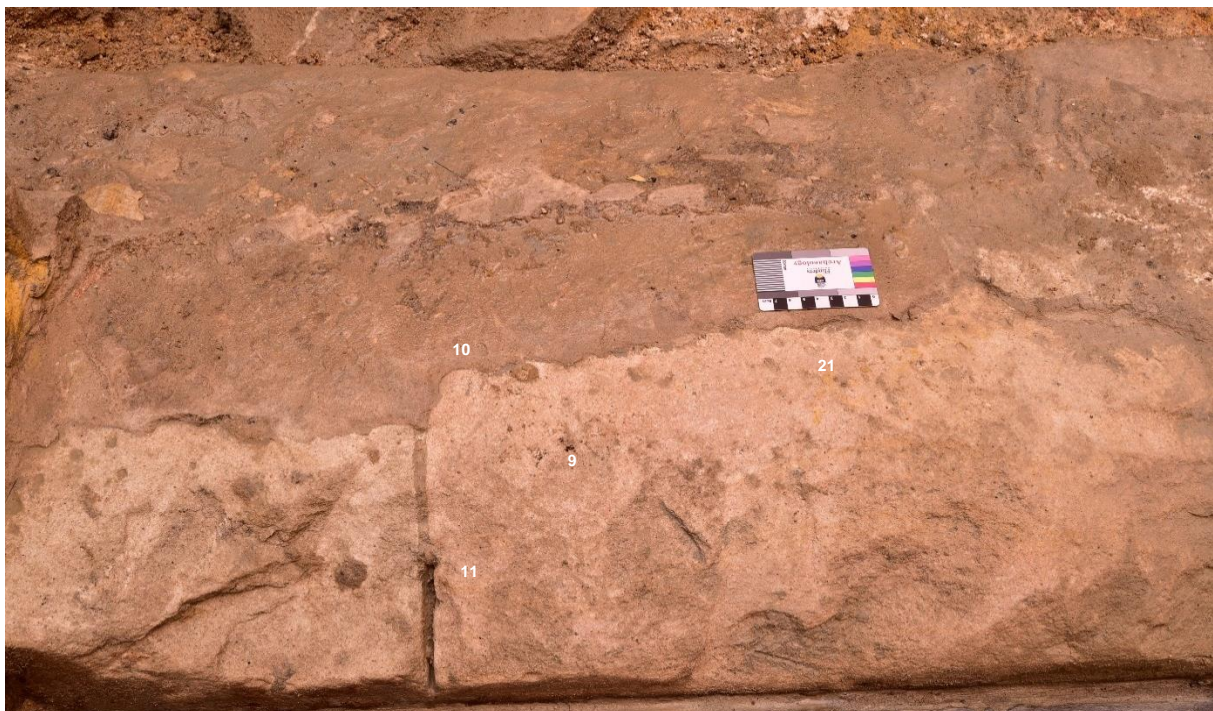
Figure 3.12 Excavation phase 2—demonstrating all phases of the site in one location. The earliest construction work (Phase 4) cut bedrock [20] to form the room, and the wall base [9]. This activity left its mark through the faint but distinct pick marks of the stonemasons [21] on the top or prepared surface of the early wall. Some faint traces of a lime mortar [10], used for construction of the wall are present on this surface. In Phase 5 the sandstone wall was partially deconstructed and re-cut using mechanical saws, resulting in the square cut lines [11]. A new brick wall was constructed to form the side of the tram inspection pit, leaving their bonding cement [10] over the top of the chamfered wall. (Source: GML 2019)

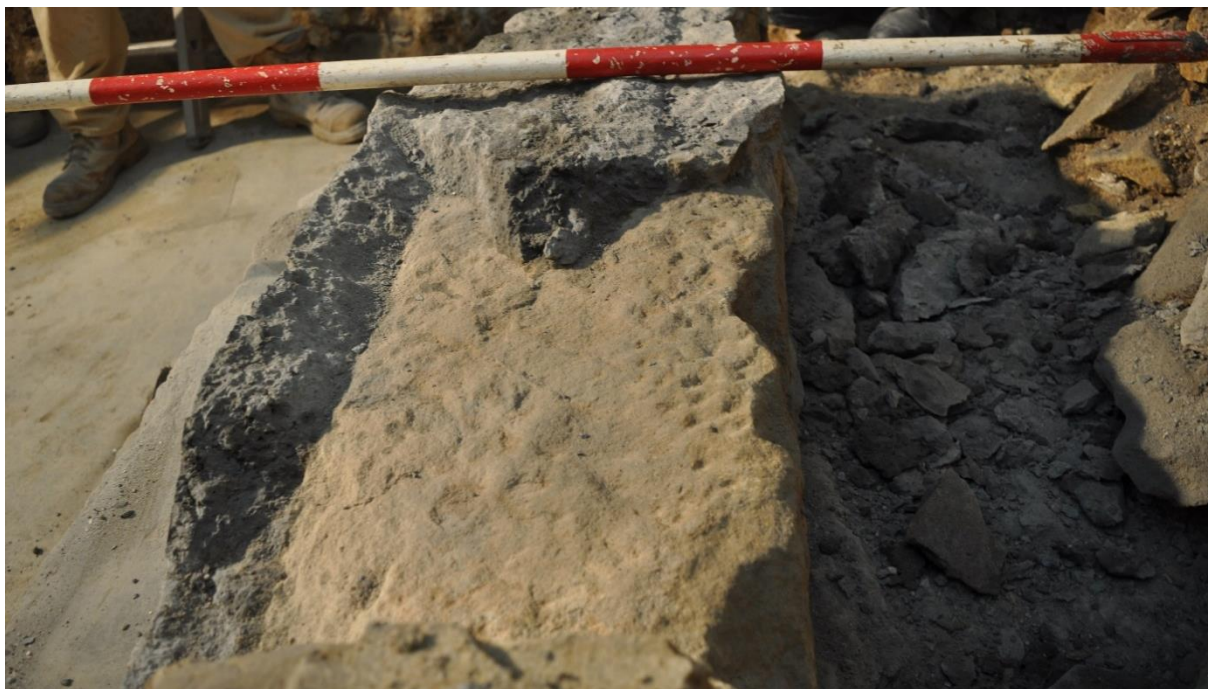
Figure 3.13 Excavation phase 2—The concrete steps [15] were cut (removed) from the sandstone steps [16], revealing the picked sandstone blockwork [21] of the earlier steps. (Source: GML 2019)

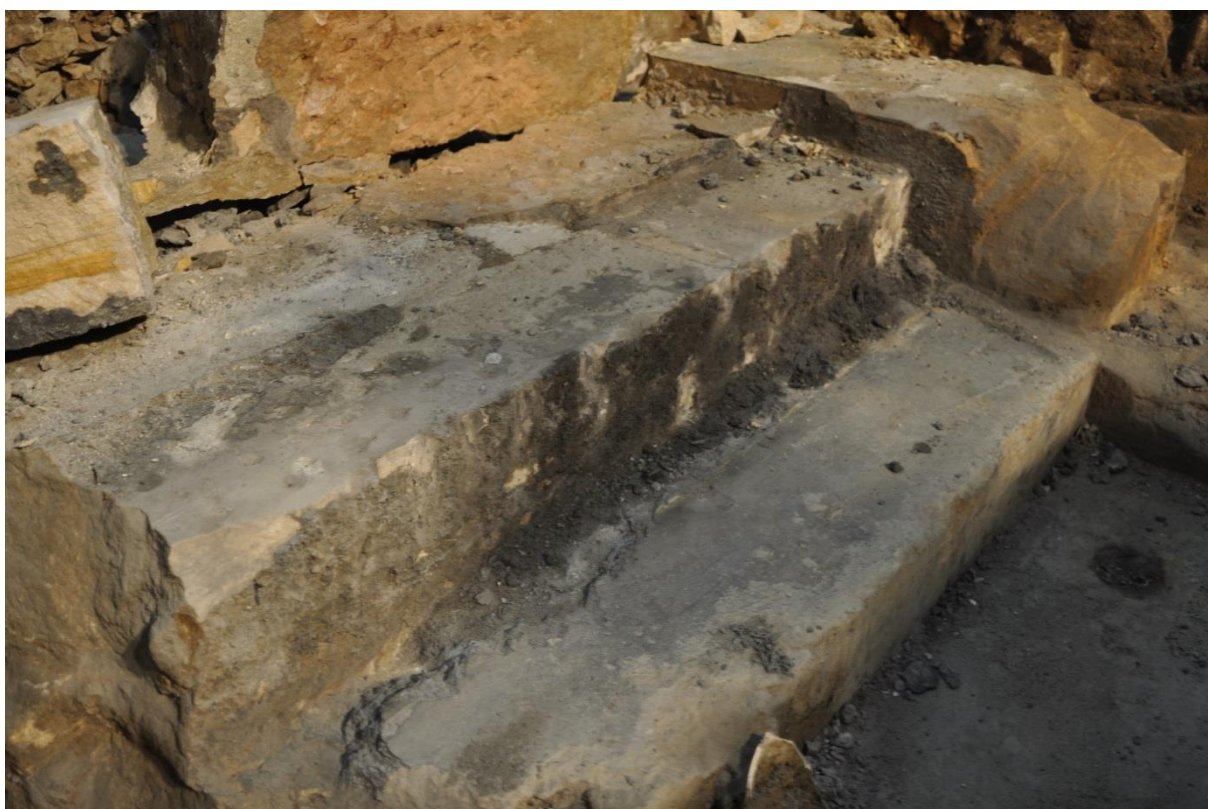
Figure 3.14 Excavation phase 2—The sandstone steps [16] were disassembled and comprised a number of distinct rectangular blocks, with some lime mortar binding. (Source: GML 2019)

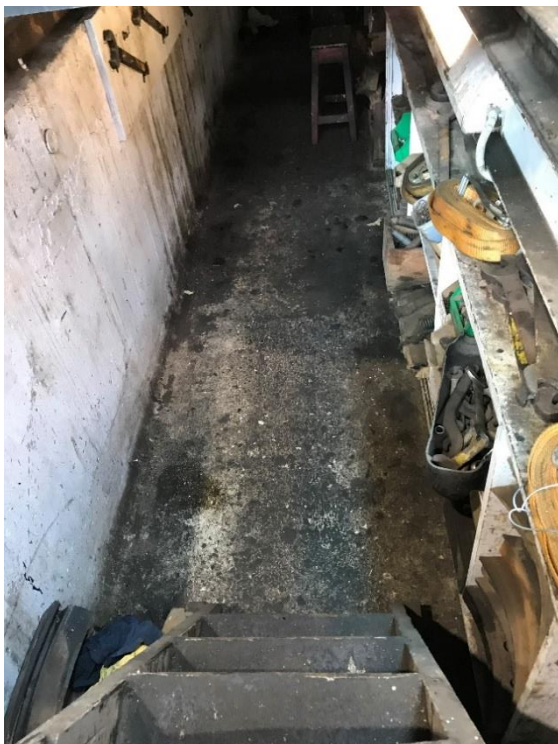
Figure 3.16 View down the stairs into a tram service pit. The wall height is around 1m. (Source: GML 2018)

These factors mean that this area was more likely used as a type of service pit rather than as a storage area during the Tramcar House phase. Contrast with other historical tram service pits (Figures 3.16 to 3.18) provide an indication of possible use. A short series of steps allows access into the shallow pit. Tools are stored within alcoves set into the wall of the pit, while the ground surface remains free of tools or other infrastructure.

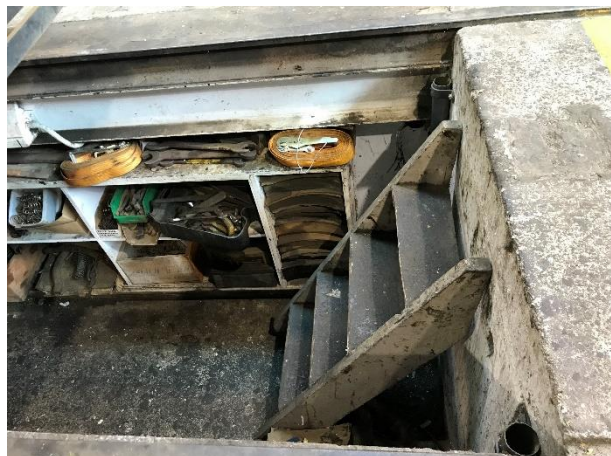
Figure 3.17 Tool storage alcoves set into the wall of the service pit. (Source: GML 2019)

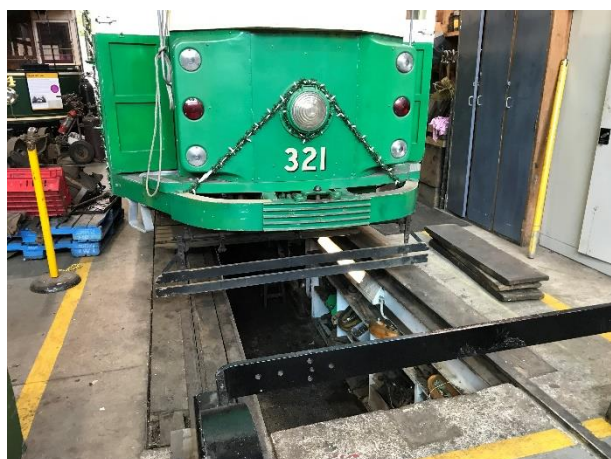
Figure 3.18 A historical tram in place over a tram service pit. (Source: GML 2019)
