Sydney Opera House—Lift 36
Historical Archaeology Excavation Report
Report prepared for Sydney Opera House
May 2019

The Sydney Opera House (SOH) is undertaking accessibility upgrades and other venue improvements on the Joan Sutherland Theatre. These include works on Lift 36 (Figure 1.1) that have the potential to impact historical archaeological deposits, structures and/or relics.

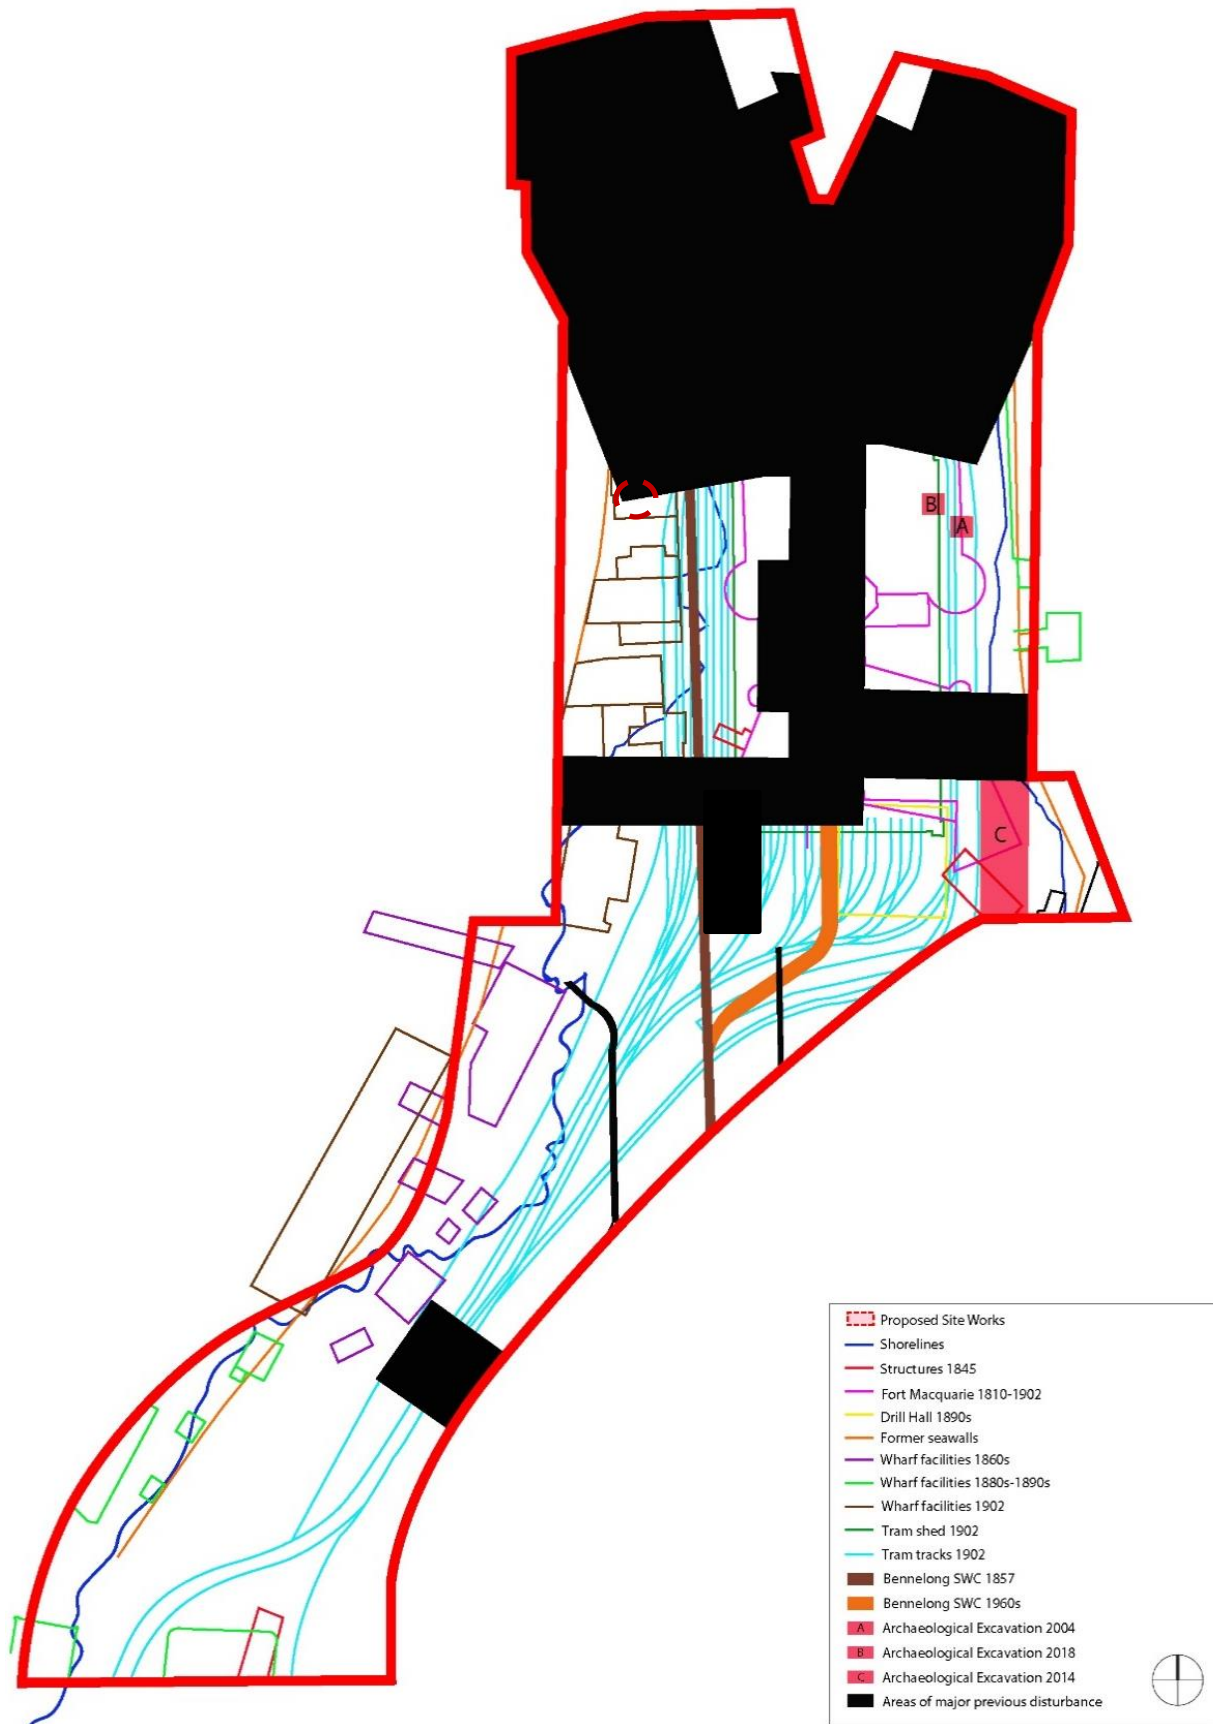
Figure 3.19 GML 2010 archaeological zoning plan for the SOH. The location of Lift 36 is shown inside the dark red circle. (Source: GML 2010: Figure 3.1)

The history and pattern of development across the wider Sydney Opera House site (illustrated with recent updates in Figure 3.19) is tempered by the place's history of development, notably the impacts resultant from Sydney Opera House construction. Incremental works to the Sydney Opera House site (eg VAPS) are also reducing the extent of the archaeological sites. The remnant archaeological resources across the Sydney Opera House site are dwindling as a resource; the area of possible evidence for original shorelines, land reclamation, and Fort Macquarie primarily restricted to the southern portions of the site.

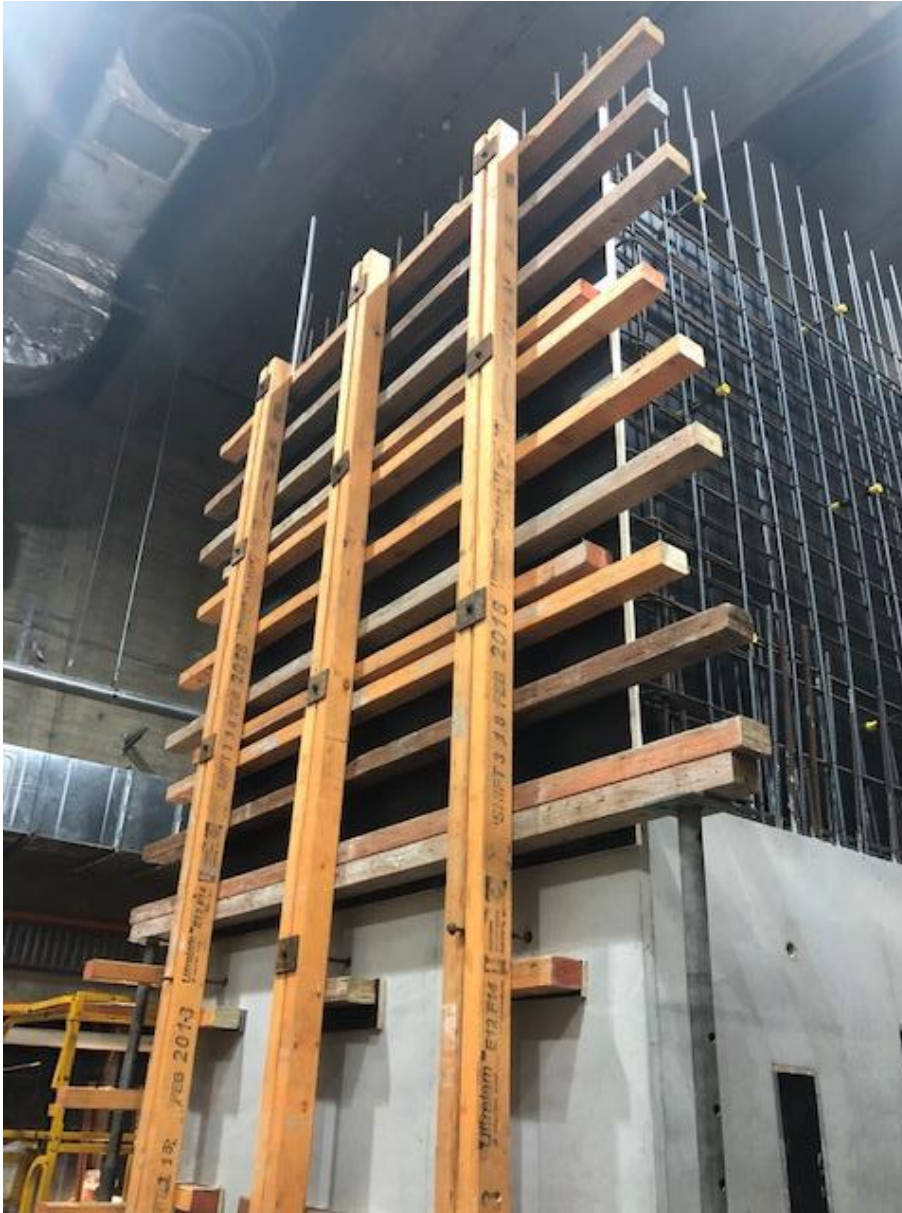
Figure 6.1 The Lift 36 area, following completion of archaeological works and initial construction to restore floor level to its prior level. (Source: SOH 2019)

Archaeological intervention and mitigation for the works connected with Lift 36 have been completed in line with the S60 approval. The area of works has now been backfilled with a mass concrete pour into the trench and the area returned to its former appearance, with the addition of construction materials for the lift (Figure 6.1).
